# Machine-Condition Monitoring using Vibration Analysis

## A Case Study from an Iron-Ore Mine

by D.N.Brown & J.C.Jørgensen  
Brüel & Kjær

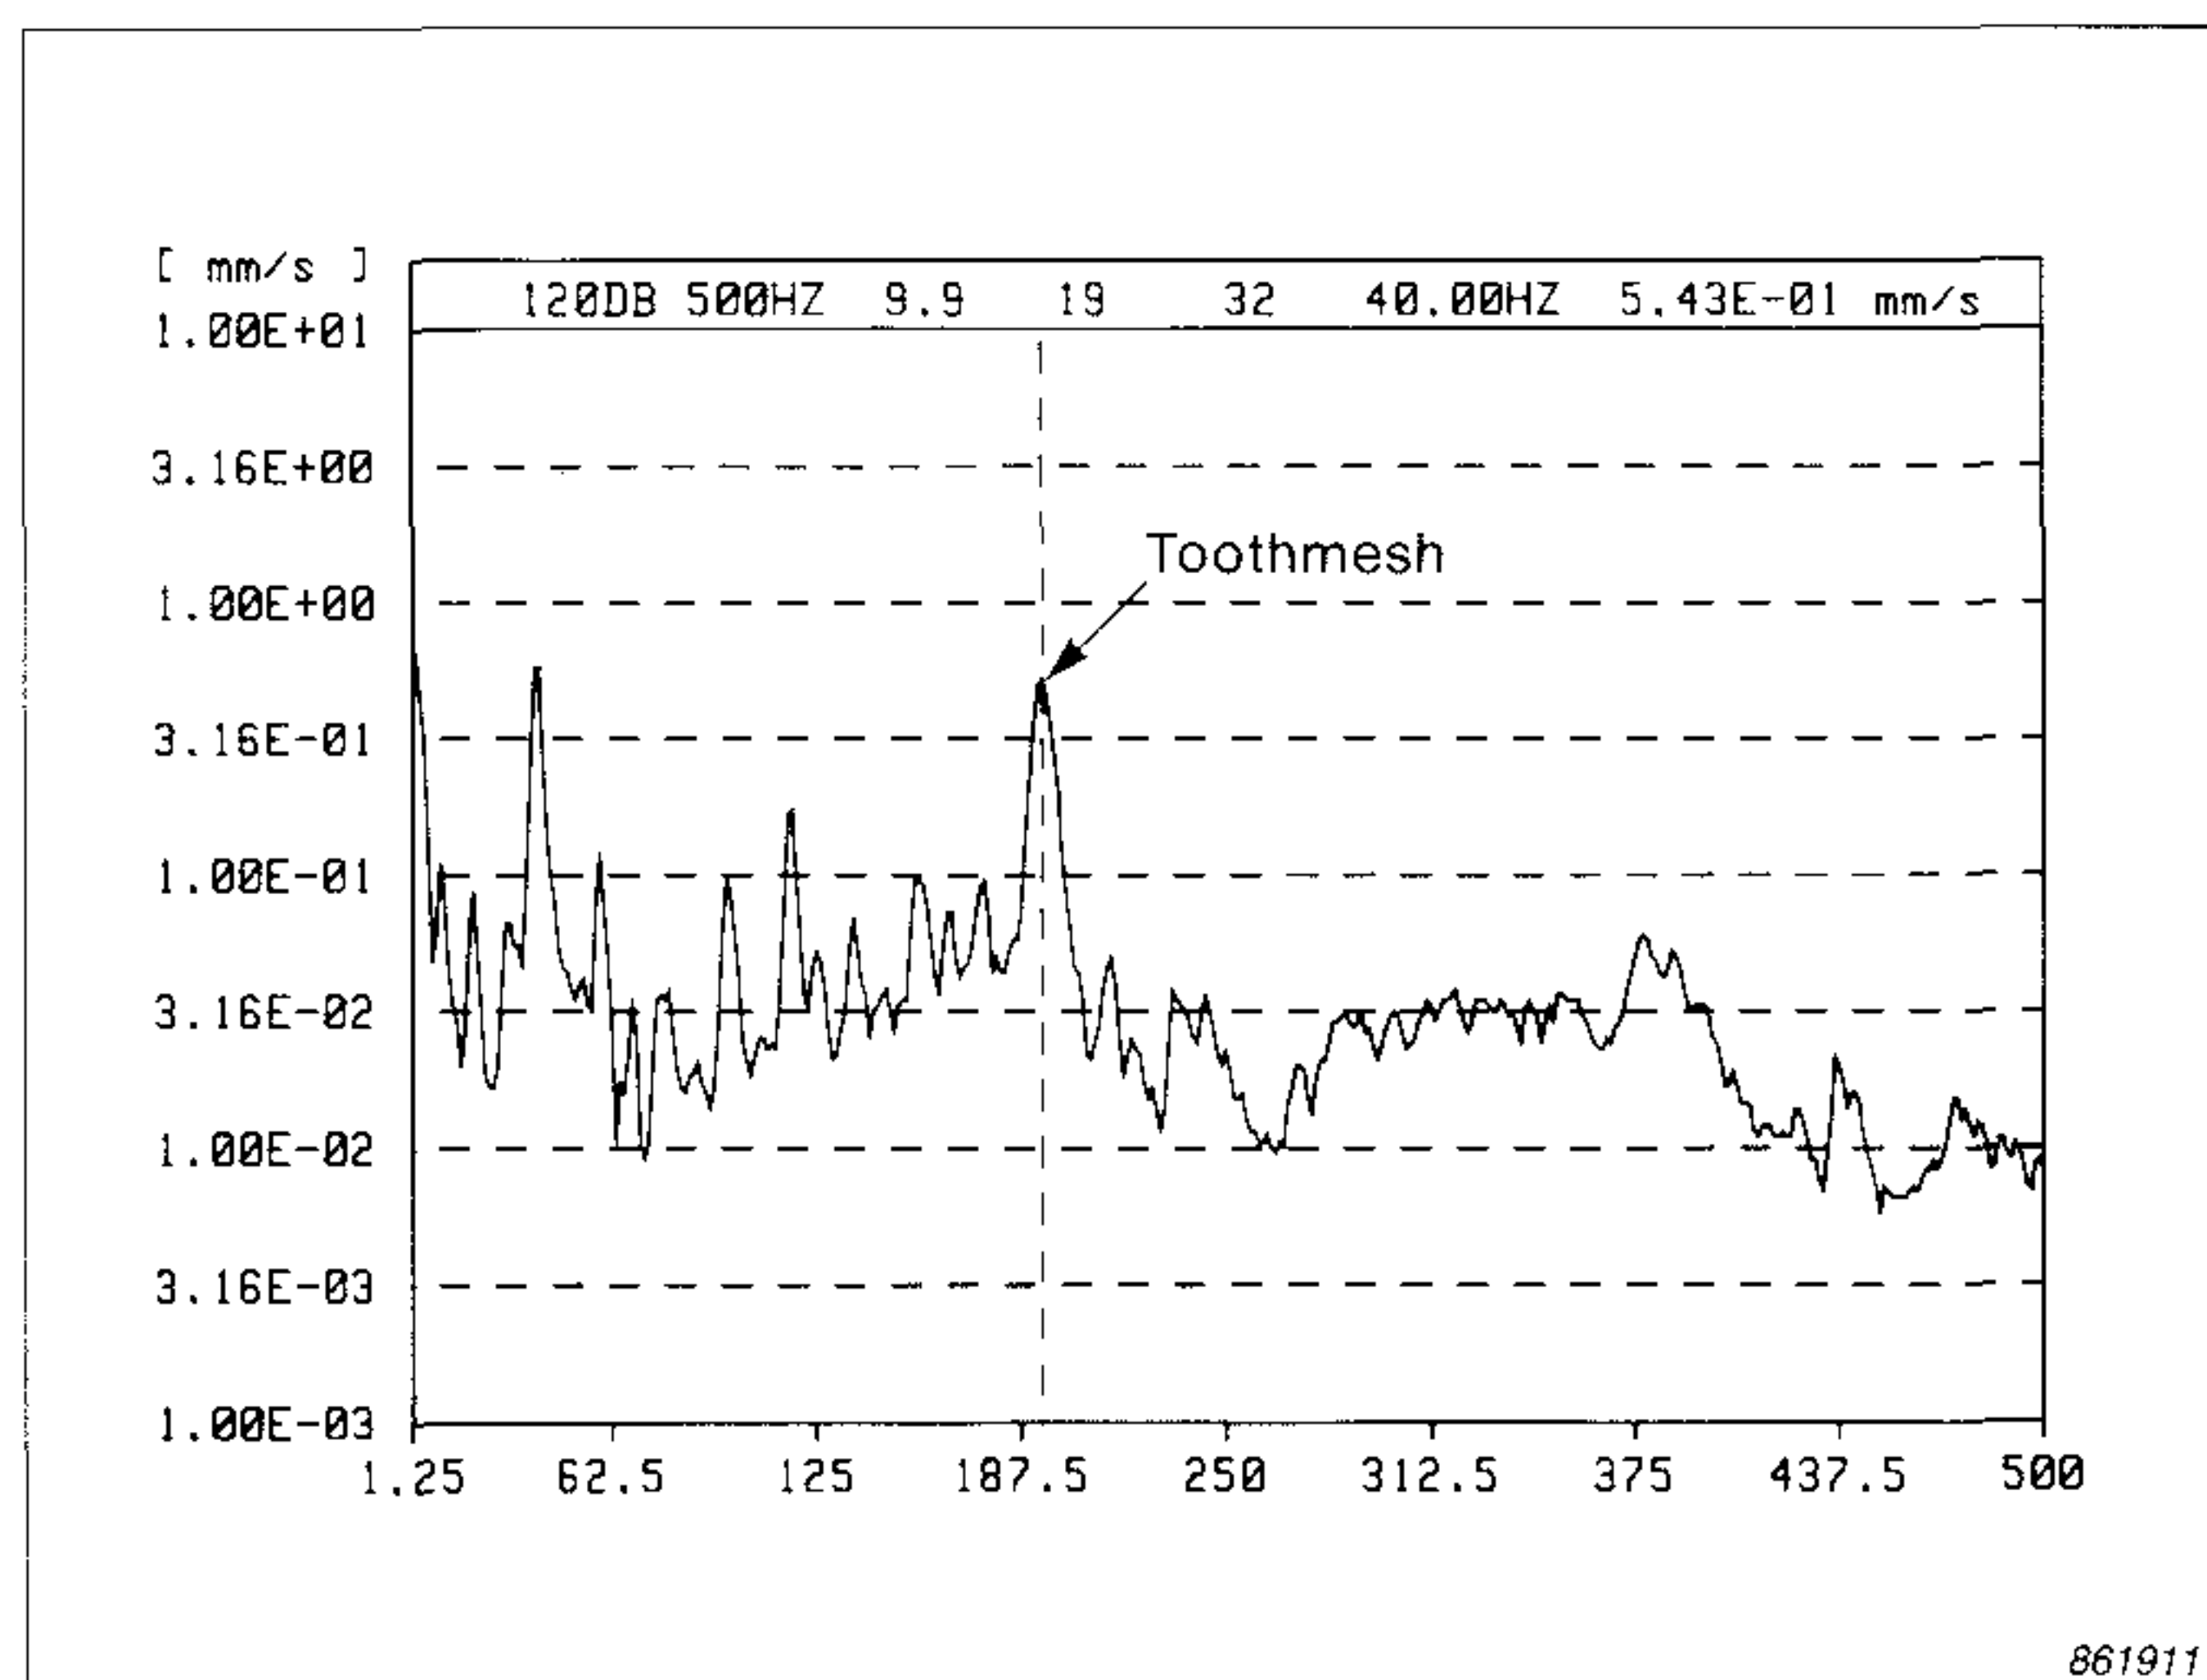
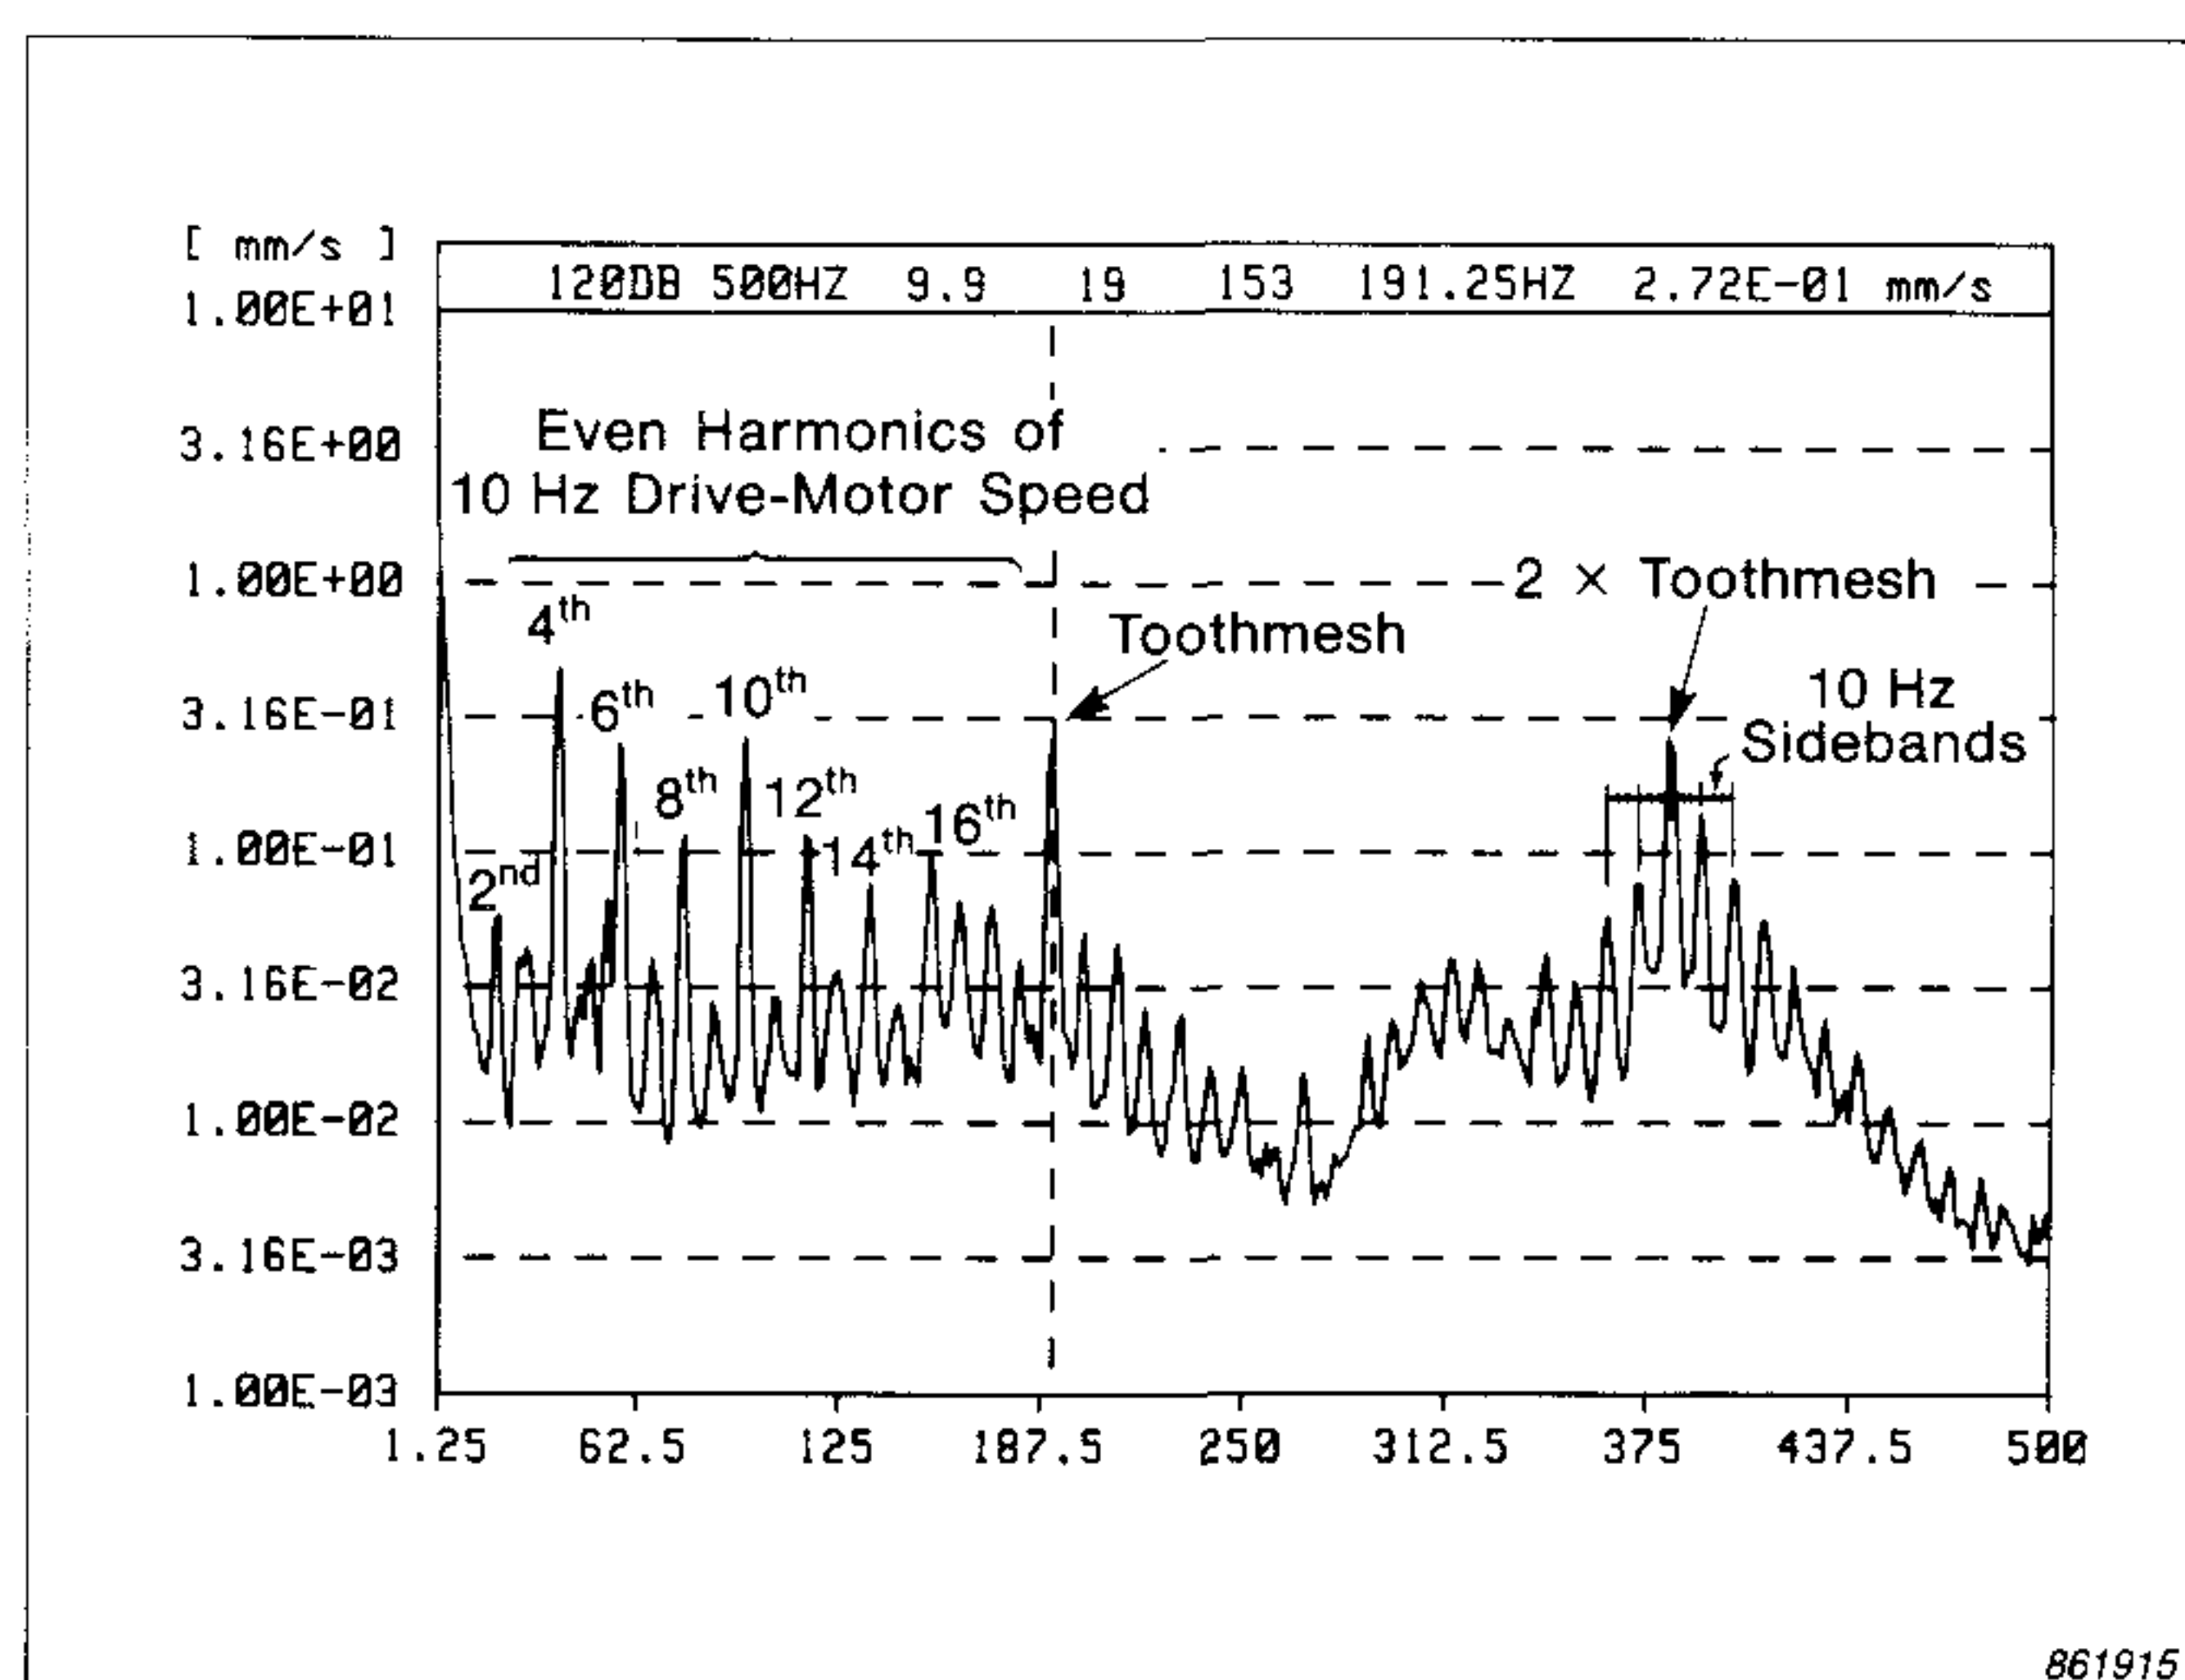
Fig. 12. Narrowband spectra from the Magnetorque<sup>®</sup>. The spectrum to the left shows the normal running conditions, whilst that to the right shows a misalignment problem

Fig.12 shows narrowband spectra from two different Magnetorques<sup>®</sup>. The spectrum to the left indicates normal running conditions. The spectrum to the right, however, shows an uncommon problem – that of misalignment between the Magnetorque<sup>®</sup> and the hoist gears. The misalignment shows itself clearly as a series of even harmonics of the drive motor fundamental (10 Hz), and a series of sidebands around the toothmeshing frequency (191,25 Hz) and its harmonics. The sideband spacing corresponds to the speed of the drive motor (10 Hz).

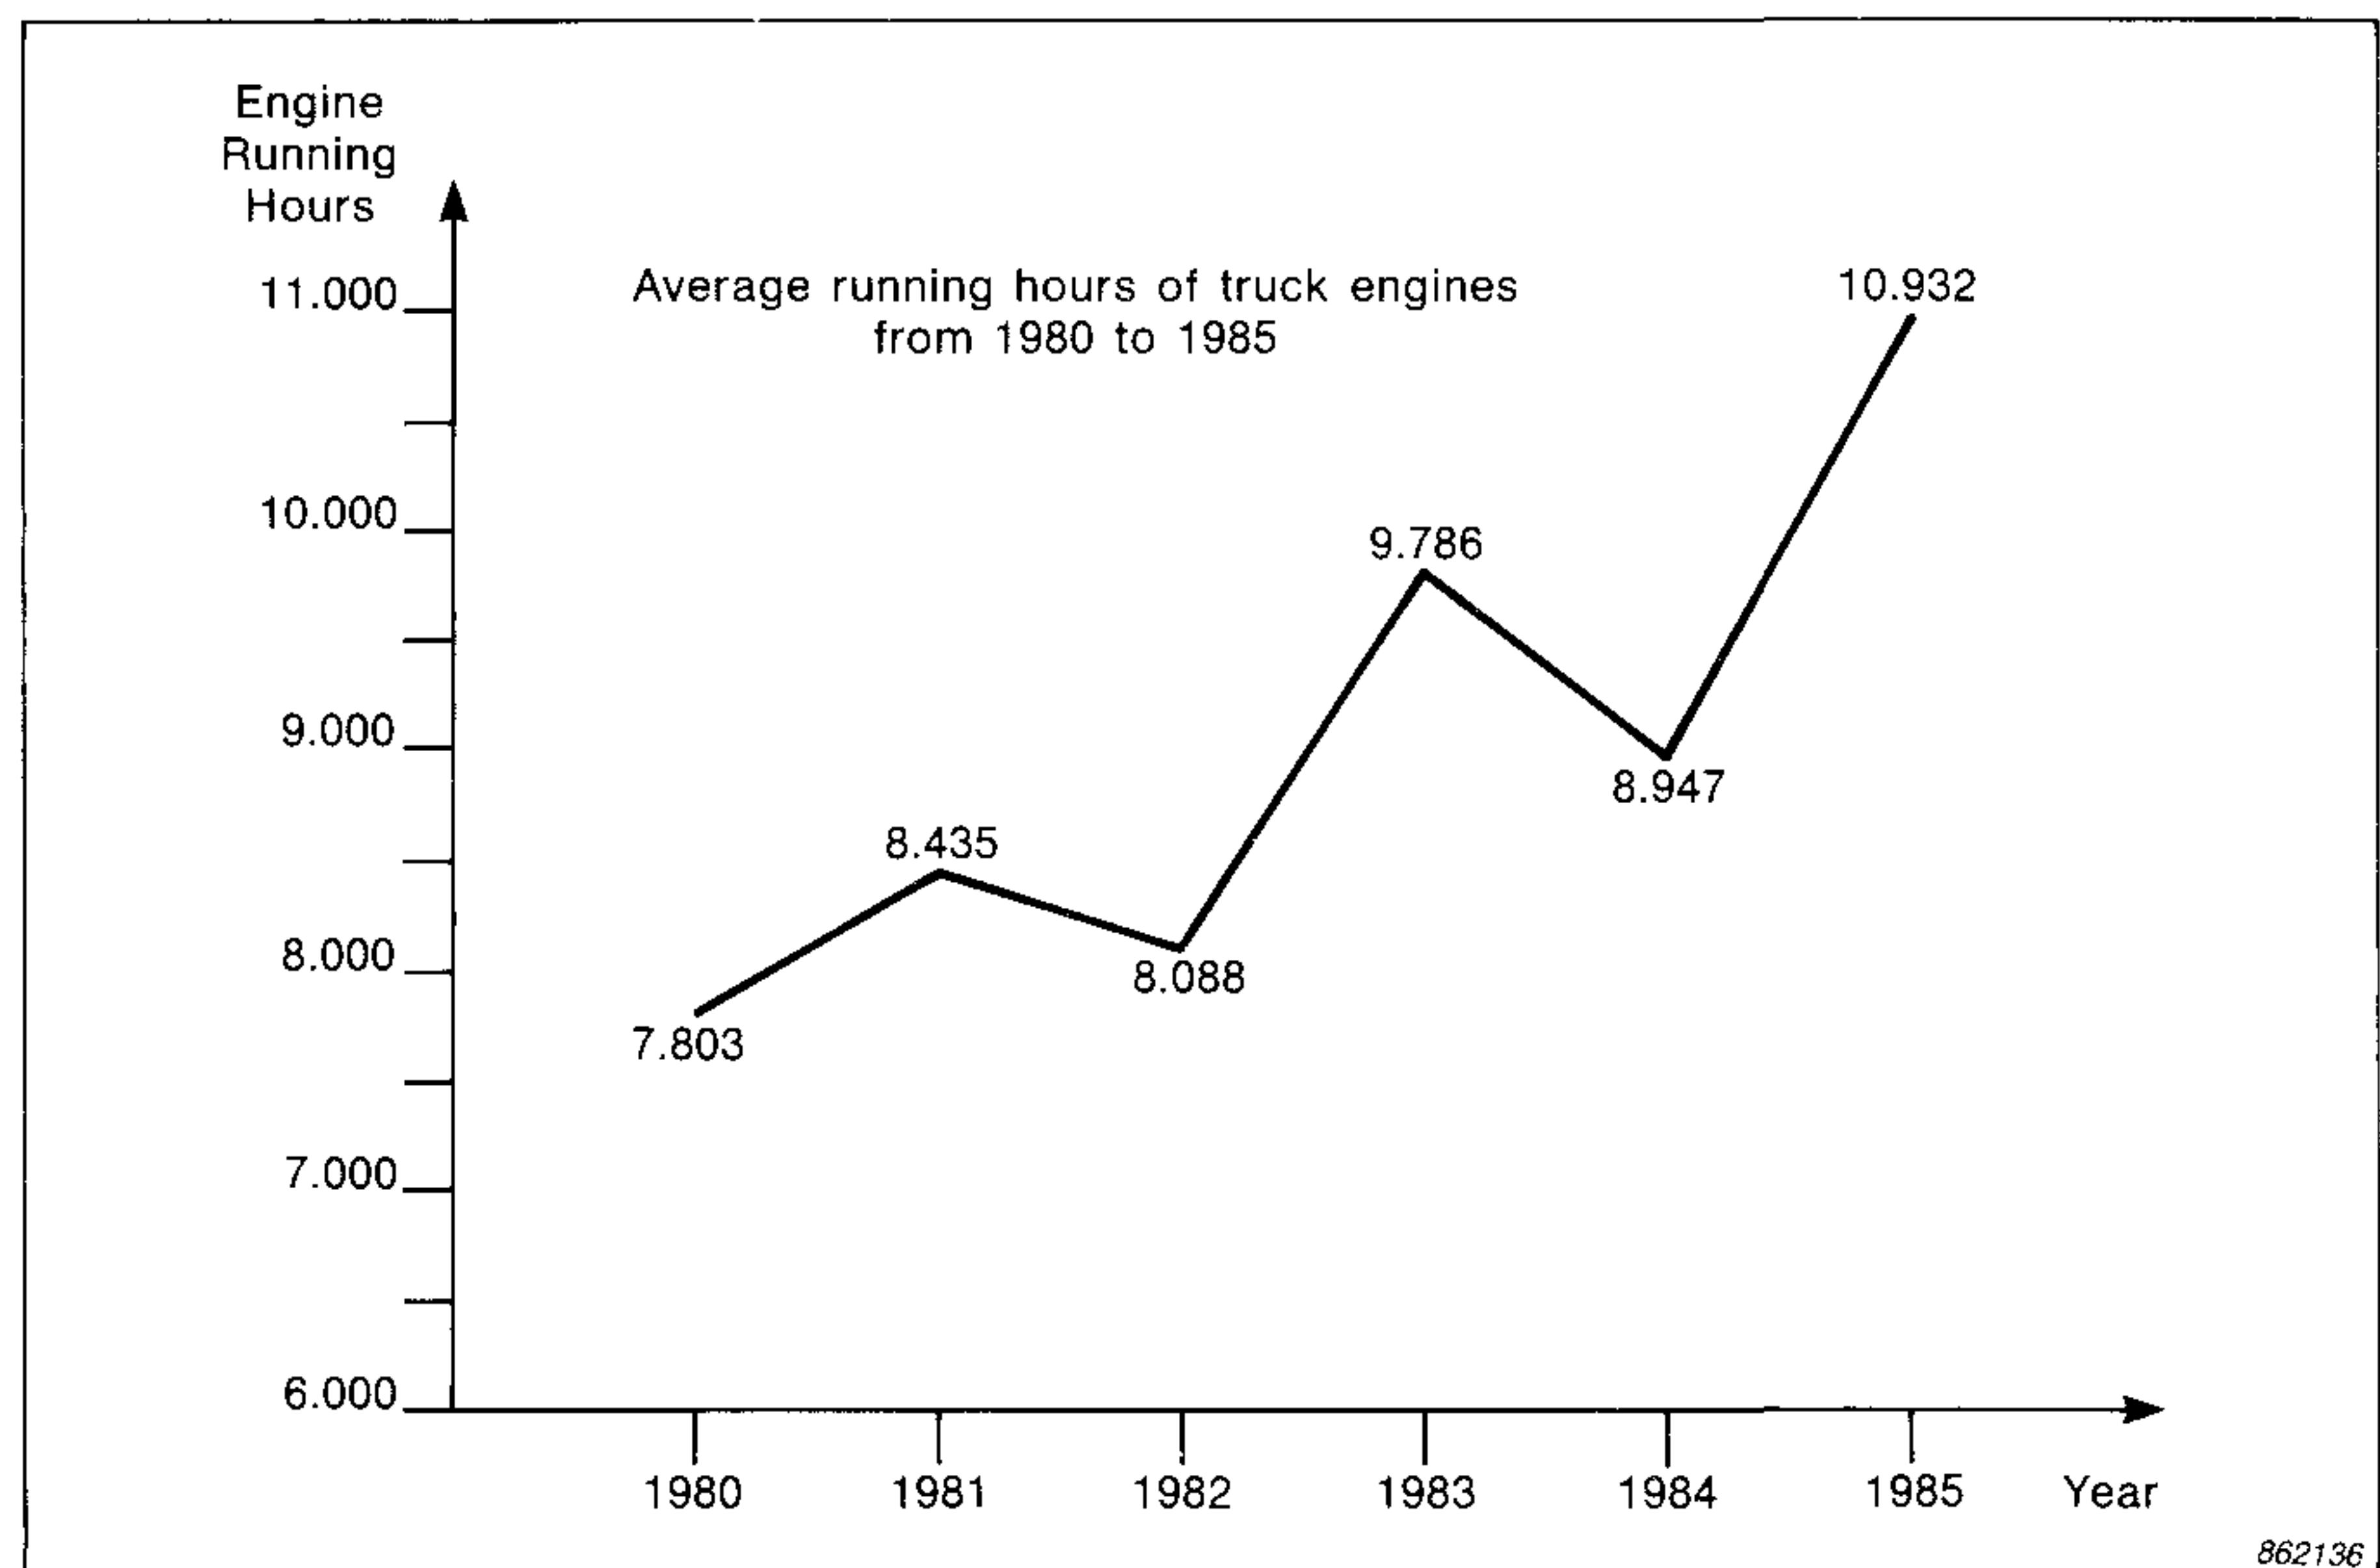
Fig. 13. Average life of truck engines

Up to 1980, the diesel engines were always changed at 10000 hours. Now, with the aid of condition monitoring, the running time has been considerably increased and at present two engines have been running for over 18000 hours. Fig. 13 shows the average life of a truck engine before being removed for reconditioning.

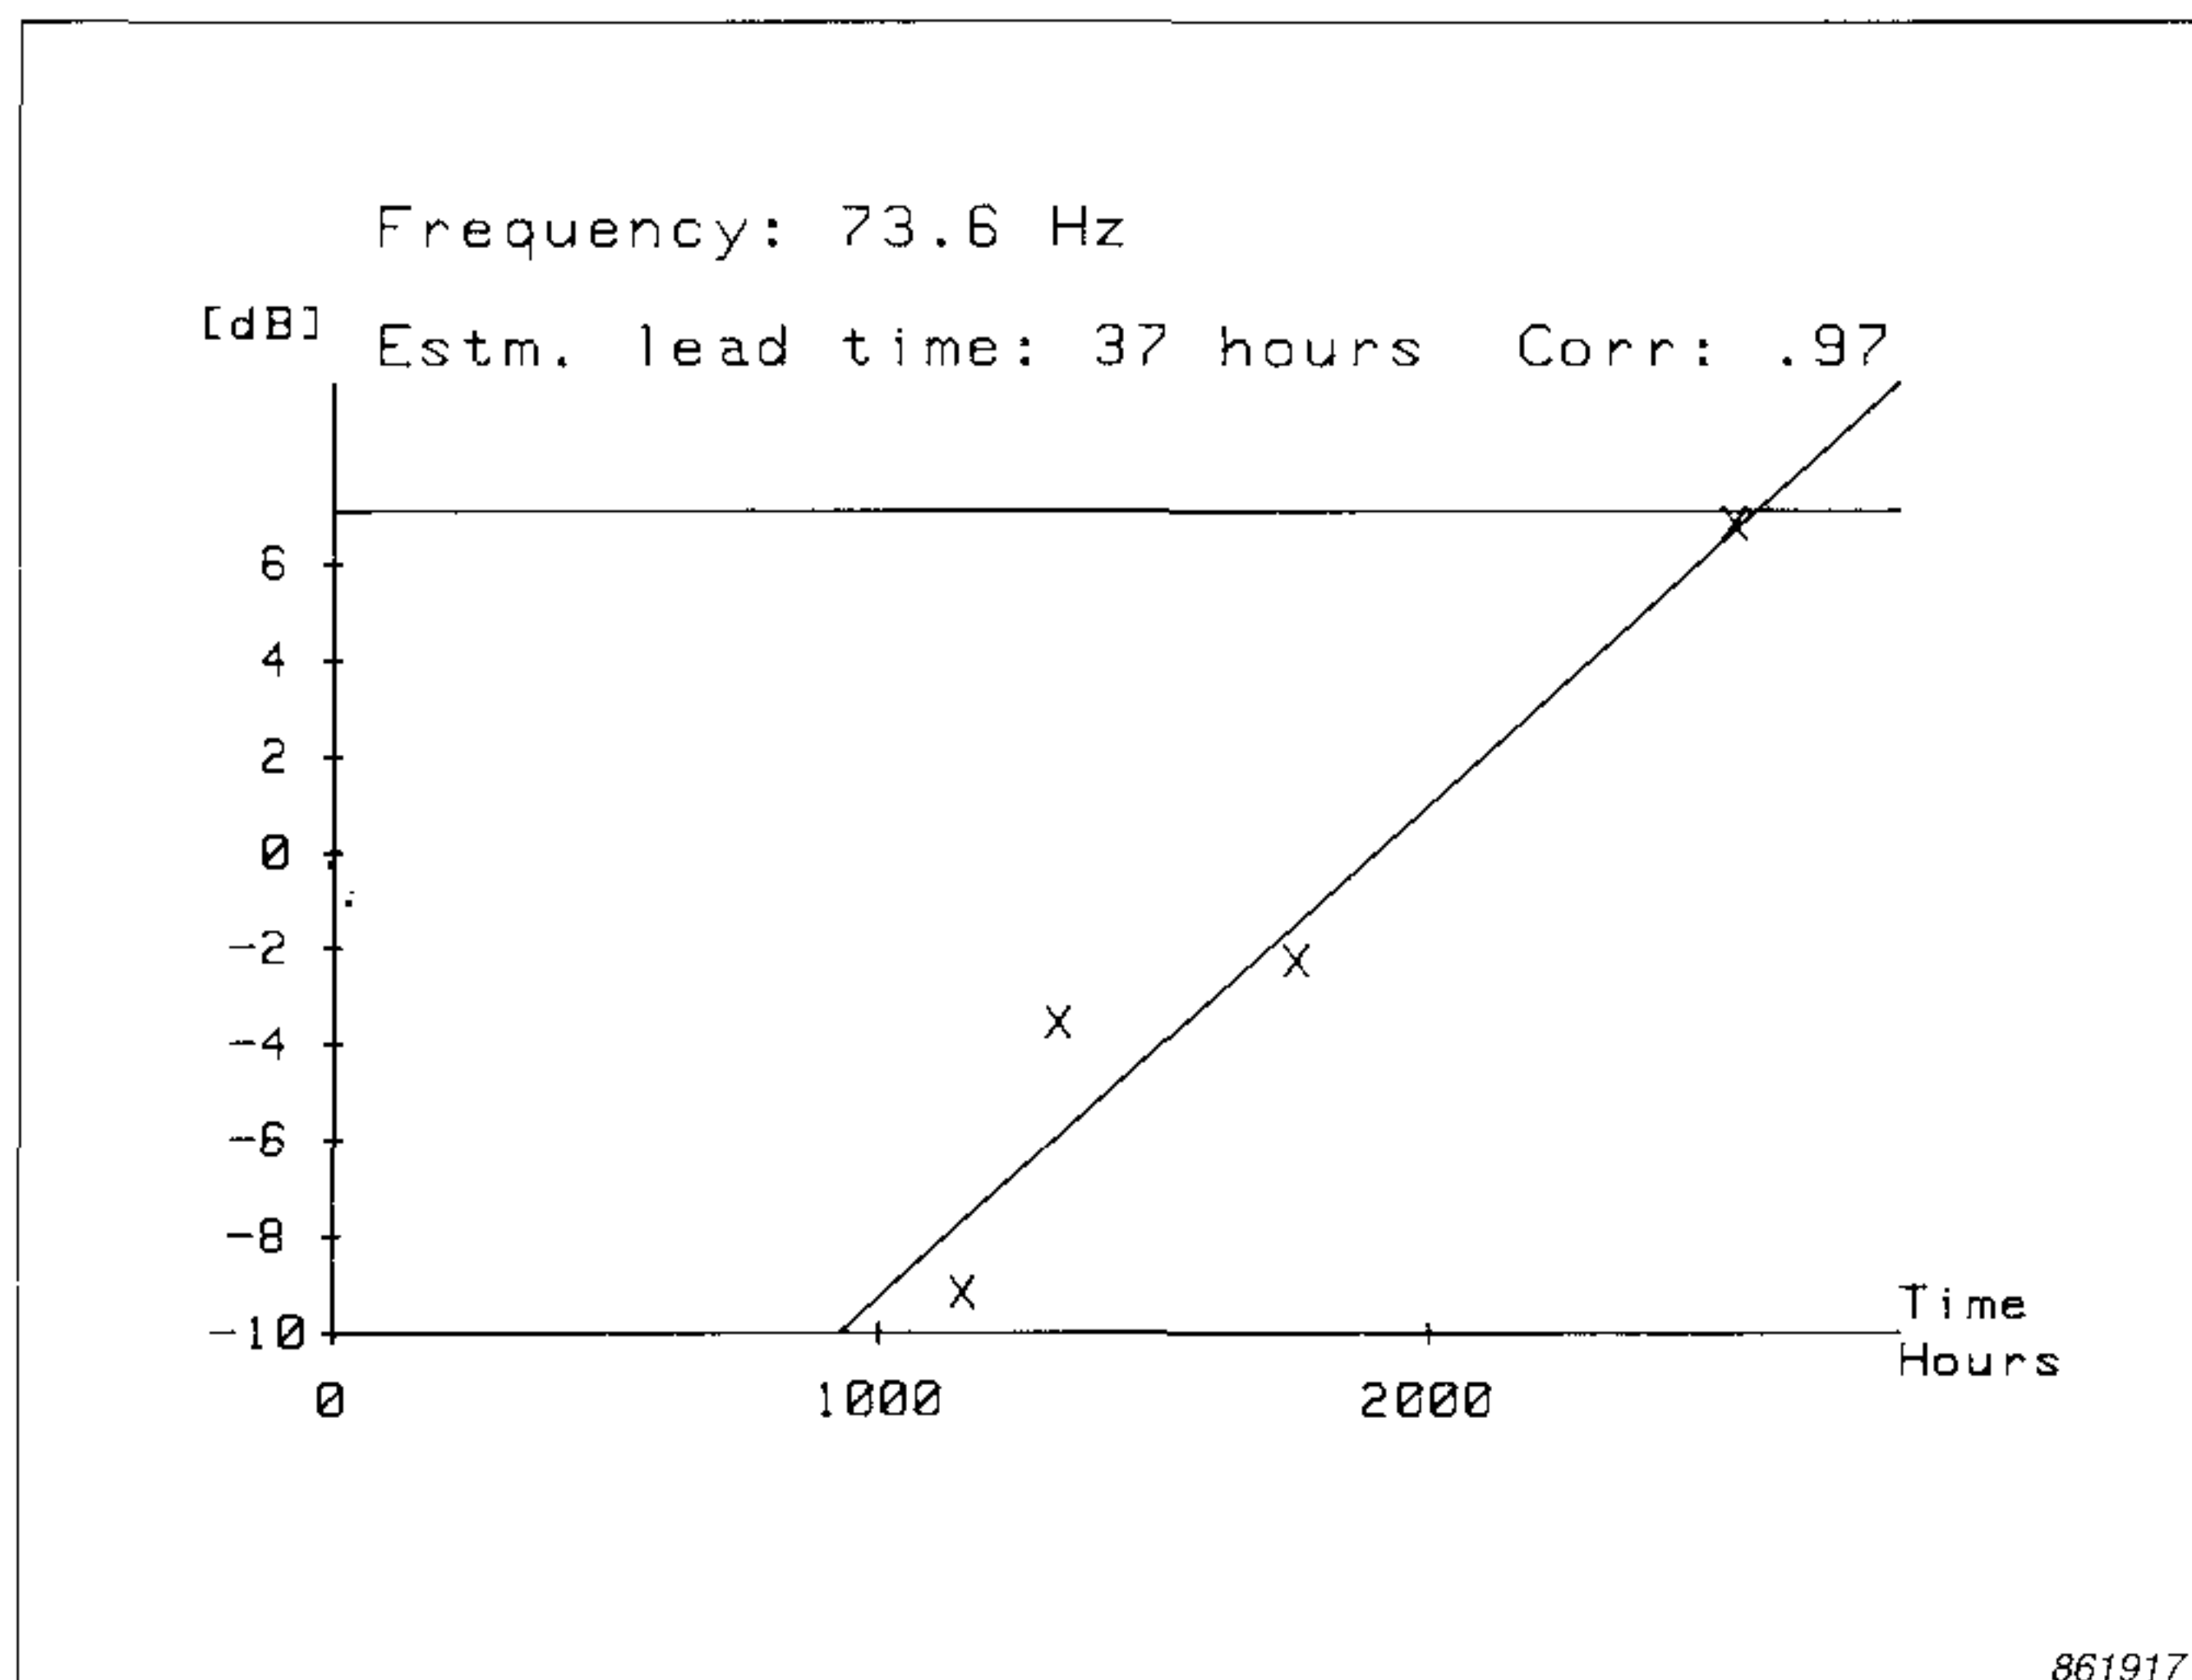
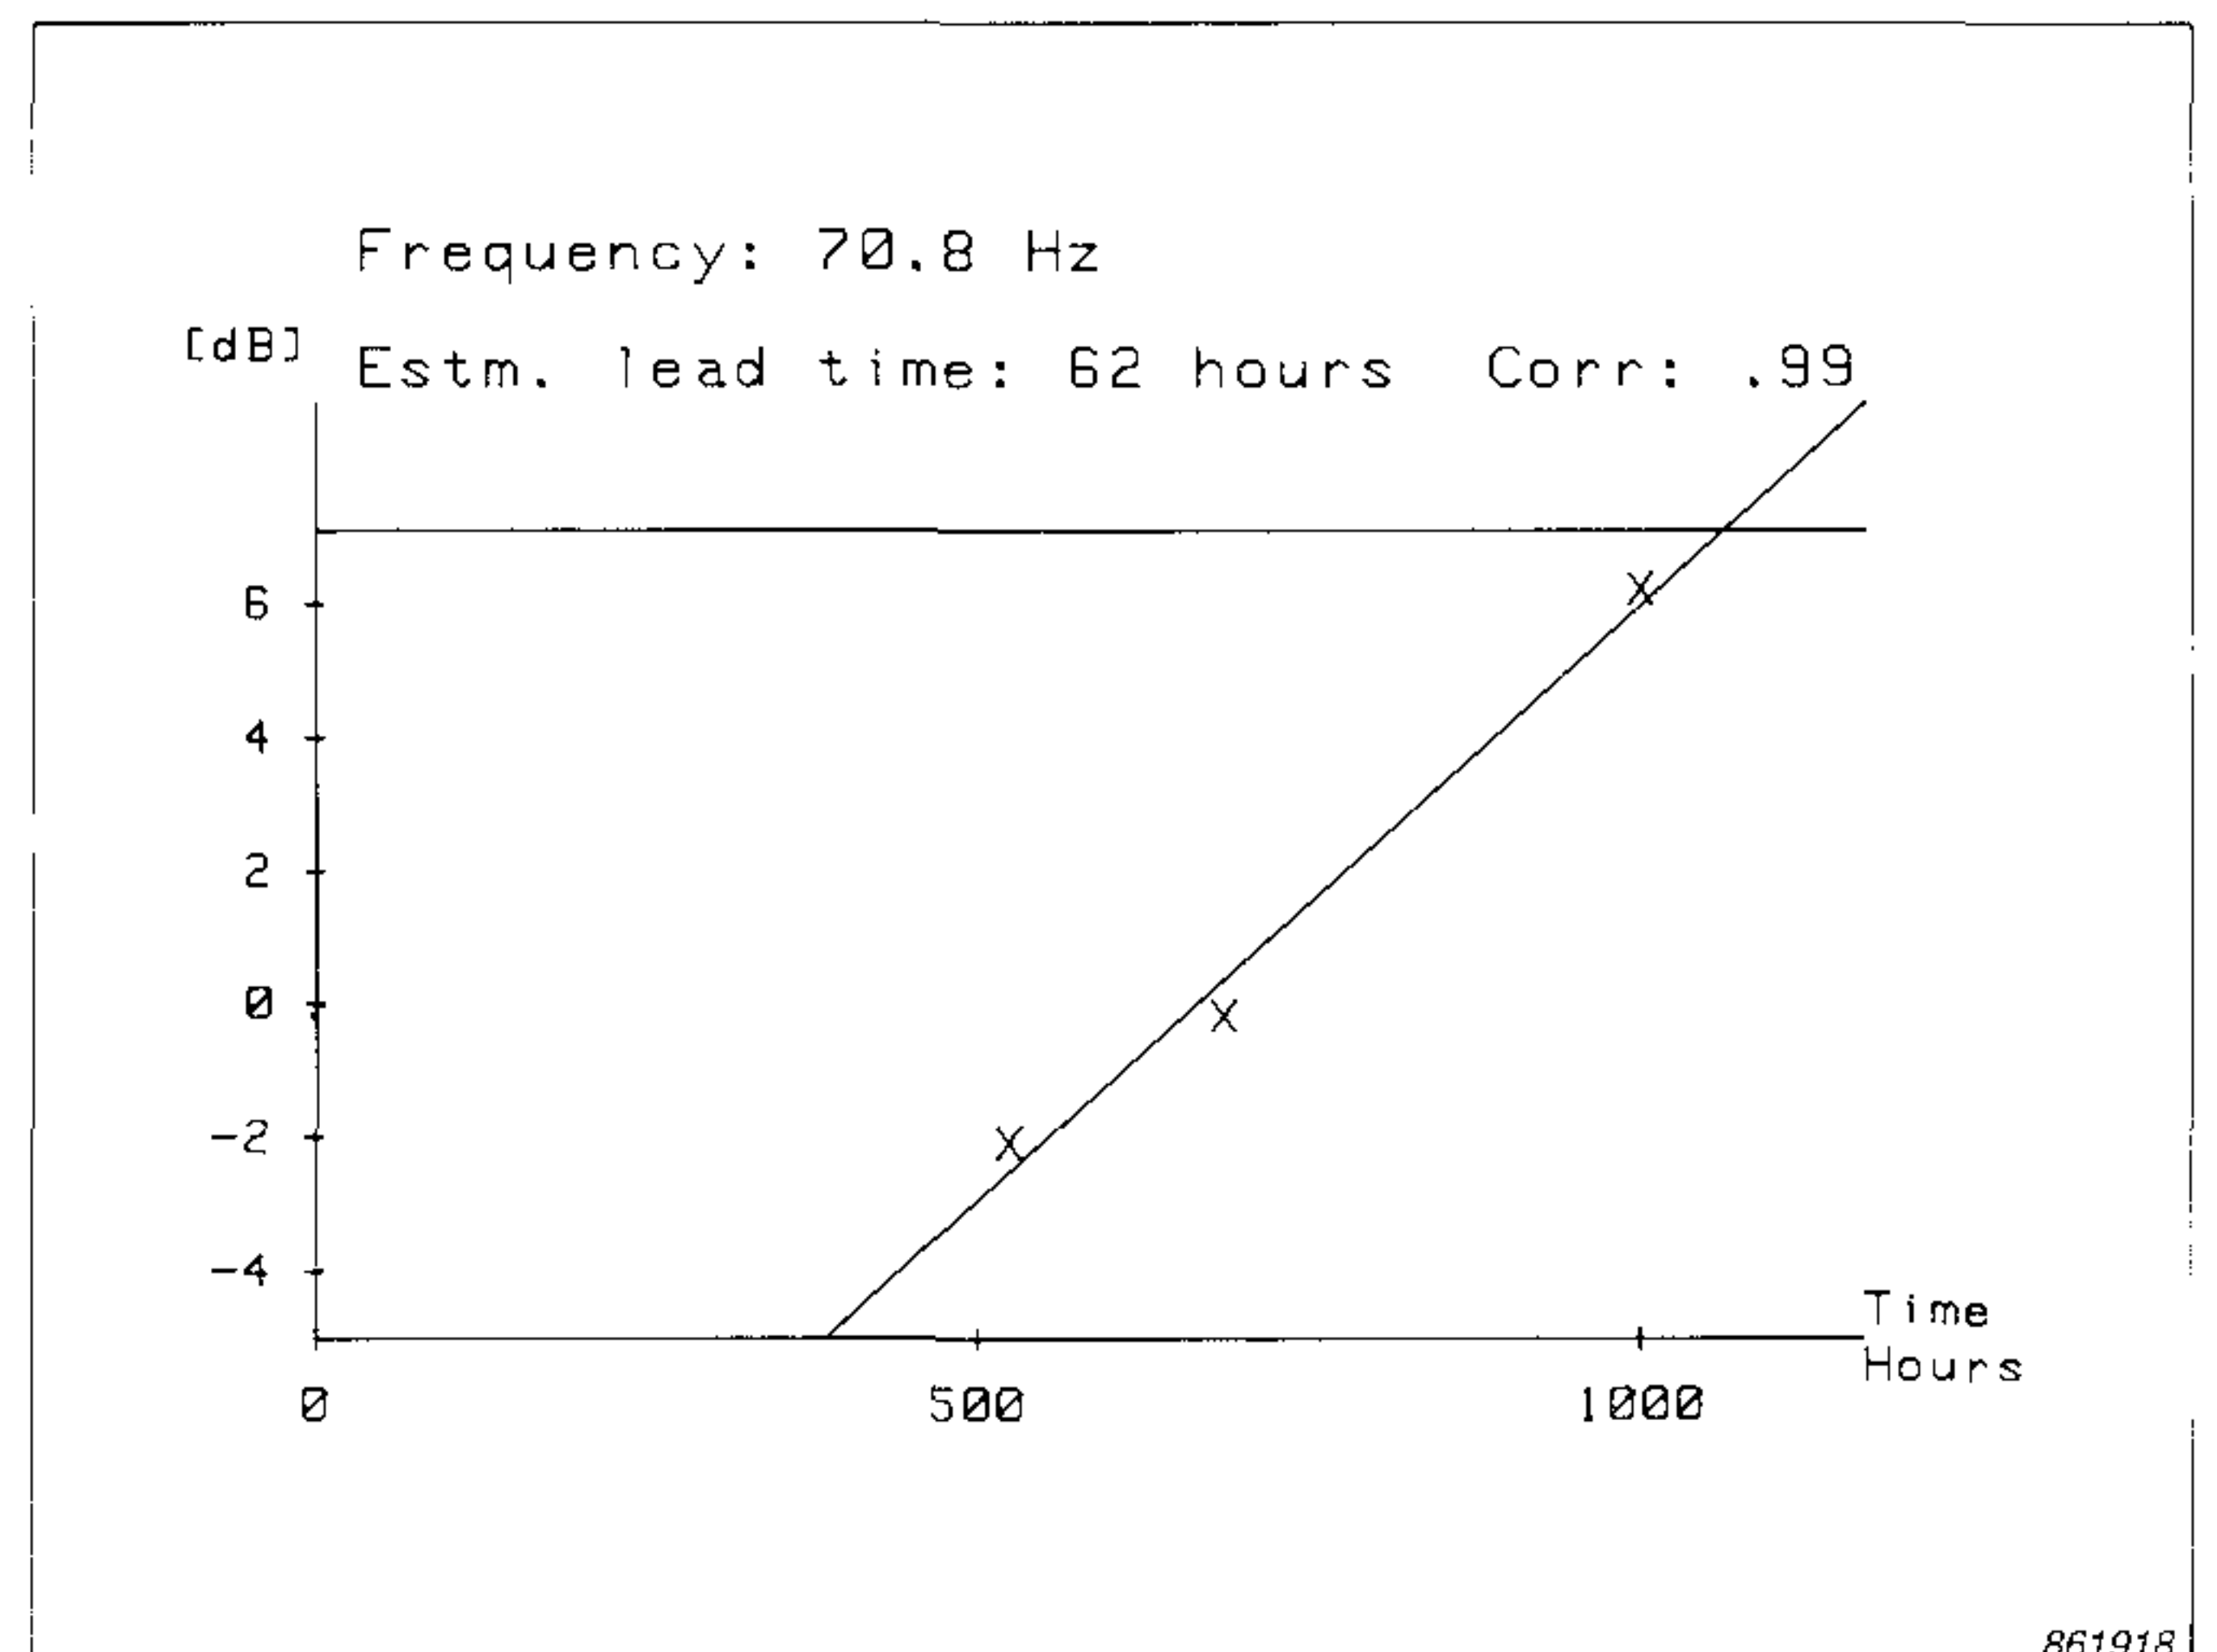
Fig. 14. Trend curves at blower drive-shaft rotational frequency. The trend to the left is for 73,6 Hz, and that to the right for 70,8 Hz

The problem was monitored using the spectrum comparison and trending facilities of the system. The problem could be characterised by an increasing vibration component at the rotation frequency of the blower drive-shaft. Fig. 14 shows trend curves made at this rotation frequency. The blower drive-shaft rotation frequency

was 73,6 Hz or 70,8 Hz depending on the engine-test speed. The upper danger level shown is the maximum vibration level tolerated before repair. Fig.15 shows a schematic layout of the engine, indicating the position of the Roots Blower and the measuring point used to detect the fault. Fig.16 shows the blower drive-shaft.

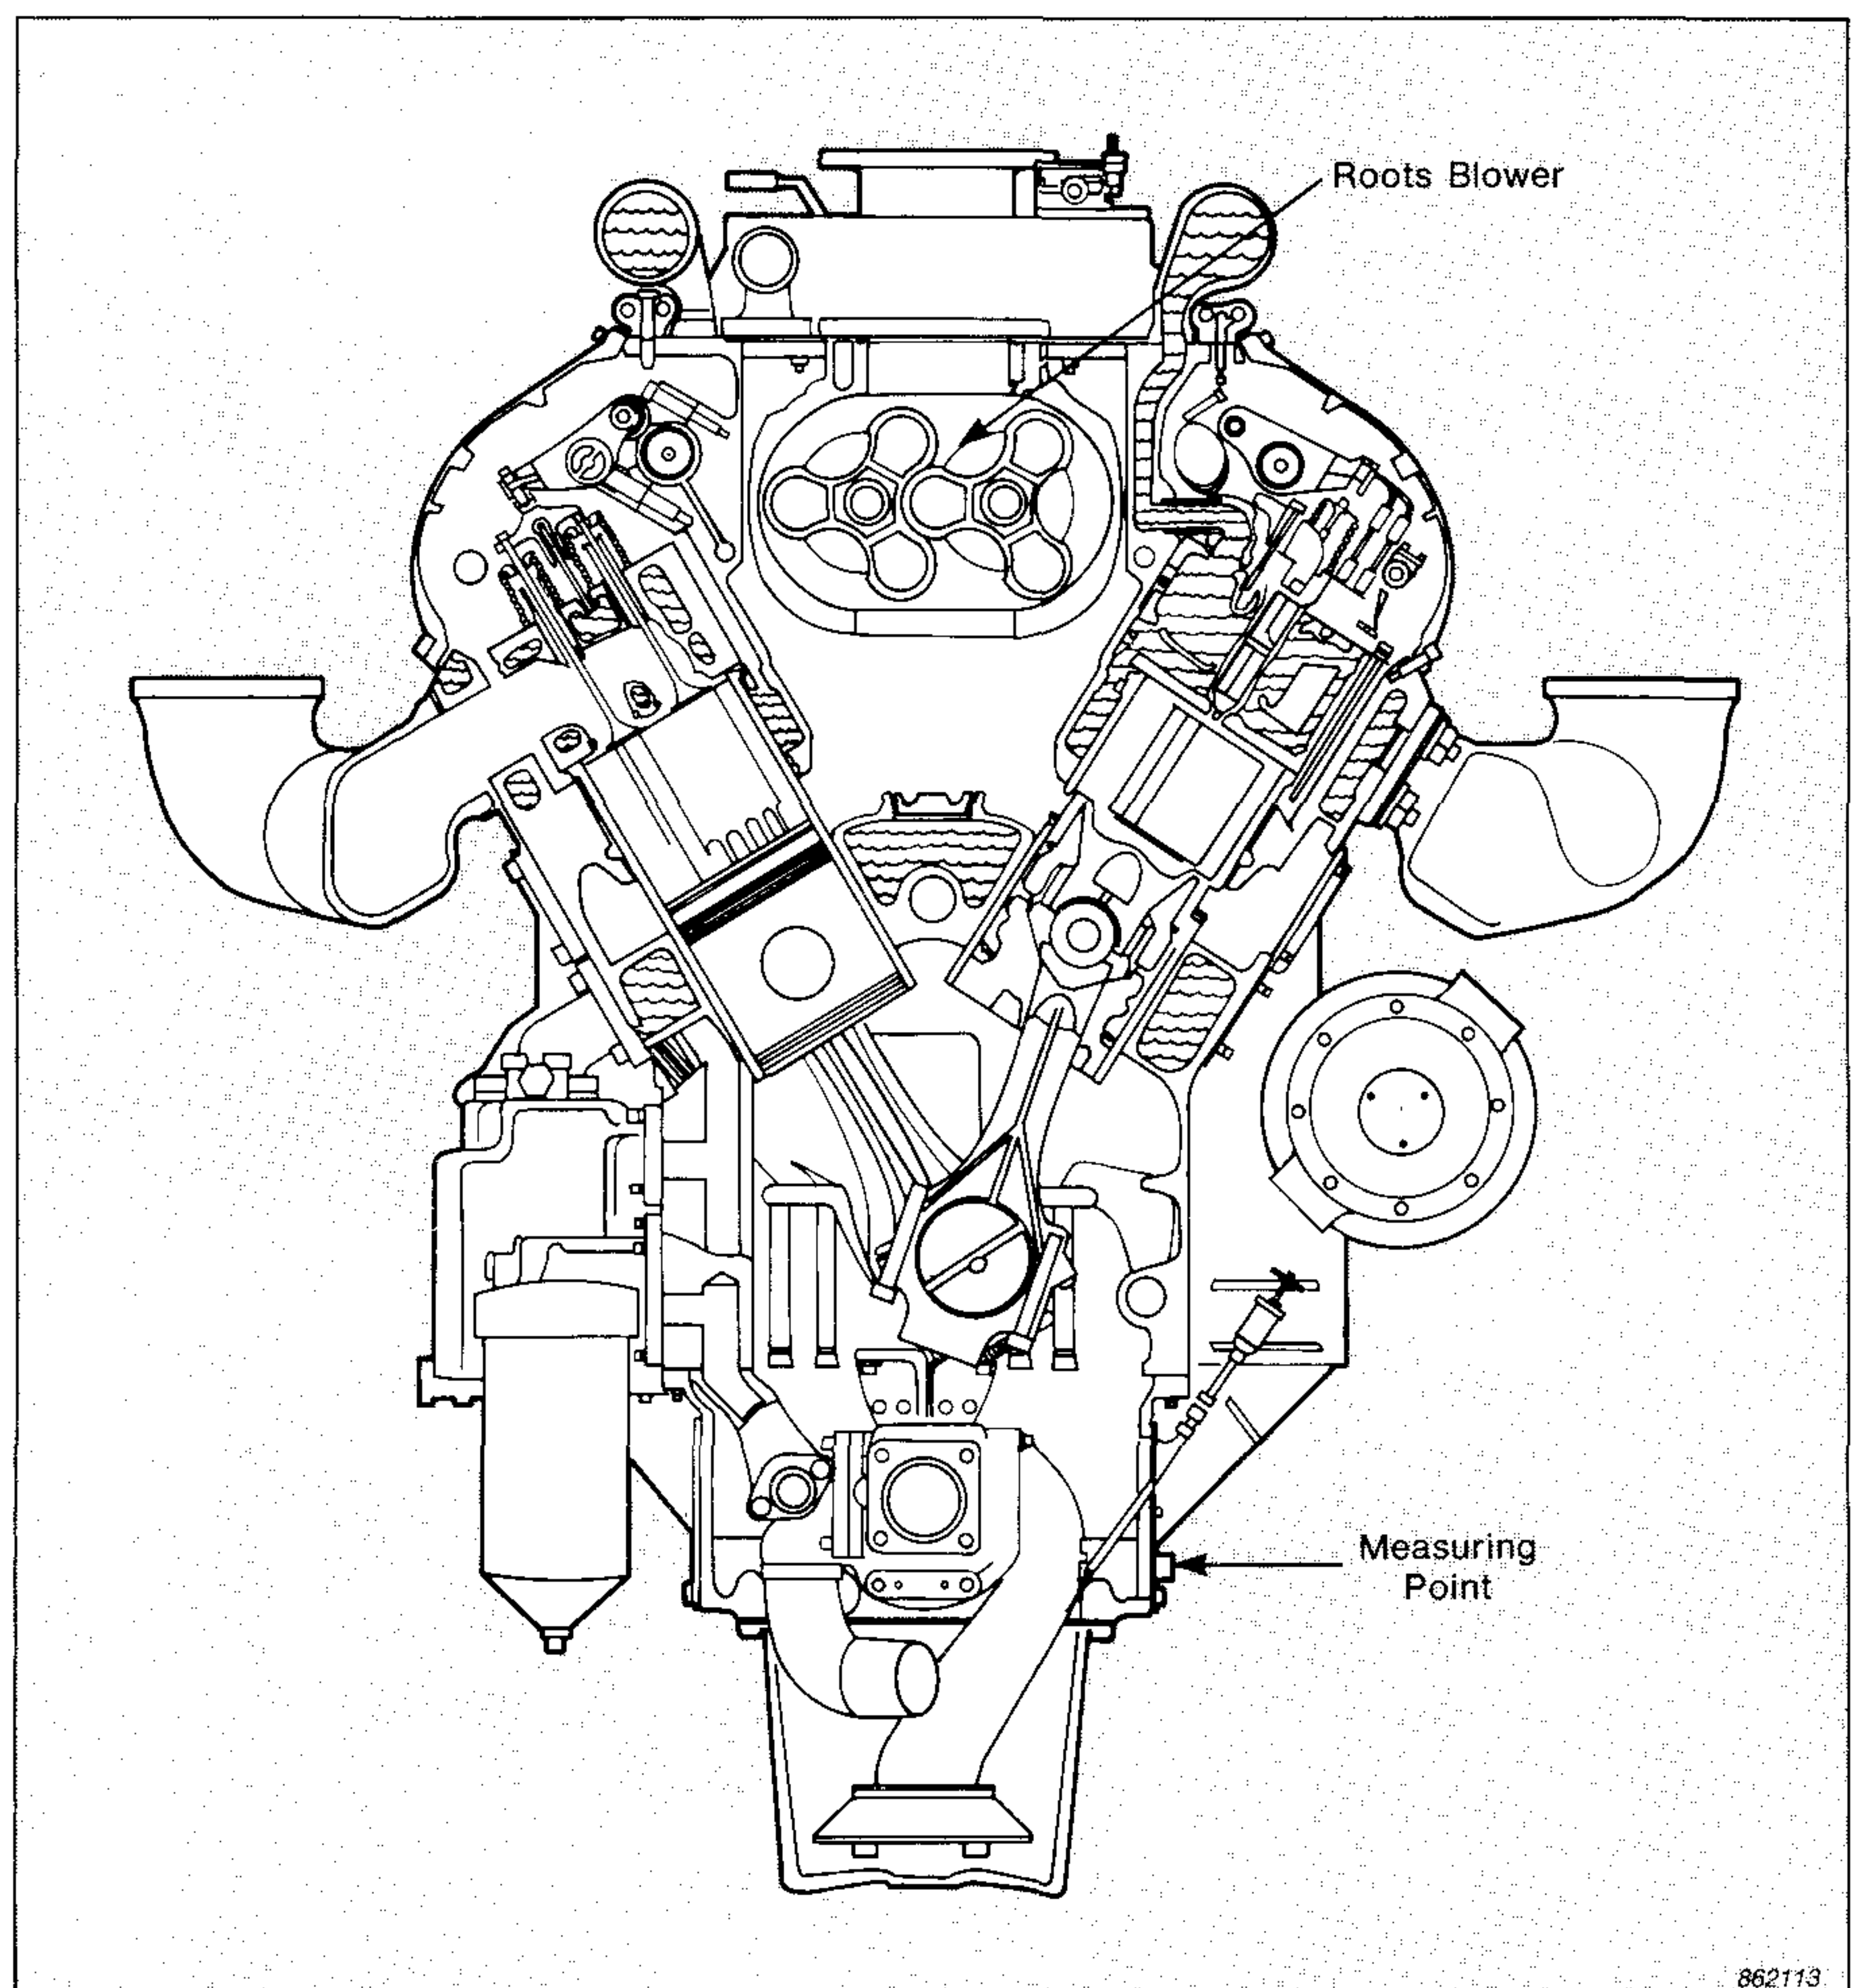
Fig. 15. The measurement point used on the truck engines to detect the Roots Blower drive problem
