# Machine-Condition Monitoring using Vibration Analysis

## A Case Study from an Iron-Ore Mine

by D.N.Brown & J.C.Jørgensen  
Brüel & Kjær

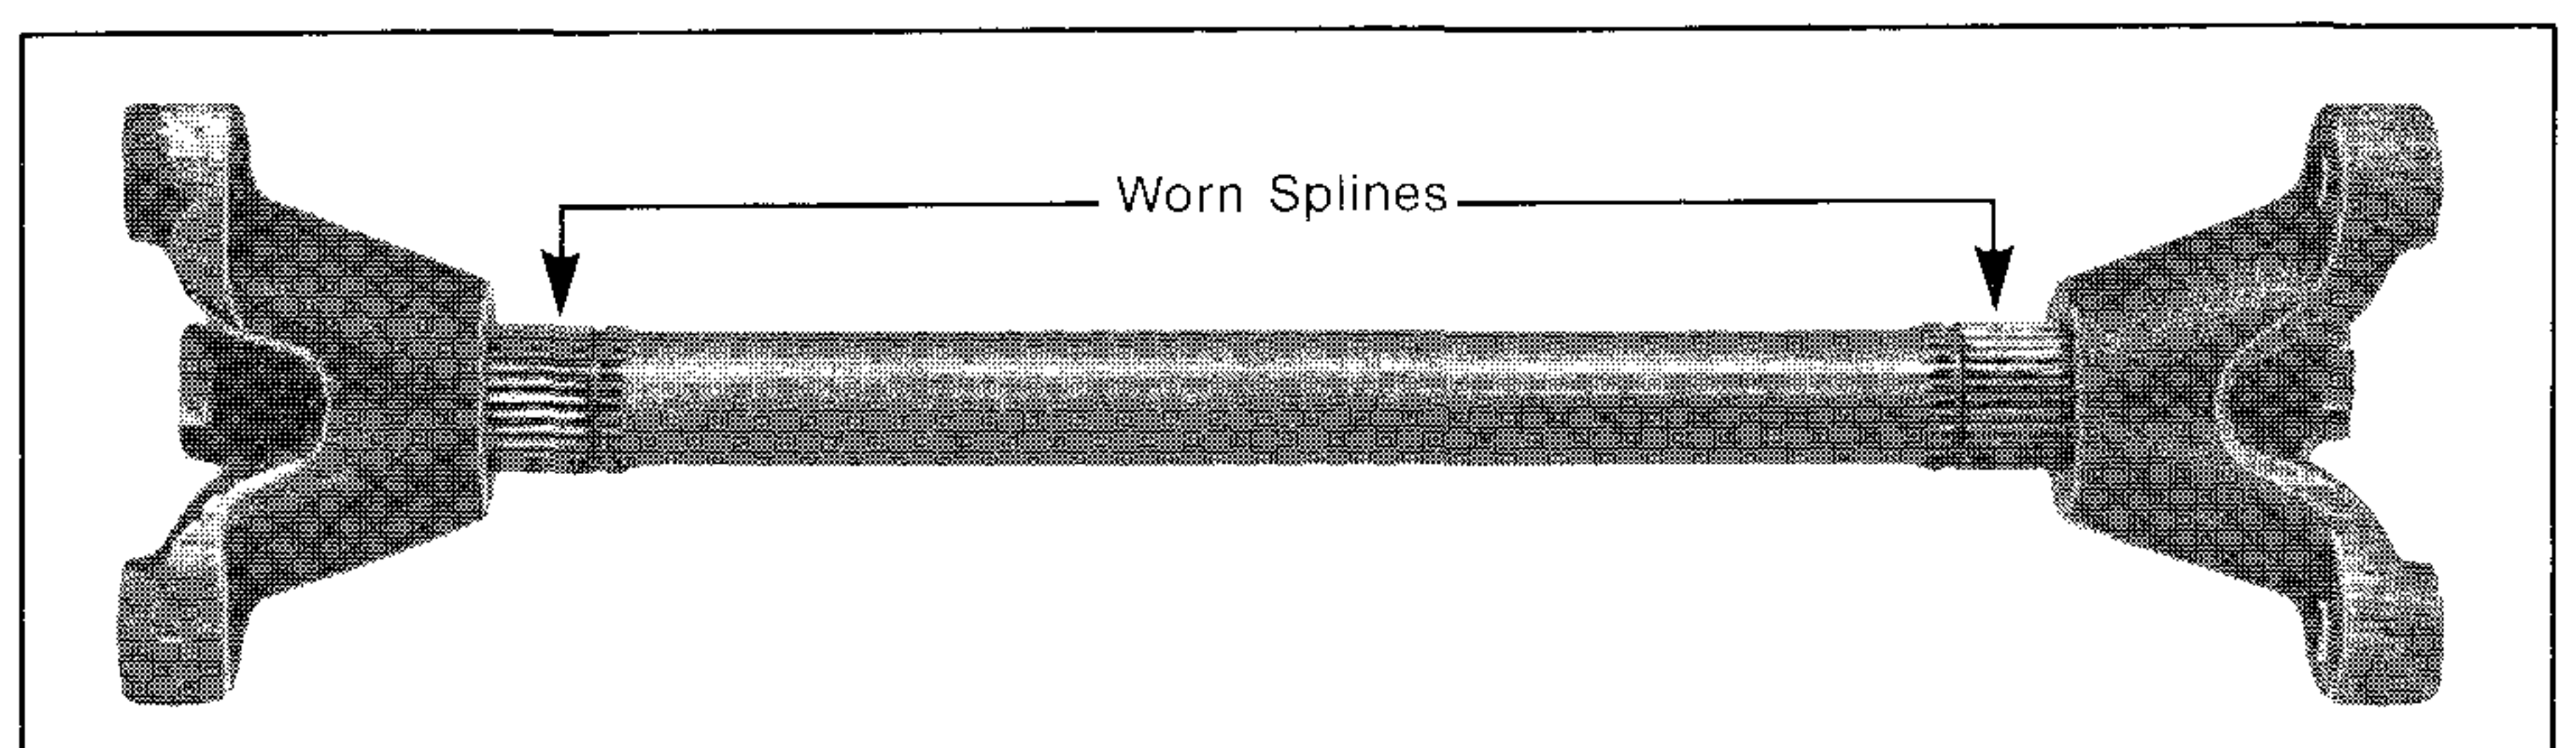
Fig. 16. The blower drive-shaft with the worn splines indicated

was 73,6 Hz or 70,8 Hz depending on the engine-test speed. The upper danger level shown is the maximum vibration level tolerated before repair. Fig.15 shows a schematic layout of the engine, indicating the position of the Roots Blower and the measuring point used to detect the fault. Fig.16 shows the blower drive-shaft.

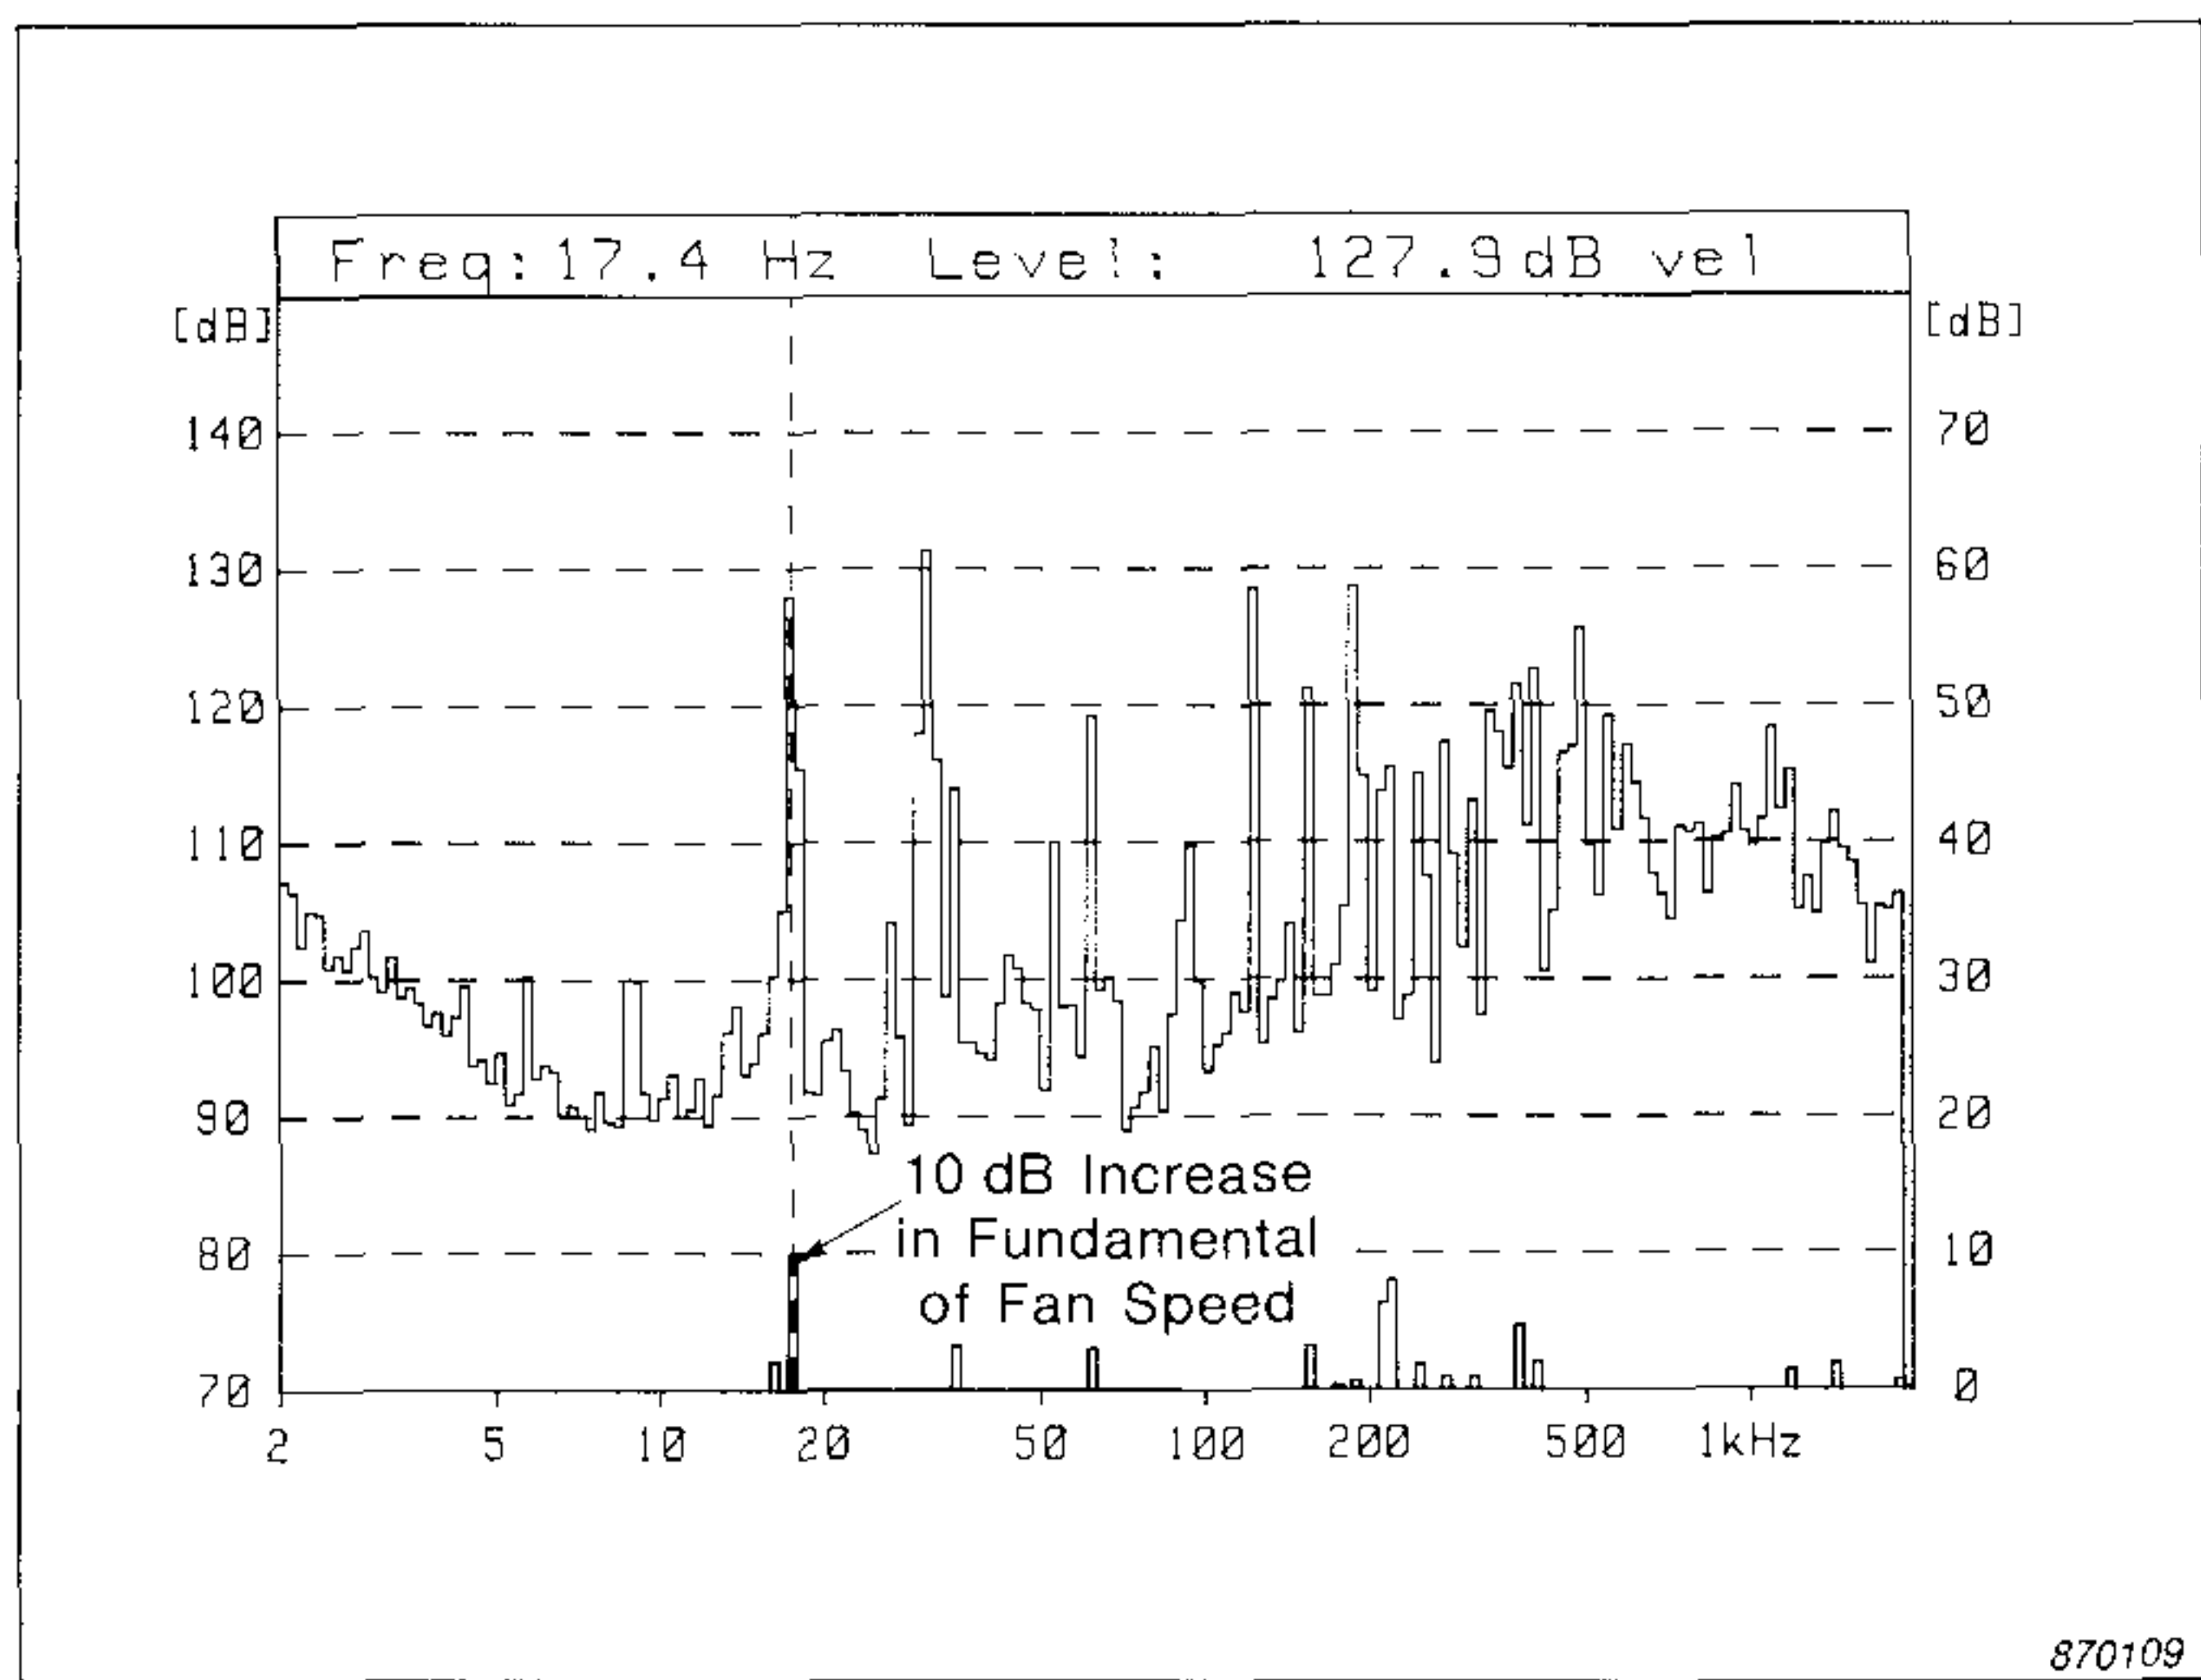
Fig. 17. Spectrum comparison showing the fan problem

Fig.17 shows a spectrum compari-

son clearly indicating the beginning of a problem at 17,8 Hz, the fan rotational frequency. Fig.18 shows a trend curve at this frequency. The upper danger level shown is the maximum vibration level tolerated. The fan was subsequently rebalanced, and the levels dropped to normal values.

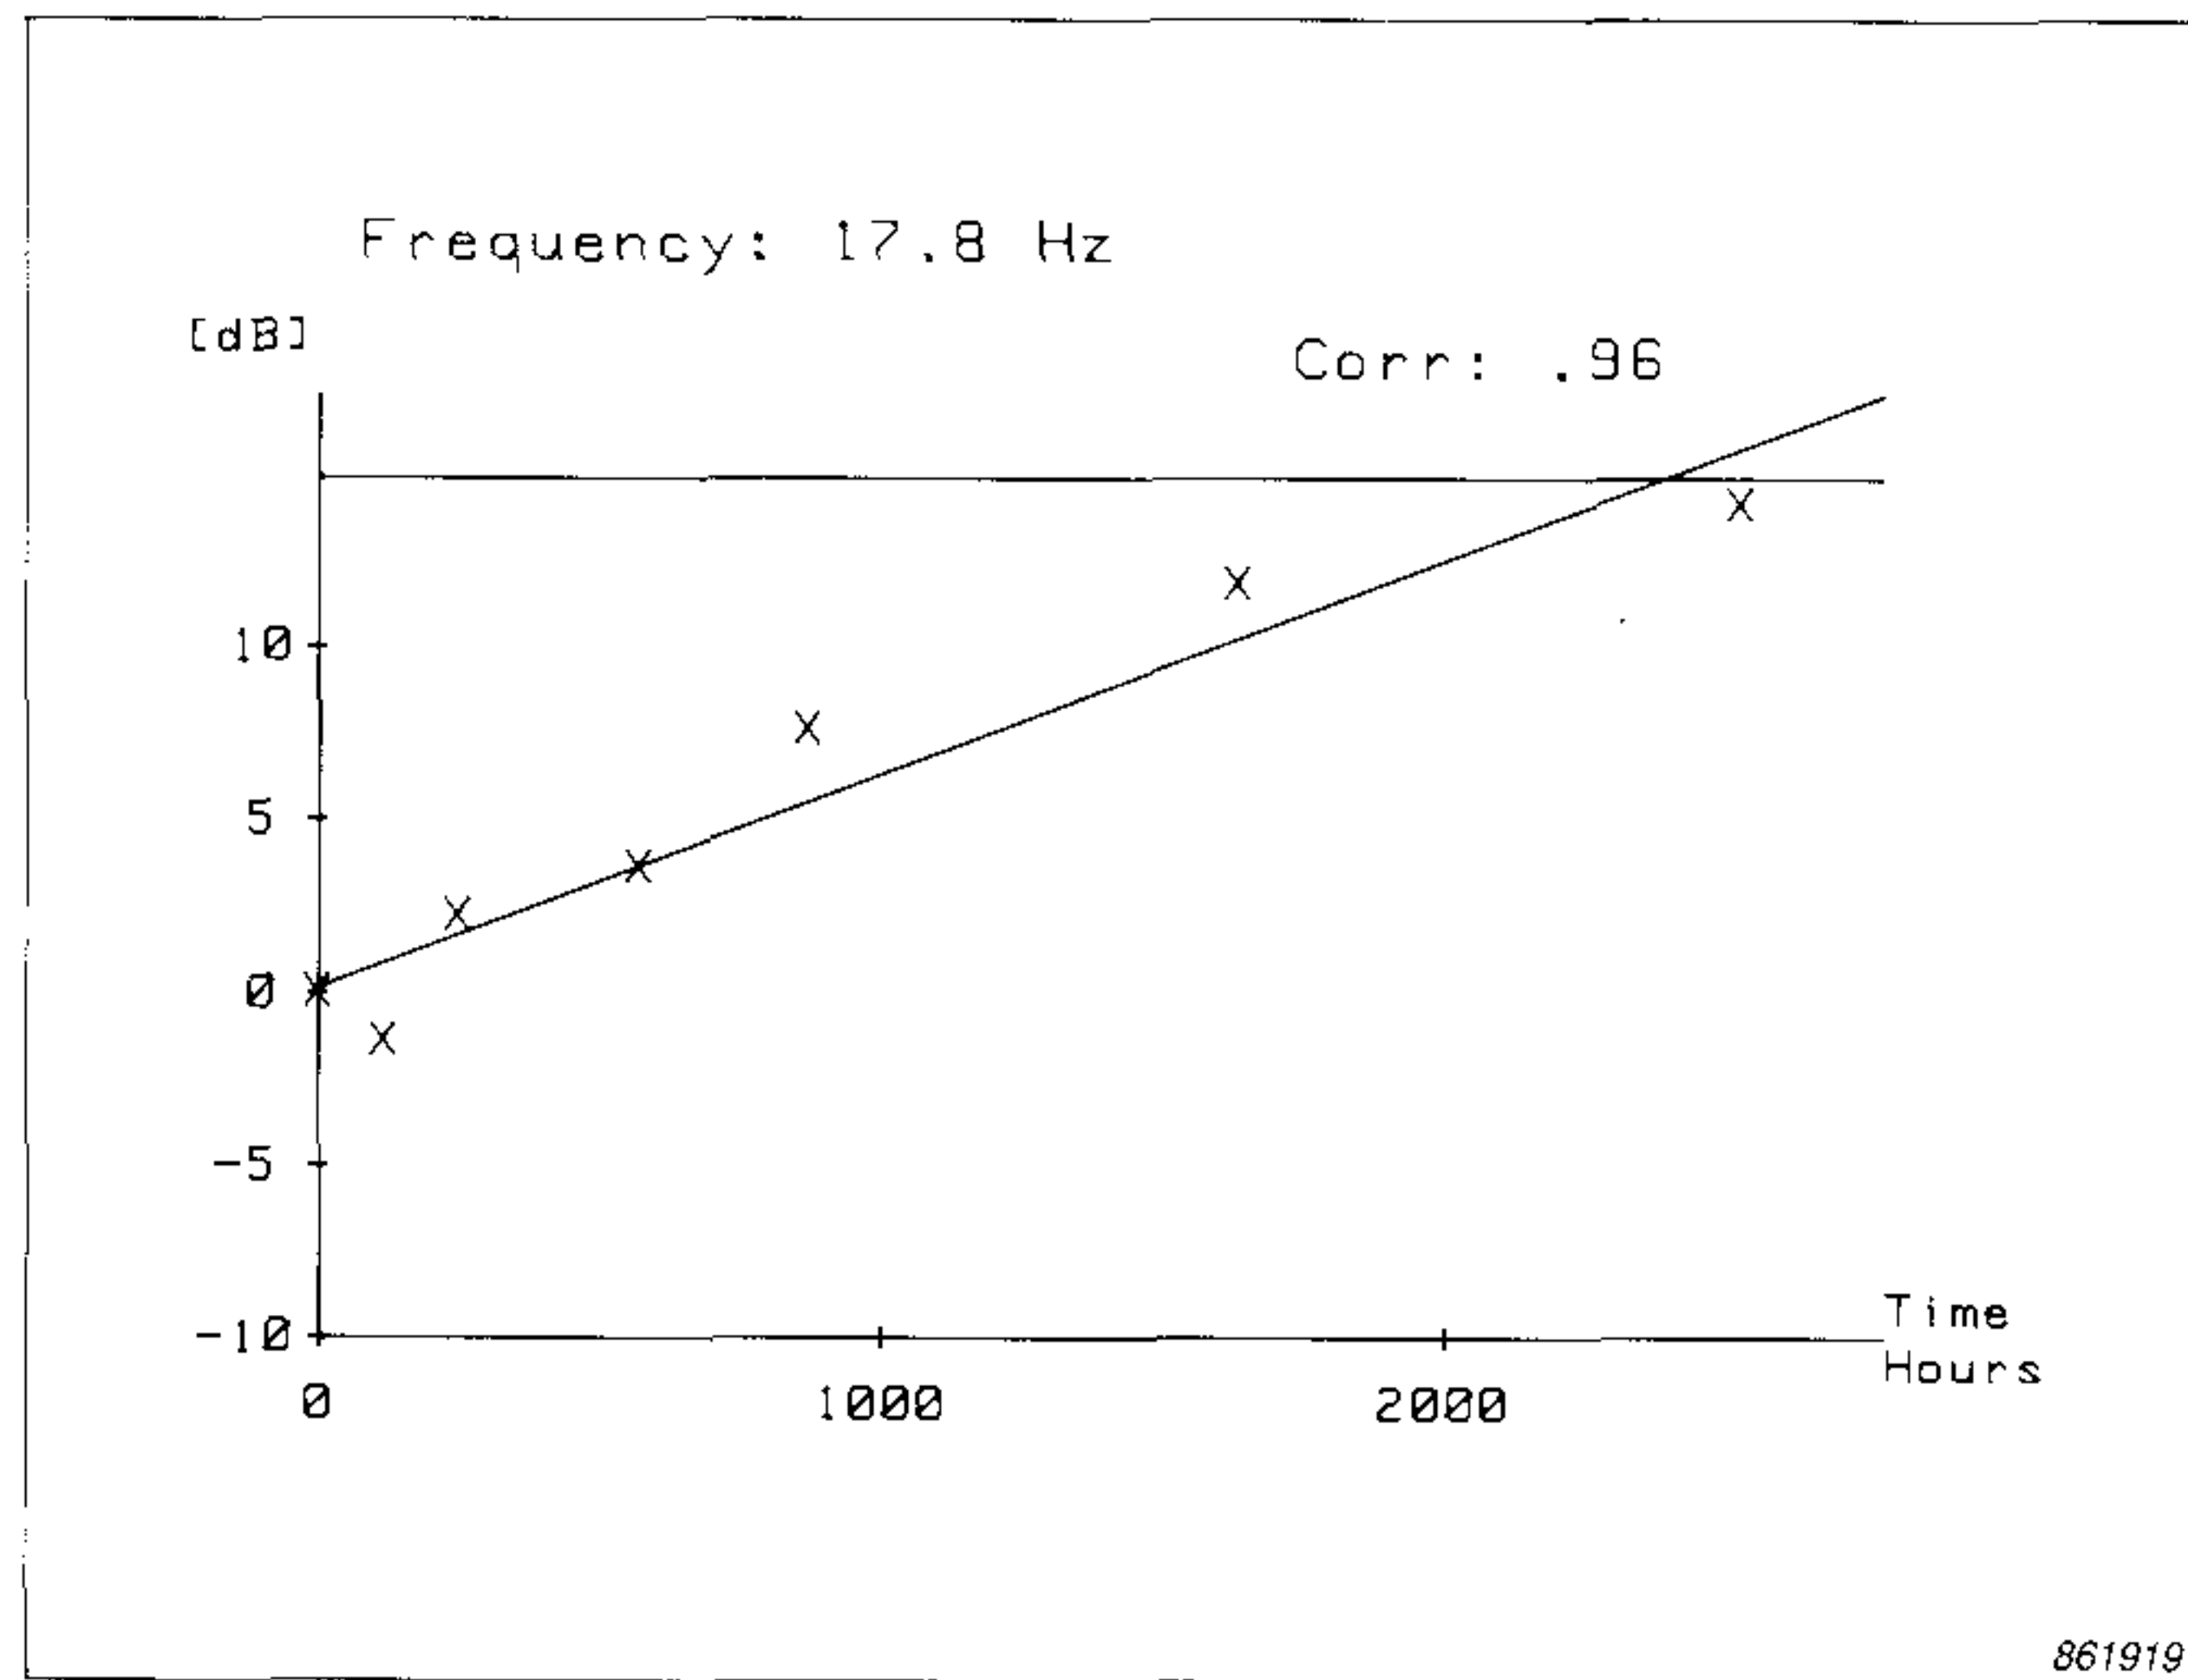
Fig. 18. Trend curve at fan rotational frequency clearly showing the fan problem

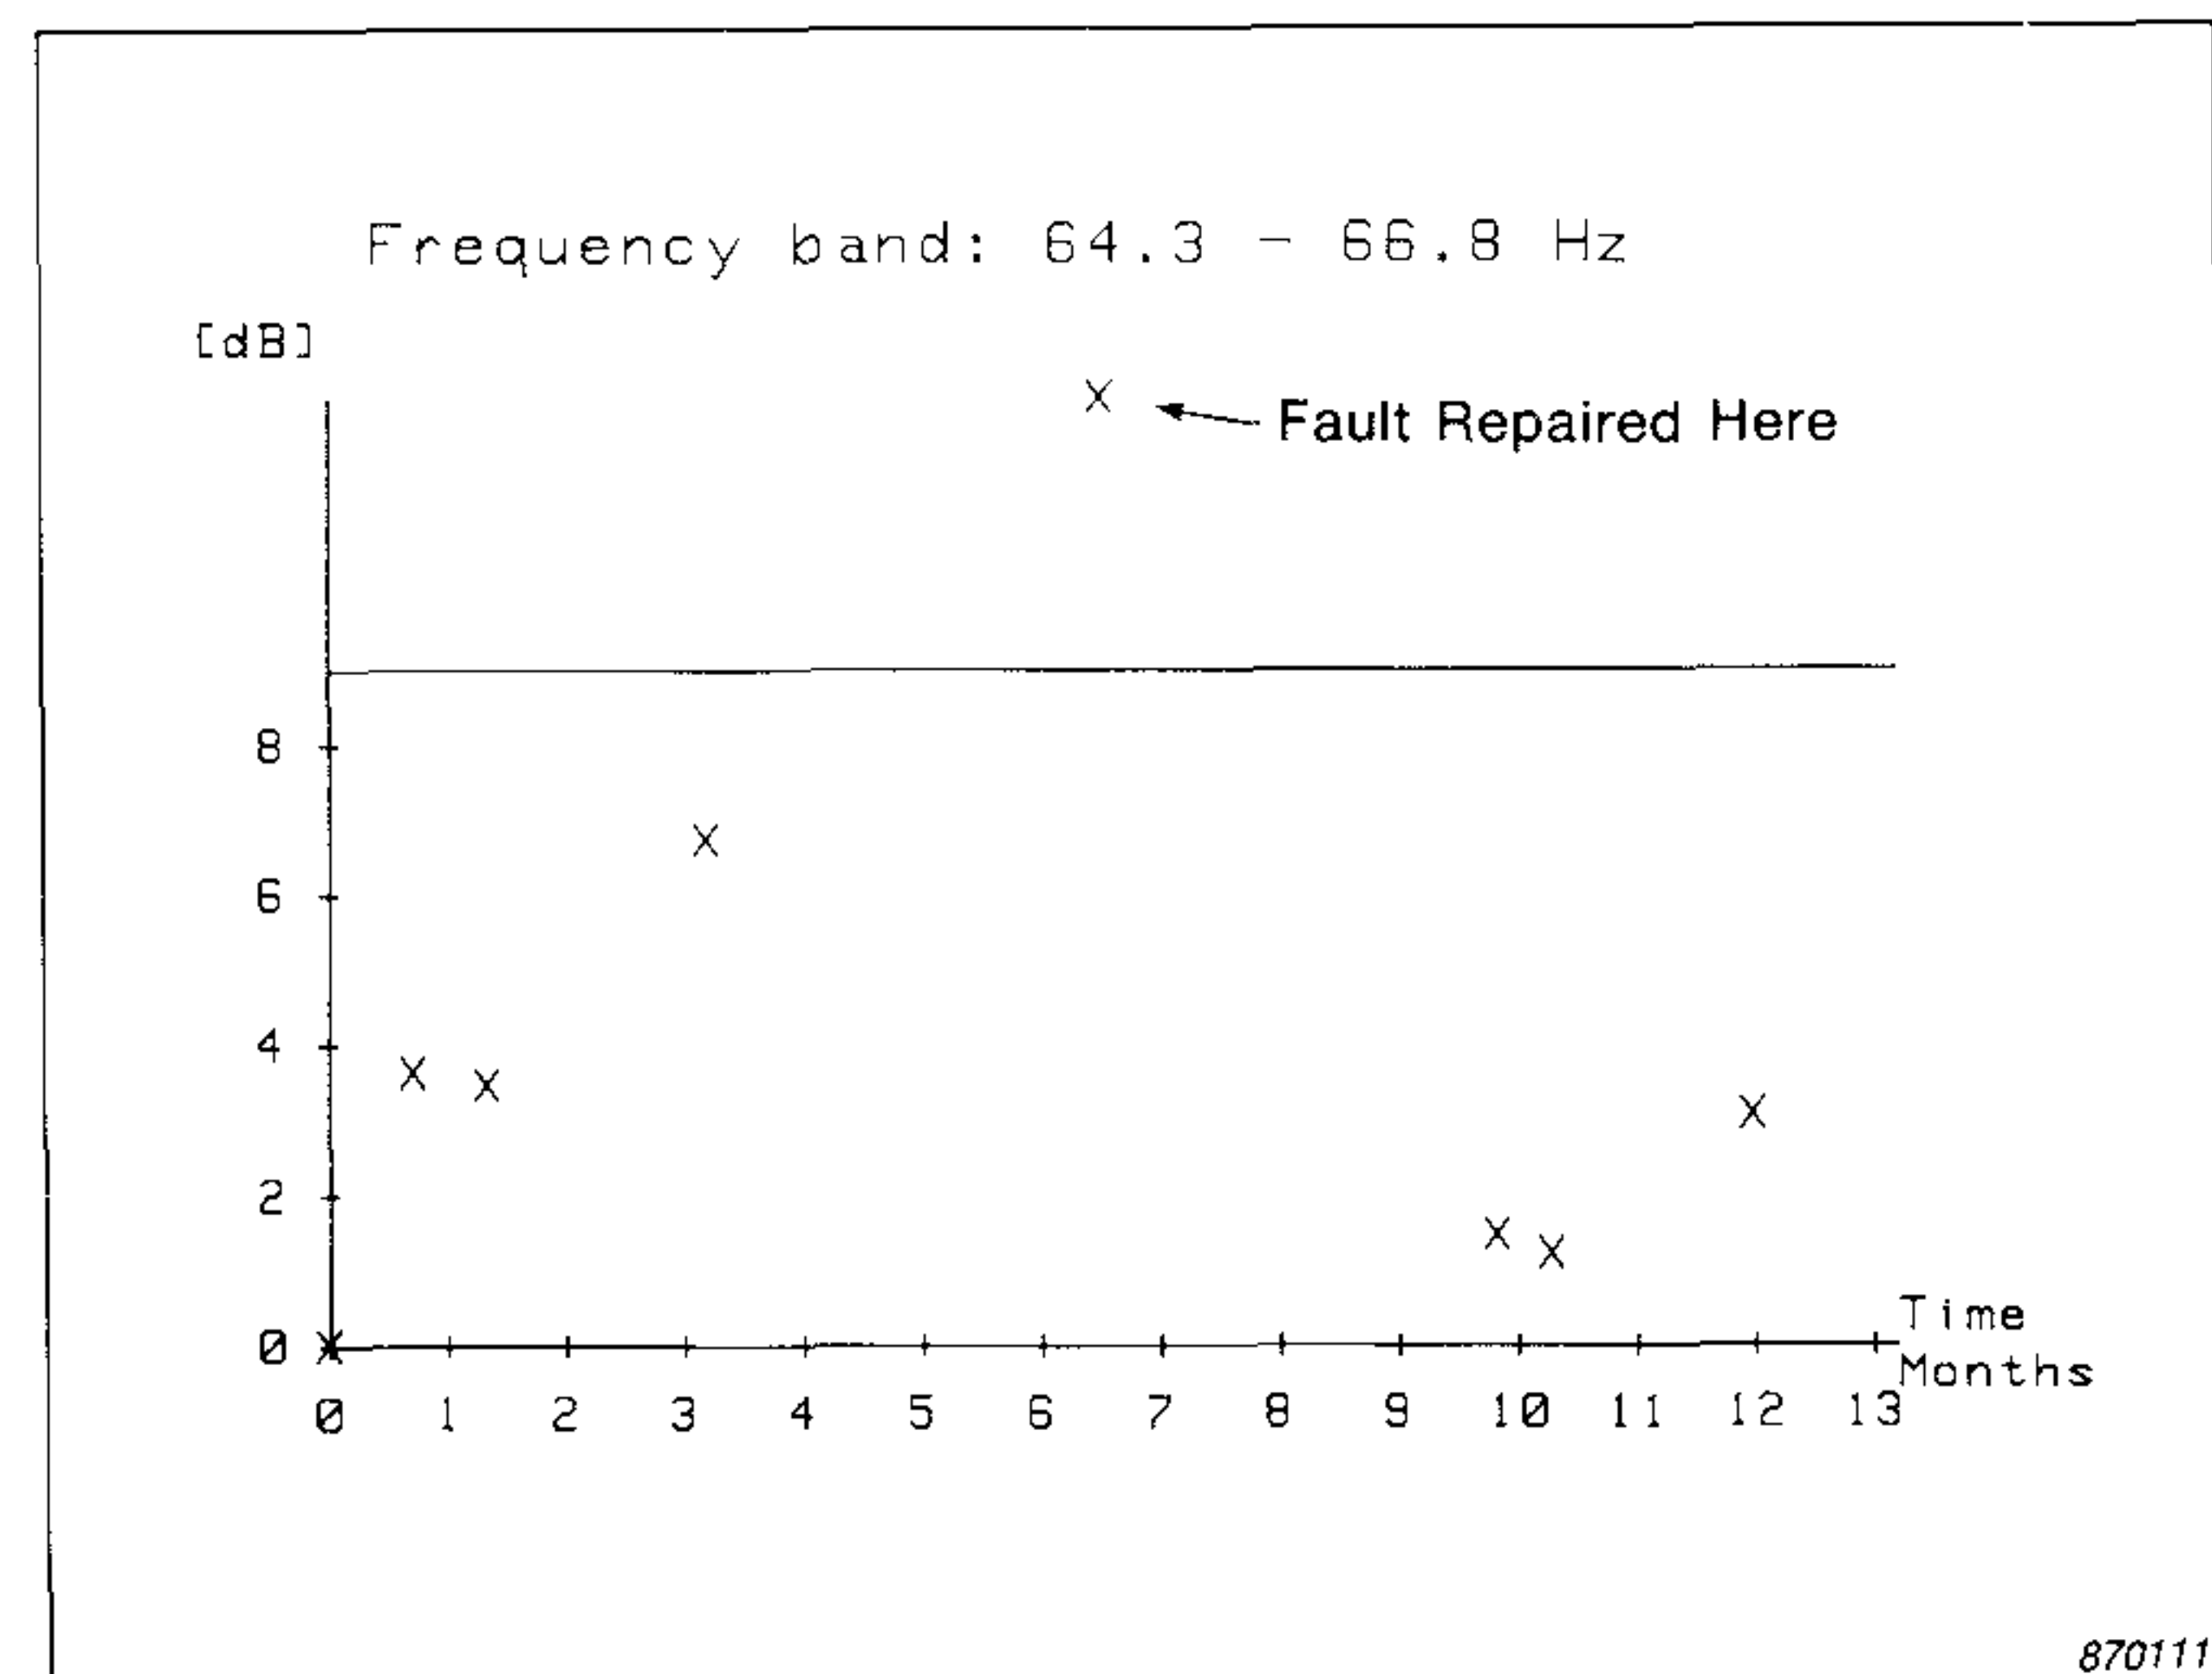
Fig. 19. Trend curve at the blower-exciter rotational frequency. The vibration level is seen to increase to danger levels and then drop-off after repair

The supply air for the blower is unfiltered, and a common problem is one of dirt on the blower causing an unbalance. In the example shown in Fig. 19,

dangerous vibration levels were recorded from the assembly, as shown in the trend curve measured at the blower speed. The blower was subsequently removed and cleaned and the levels seen to drop.

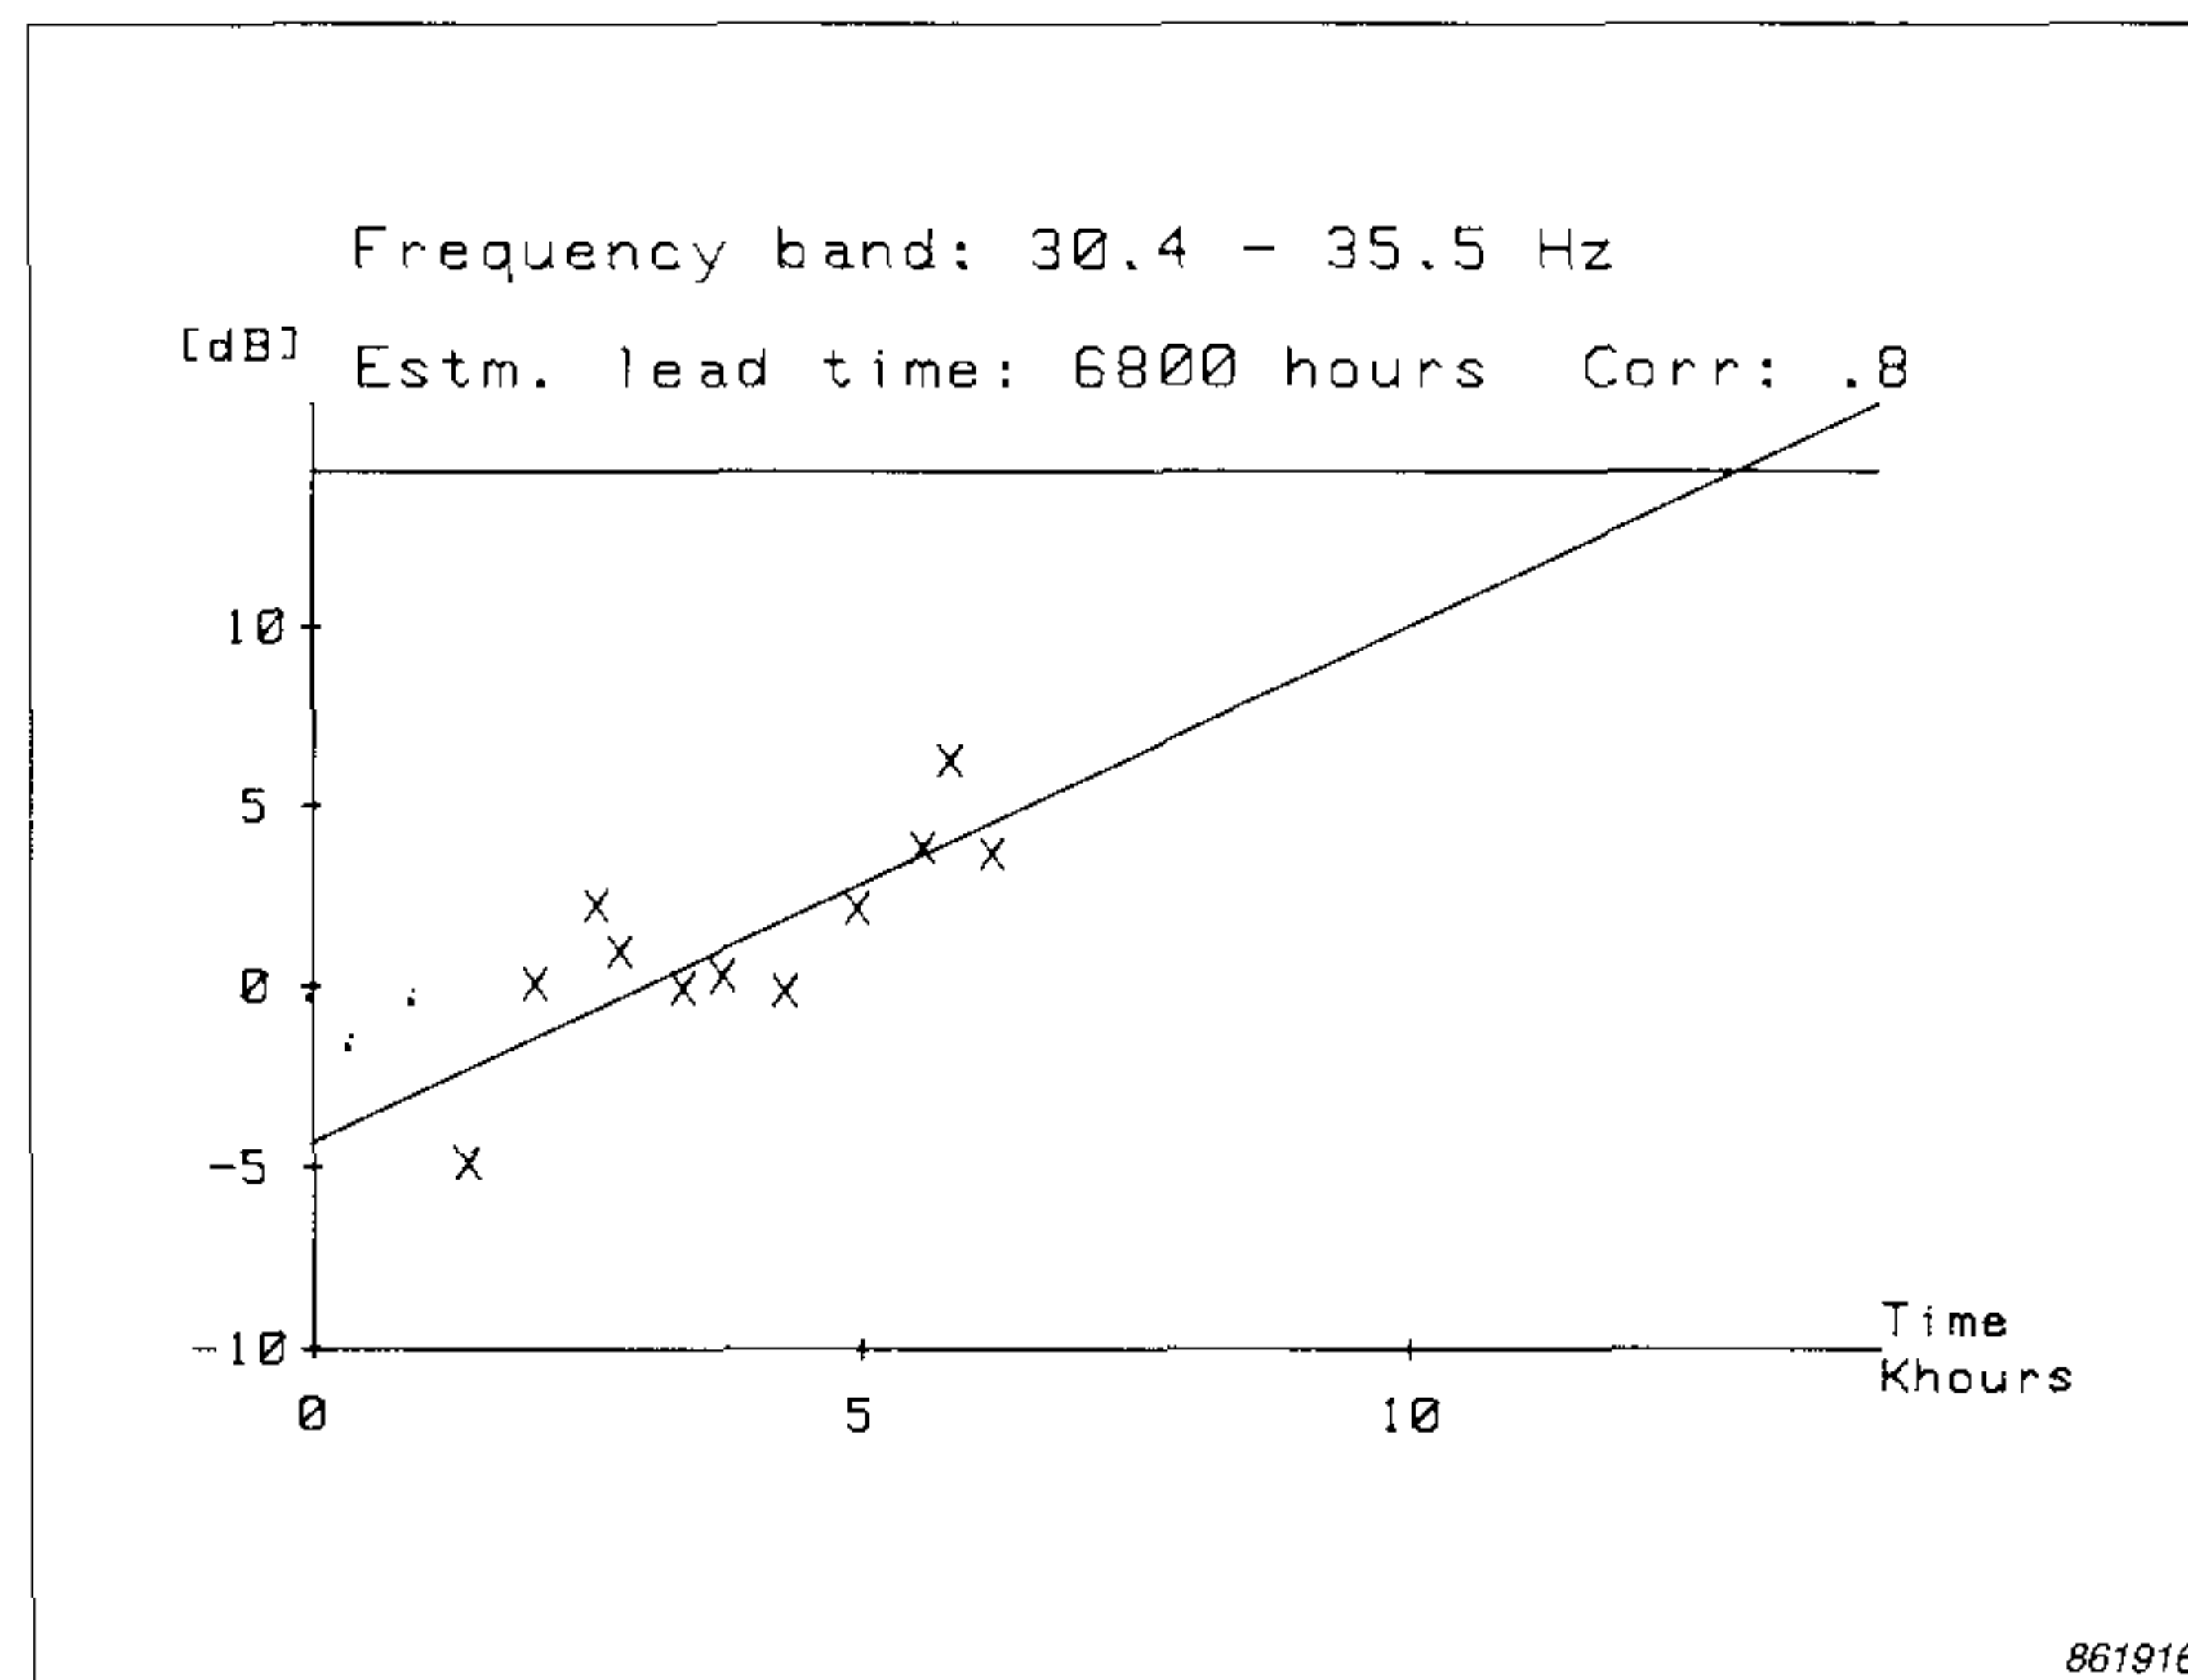
Fig. 20. Trend curve at the crankshaft frequency

The trend curve shown in Fig.20 shows some interesting results. The curve indicates a steady upward trend in vibration level at the crankshaft frequency. This type of trend curve, in conjunction with other "health" indicators on the engine, could be effectively used as an indication of general wear in the engine. As soon as the vibration level approaches the danger level, an overhaul can be scheduled.

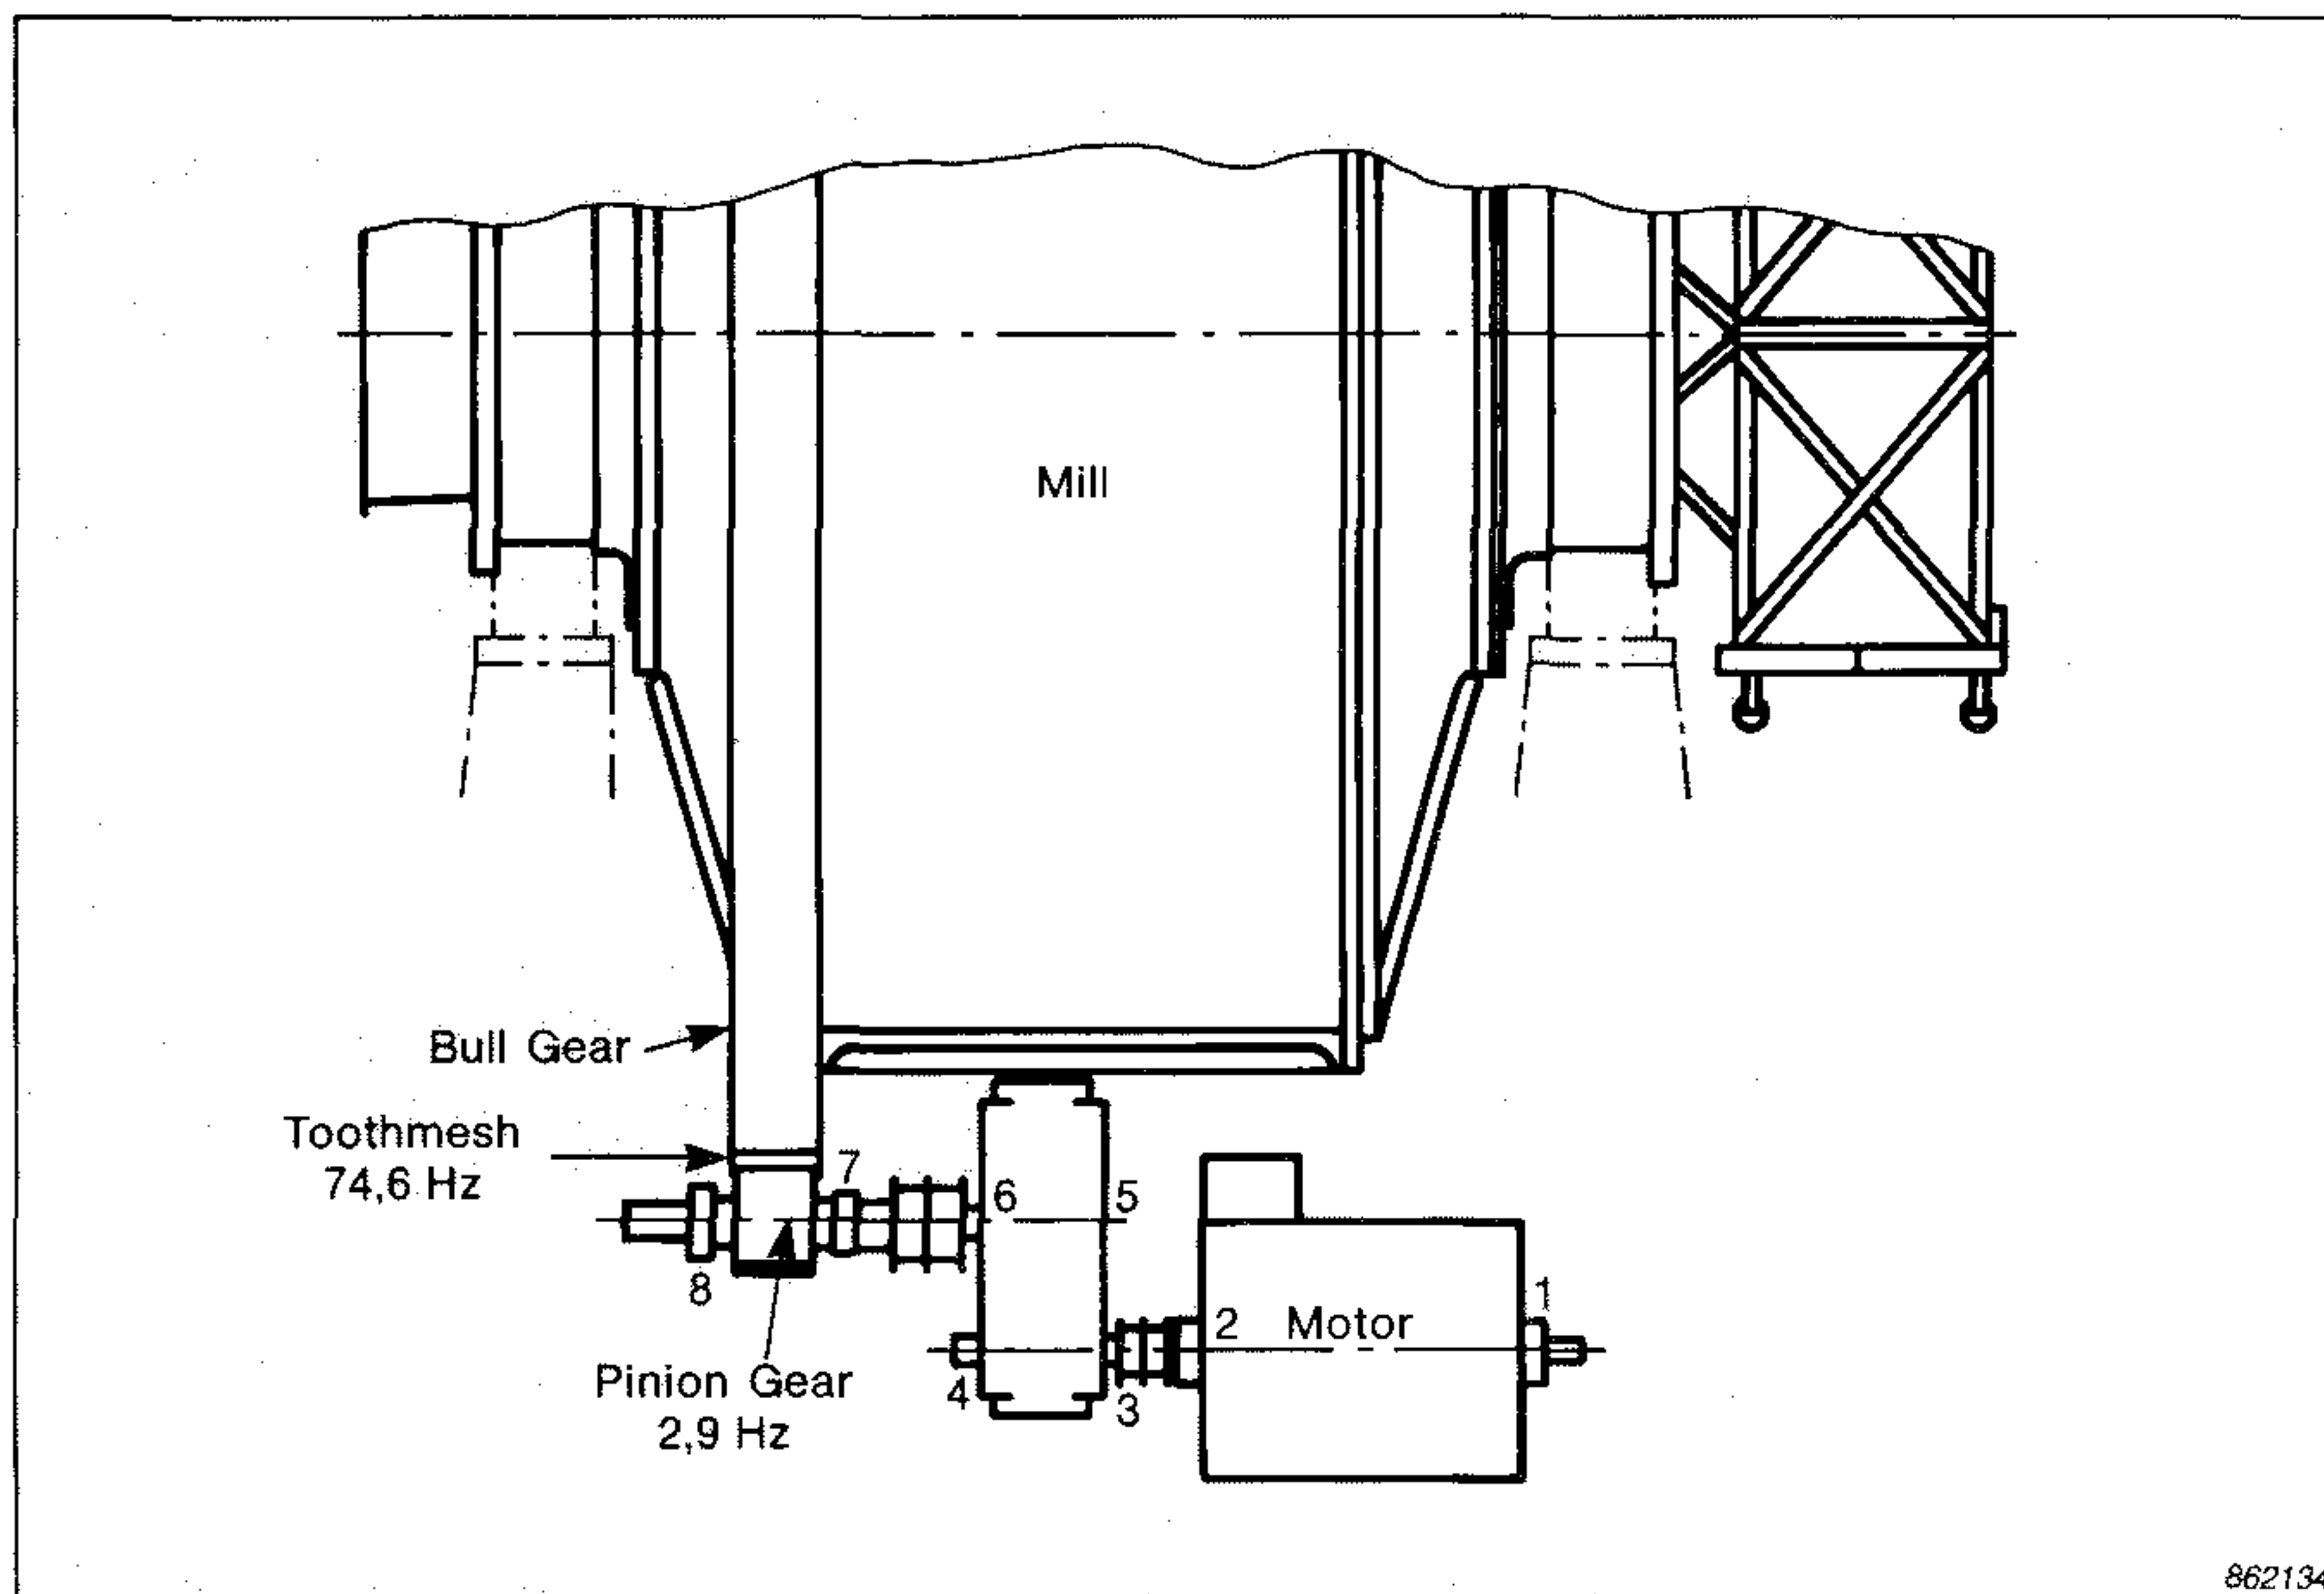
Fig. 21. Measuring points on the autogeneous mill drive
