# Machine-Condition Monitoring using Vibration Analysis

## A Case Study from an Iron-Ore Mine

by D.N.Brown & J.C.Jørgensen  
Brüel & Kjær

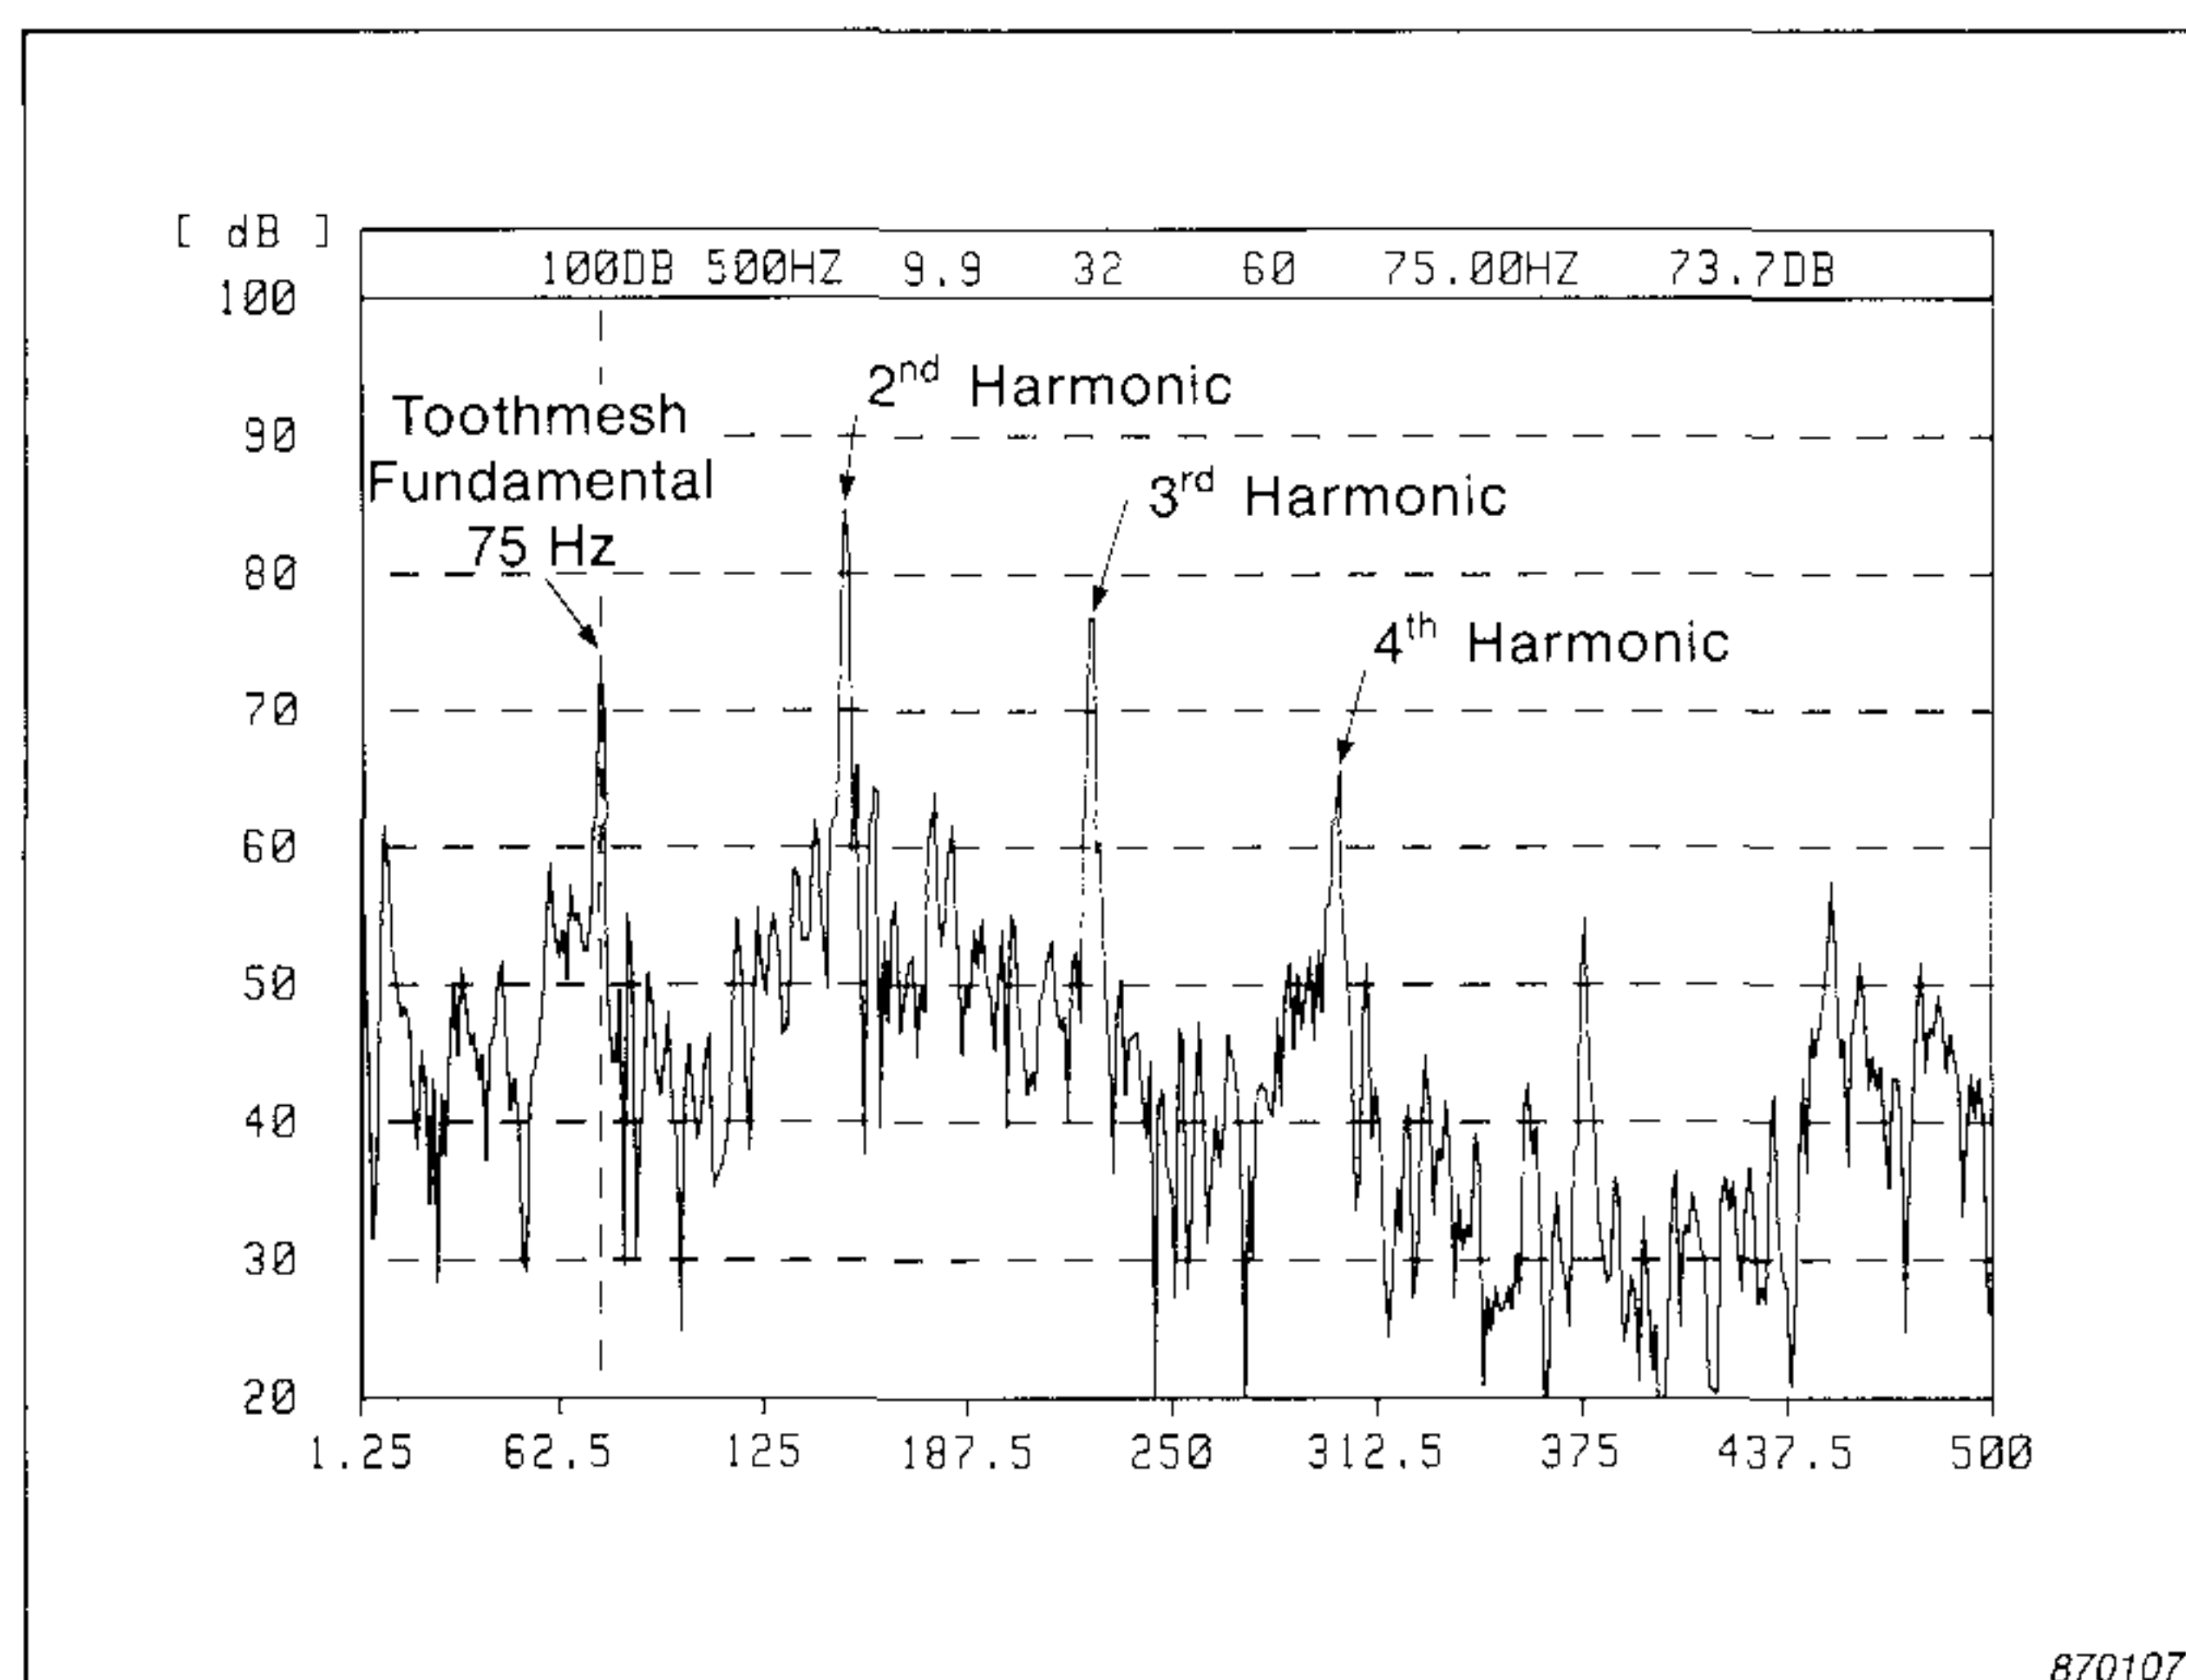
Fig. 22. Narrowband spectrum from the mill gearbox, showing a strong harmonic series at the pinion/bull-gear toothmesh frequency

Figs. 22 and 23 show examples of narrowband spectra taken from the gearbox. In Fig. 22 can be seen a very dominant toothmesh frequency from the pinion and mill bull-gear, together with a strong harmonic series. Fig. 23 shows a zoomed narrowband spectrum around the toothmesh fundamental,

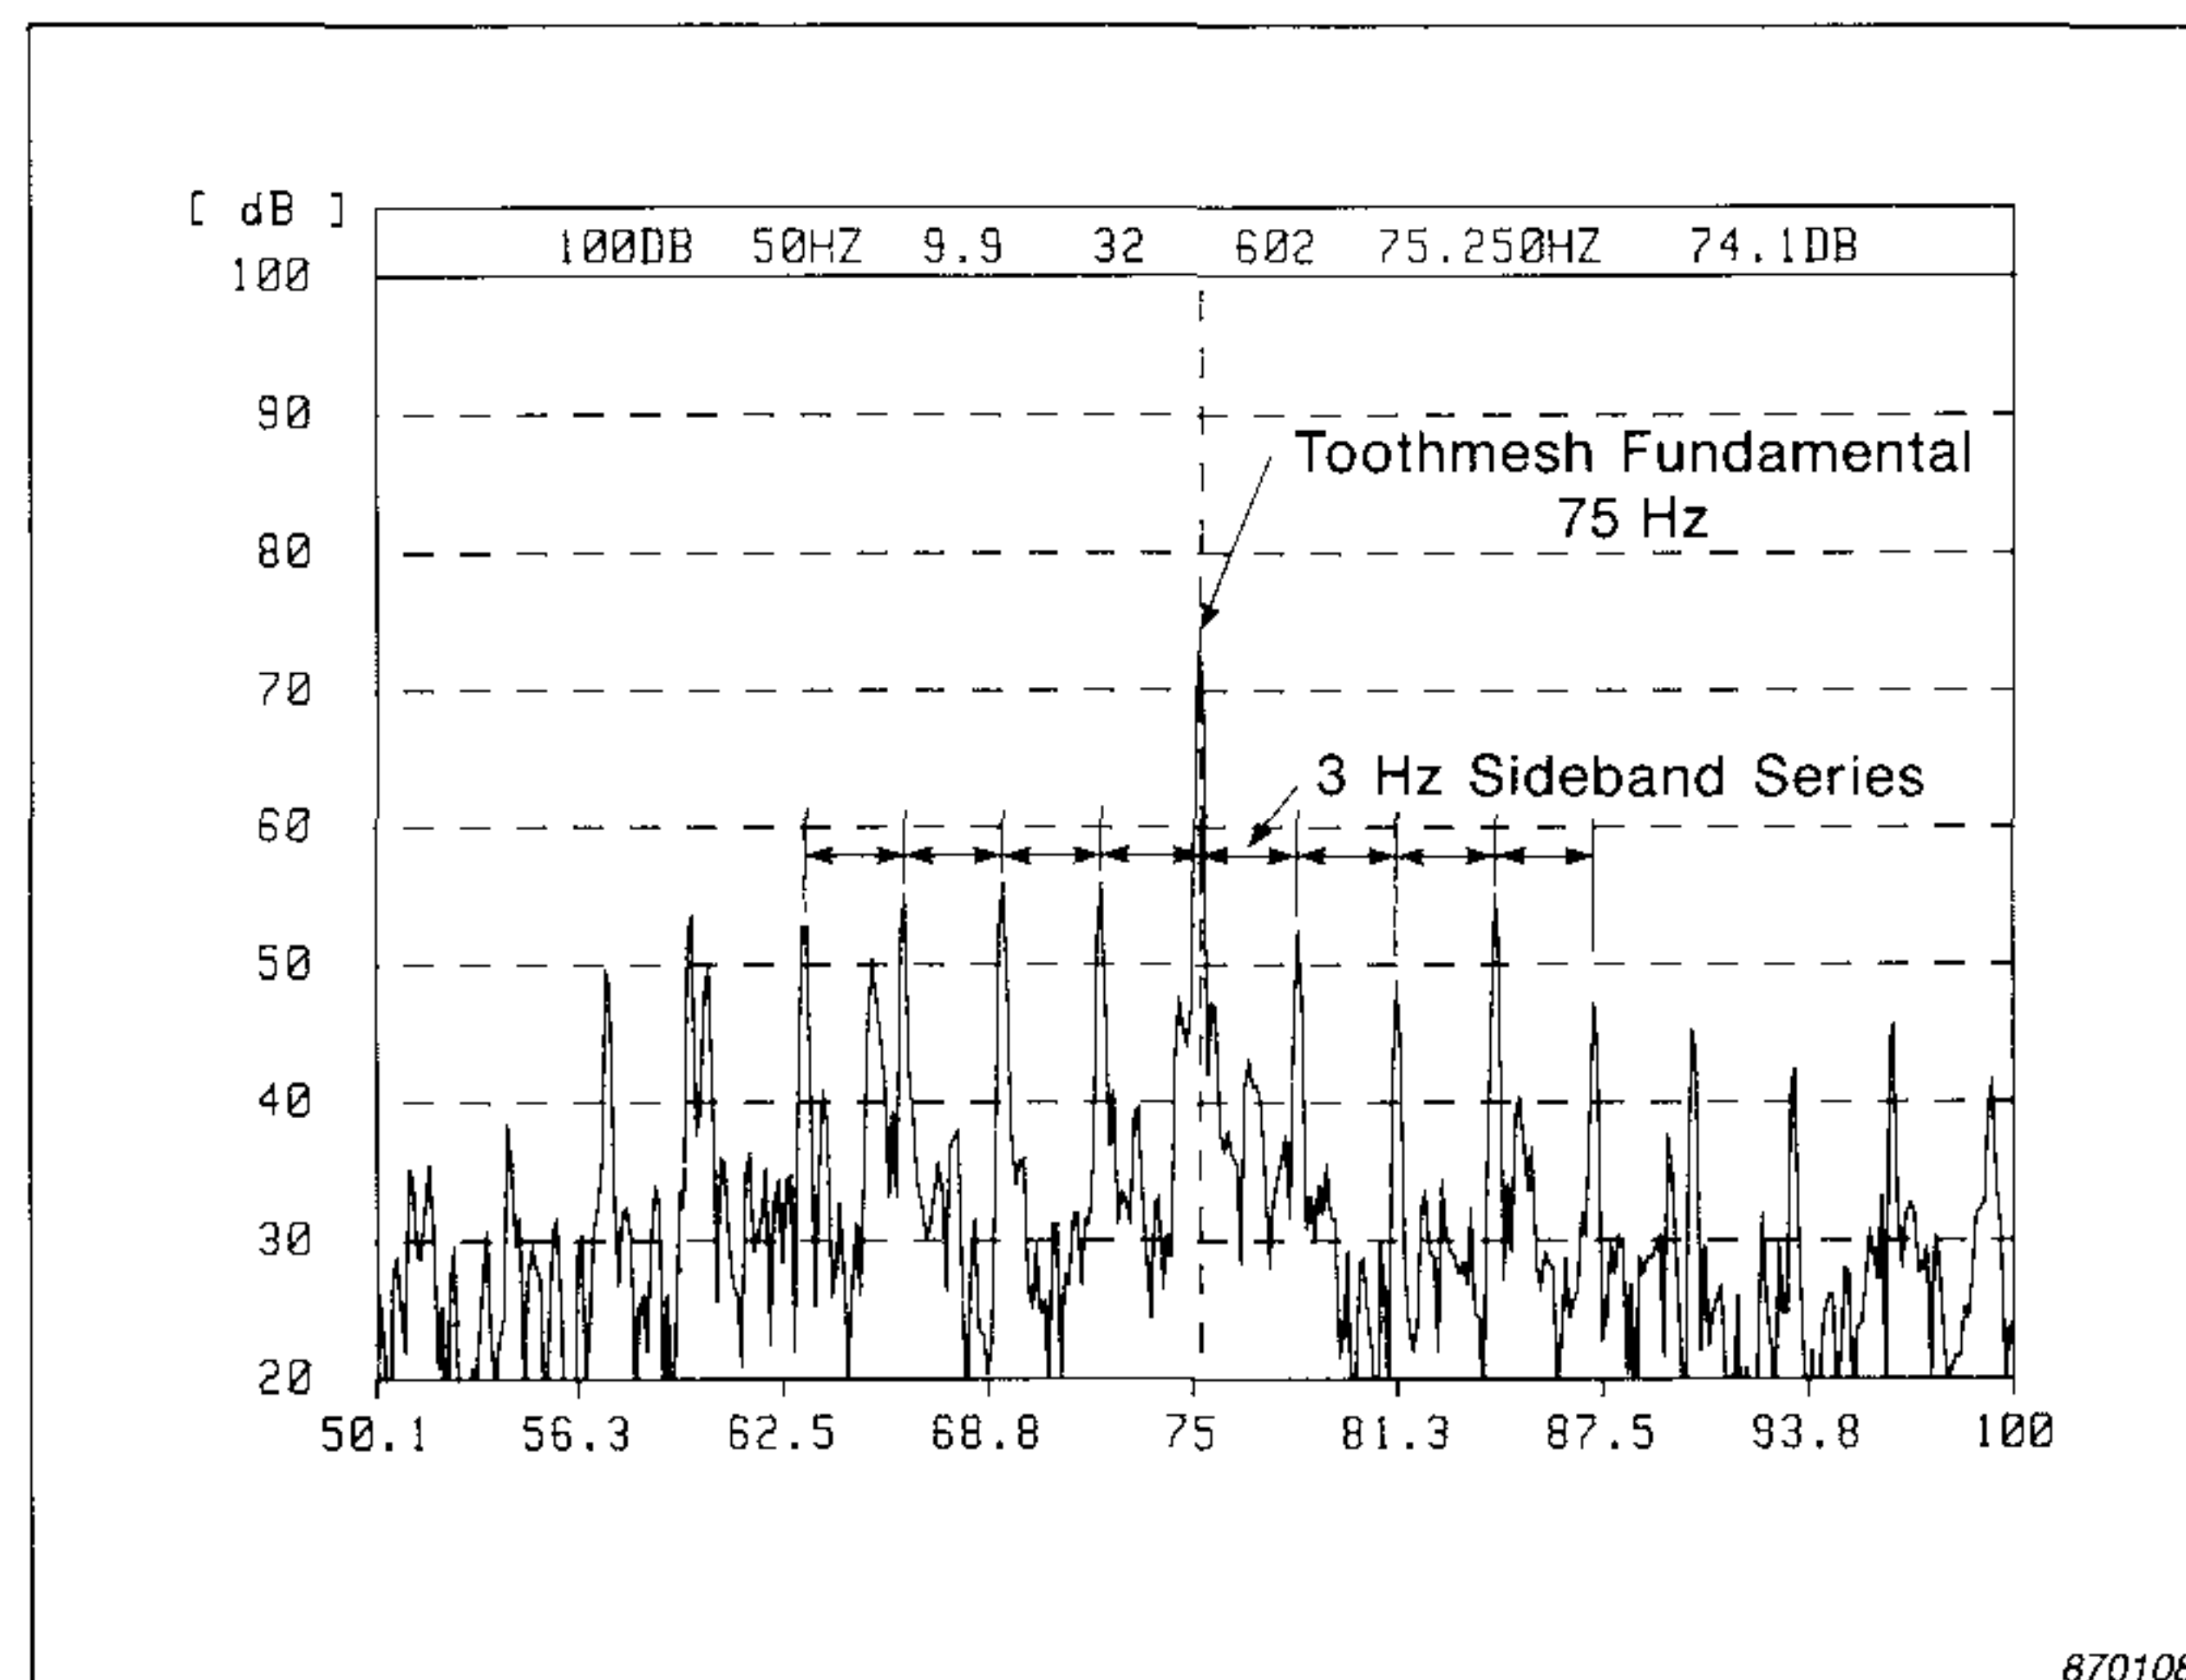
Fig. 23. Zoomed narrowband spectrum about the pinion/bull-gear toothmesh, showing a marked sideband pattern

showing a pattern of sidebands with a spacing of 3 Hz, which corresponds to the pinion gear rotational frequency. At first it was thought that the problem was one of misalignment. However, after careful examination of the spectra, it was deduced that the cause of these prominent patterns in the spectra was from a mismatch in wear patterns between the pinion and bull-gear, and possibly slight eccentricity of the pinion gear. The pinion gear was relatively new, whereas the bull-gear had not been changed for some time.
