# **Brüel & Kjær**

### Envelope analysis – the key to rolling-element bearing diagnosis

by Joëlle Courrech and Mark Gaudet

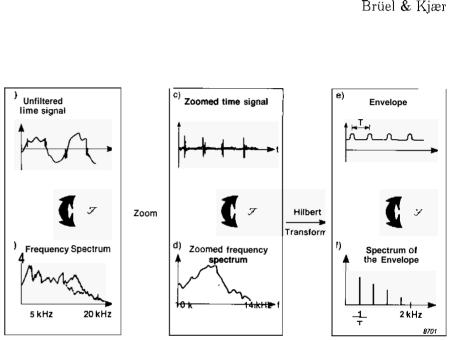
The 2032/34 uses zoom lo extract the region of the resonance excited by the hearing-fault, from the frequency spectrum. Then lhe Hilhert transform is used to produce the envelope of the filtered lime signal.

The envelope-analysis principle of the 2032/34-based system is shown on the previous page:

(a) is the time signal of the vibration measurement, from the bearing housing.

(h) is the corresponding frequency spectrum, which is related to the time signal by the Fourier transform. An increase in level in a particular frequency range (as indicated by the dotted line) is detected when a structural resonance has been excited hy a fault. (d) is the frequency spectrum extracted by zooming around this particular frequency range. It contains the structural resonances which have been excited hy the impacts produced by the fault(s).

(c) is the corresponding time signal, which contains only the resonance frequency which is modulated by the impact frequency.

(e) In the analogue process, the time signal is then rectified and smoothed by a detector to produce the envelope of the time signal. Consequently, the envelope contains only the low modulation-frequency cnmponent relating to the impact rate(s). The 2032/34 produces a very accurate representation of the time signal, which is free from the limitations of a smoothing circuit, by using the Hilhert transform to calculate the magnitude of the time signal.

(f) The time envelope is then frequency analyzed to establish the impact

frequencies. This reveals the presence of a bearing fault. The Dual-Channel **Analyzer** Type 2032/34 computes the frequency spectrum of the envelope of the zoomed time signal, when controlled either by a computer with the Envelope Analysis Program for the 2032134 or by Graphics Recorder Type 2313 with Application Package BZ7006.

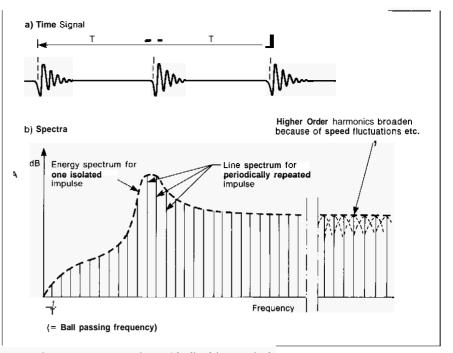
Fig 2. The modulation effect **caused** by a fault on the stationary and on the rotating race.

Fig. 1. Frequency spectrum for an idealized impact fault.

Figure 2 illustrates the difference between the signal produced by a fault on the stationary race and a fault on the rotating race. In the first case, the fault will always he subject to the same load and the resulting impacts will have equal amplitudes. In the second case, the fault will rotate in and out of the loaded region, causing mudulation of the impact amplitudes by the rotation speed of the shaft.

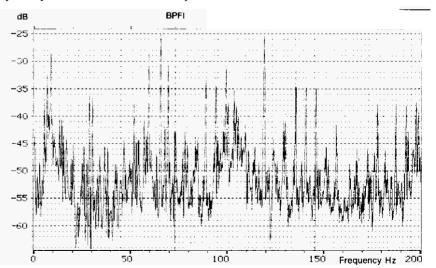
Fig. 3. Baseband vibration spectrum up to 200 Hz for a faulty ball-bearing. It is very difficult to detect any of the bearing characteristic frequencies.

The frequency spectrum of the acceleration signal for the ball bearing is shown in Fig. 3. This is the region in which we would expect to detect the hearing characteristic frequencies for a faulty hearing. It's very difficult, to detect any of the bearing frequencies in the baseband measurement because other vibration sources have produced more dominant frequency components.

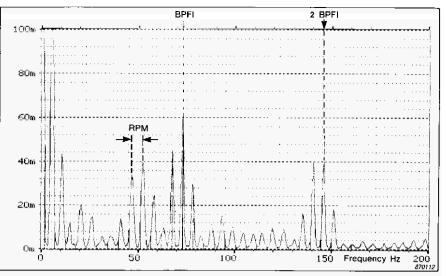
Fig. 4. Envelope of the frequency analysis (zoomed around 9kHz) of the faulty ball-bearing. The BPFI and sidebands modulated by the RPM are clearly evident.

Consequently. 2032/34-based envelope analysis was used to produce the envelope of the zoomed time signal. The corresponding frequency spectrum was calculated using the Graphics Recorder Type 2313 together with the BZ 7006 Application Package. and this is shown in Fig. 4. This clearly shows the RPFI at 73 Hz and the second harmonic at 146 Hz; the sidehands are caused by modulation due to the rotation speed which is 5,3 Hz. This modulation occurs as the fault mores through the loaded area of the hearing.

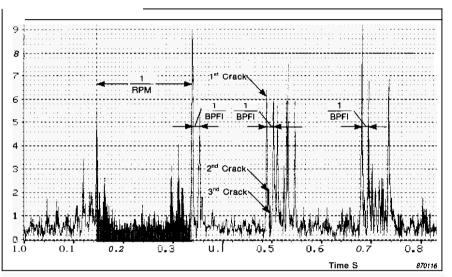
Fig. 5. The envelope's time-signal showing a series of impacts repeating at the rotation frequency. Close inspection reveals three closely-spaced peaks, relating to three transverse cracks on the inner race.

The envelope of the zoomed timesignal is shown in Fig. 5. This reveals a series of peaks repeating with a period equal to 1/BPFI. Each time a hall passes a crack, an impulse is produced, which results in a peak. On examining Fig. 5 more closely, three more-narrowly spaced peaks are evident. These **peaks** originate from three transverse cracks on the inner race. The three-peak pattern is repeated as balls pass over the three cracks. These impacts are clearly amplitude modulated with a period equal to 1/roller-rotation frequency.

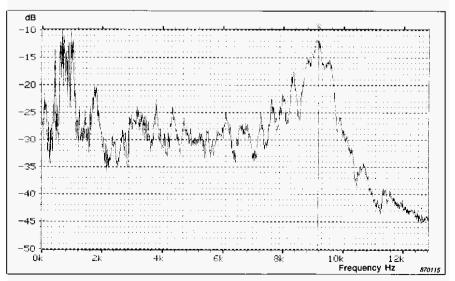
Fig. 6. Response function (0-12,5kHz) produced by a hammer test, showing the structural resonances for the bearing housing. The resonance at 9kHz was used for the zoom analysis.

As nn reference spectra were available for the paper-drier, a hammer test was used to produce the frequency response to an impact. This reveals the structural resonances of the hearing, which are shown in Fig. ti. The structural resonances are concentrated in the 8kHz to 10kHz region, which is the region most suitable for zoom analysis as it offers the greatest signal-to-noise ratio.

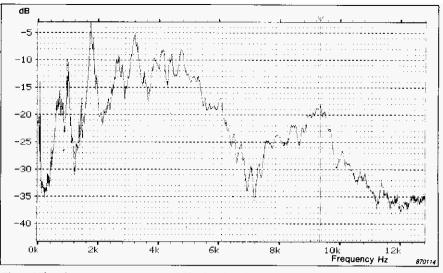
Fig. 7 Vibration spectrum up to 12,5 kHz showing the same resonance region as the hammerlest response.

To perform a hammer test on the hearing housing, the machine has Io be stopped. Often, this is impossible (for example: in the continuous process industry) and in this case the vibration spectrum must be used to *es*-tablish the must suitable zoom region. The vibration spectrum up to 12,5 kHz is shown in Fig. 7; the same structural resonance region is evident in the 8kHz to 10kHz region.
