Application Notes

Early Detection of Gear Faults Using Vibration Analysis in a Manufacturer's Test Department

by Laszlo Boros, RABA, Győr, Hungary and Glenn H. Bate, Brüel & Kjær, Denmark

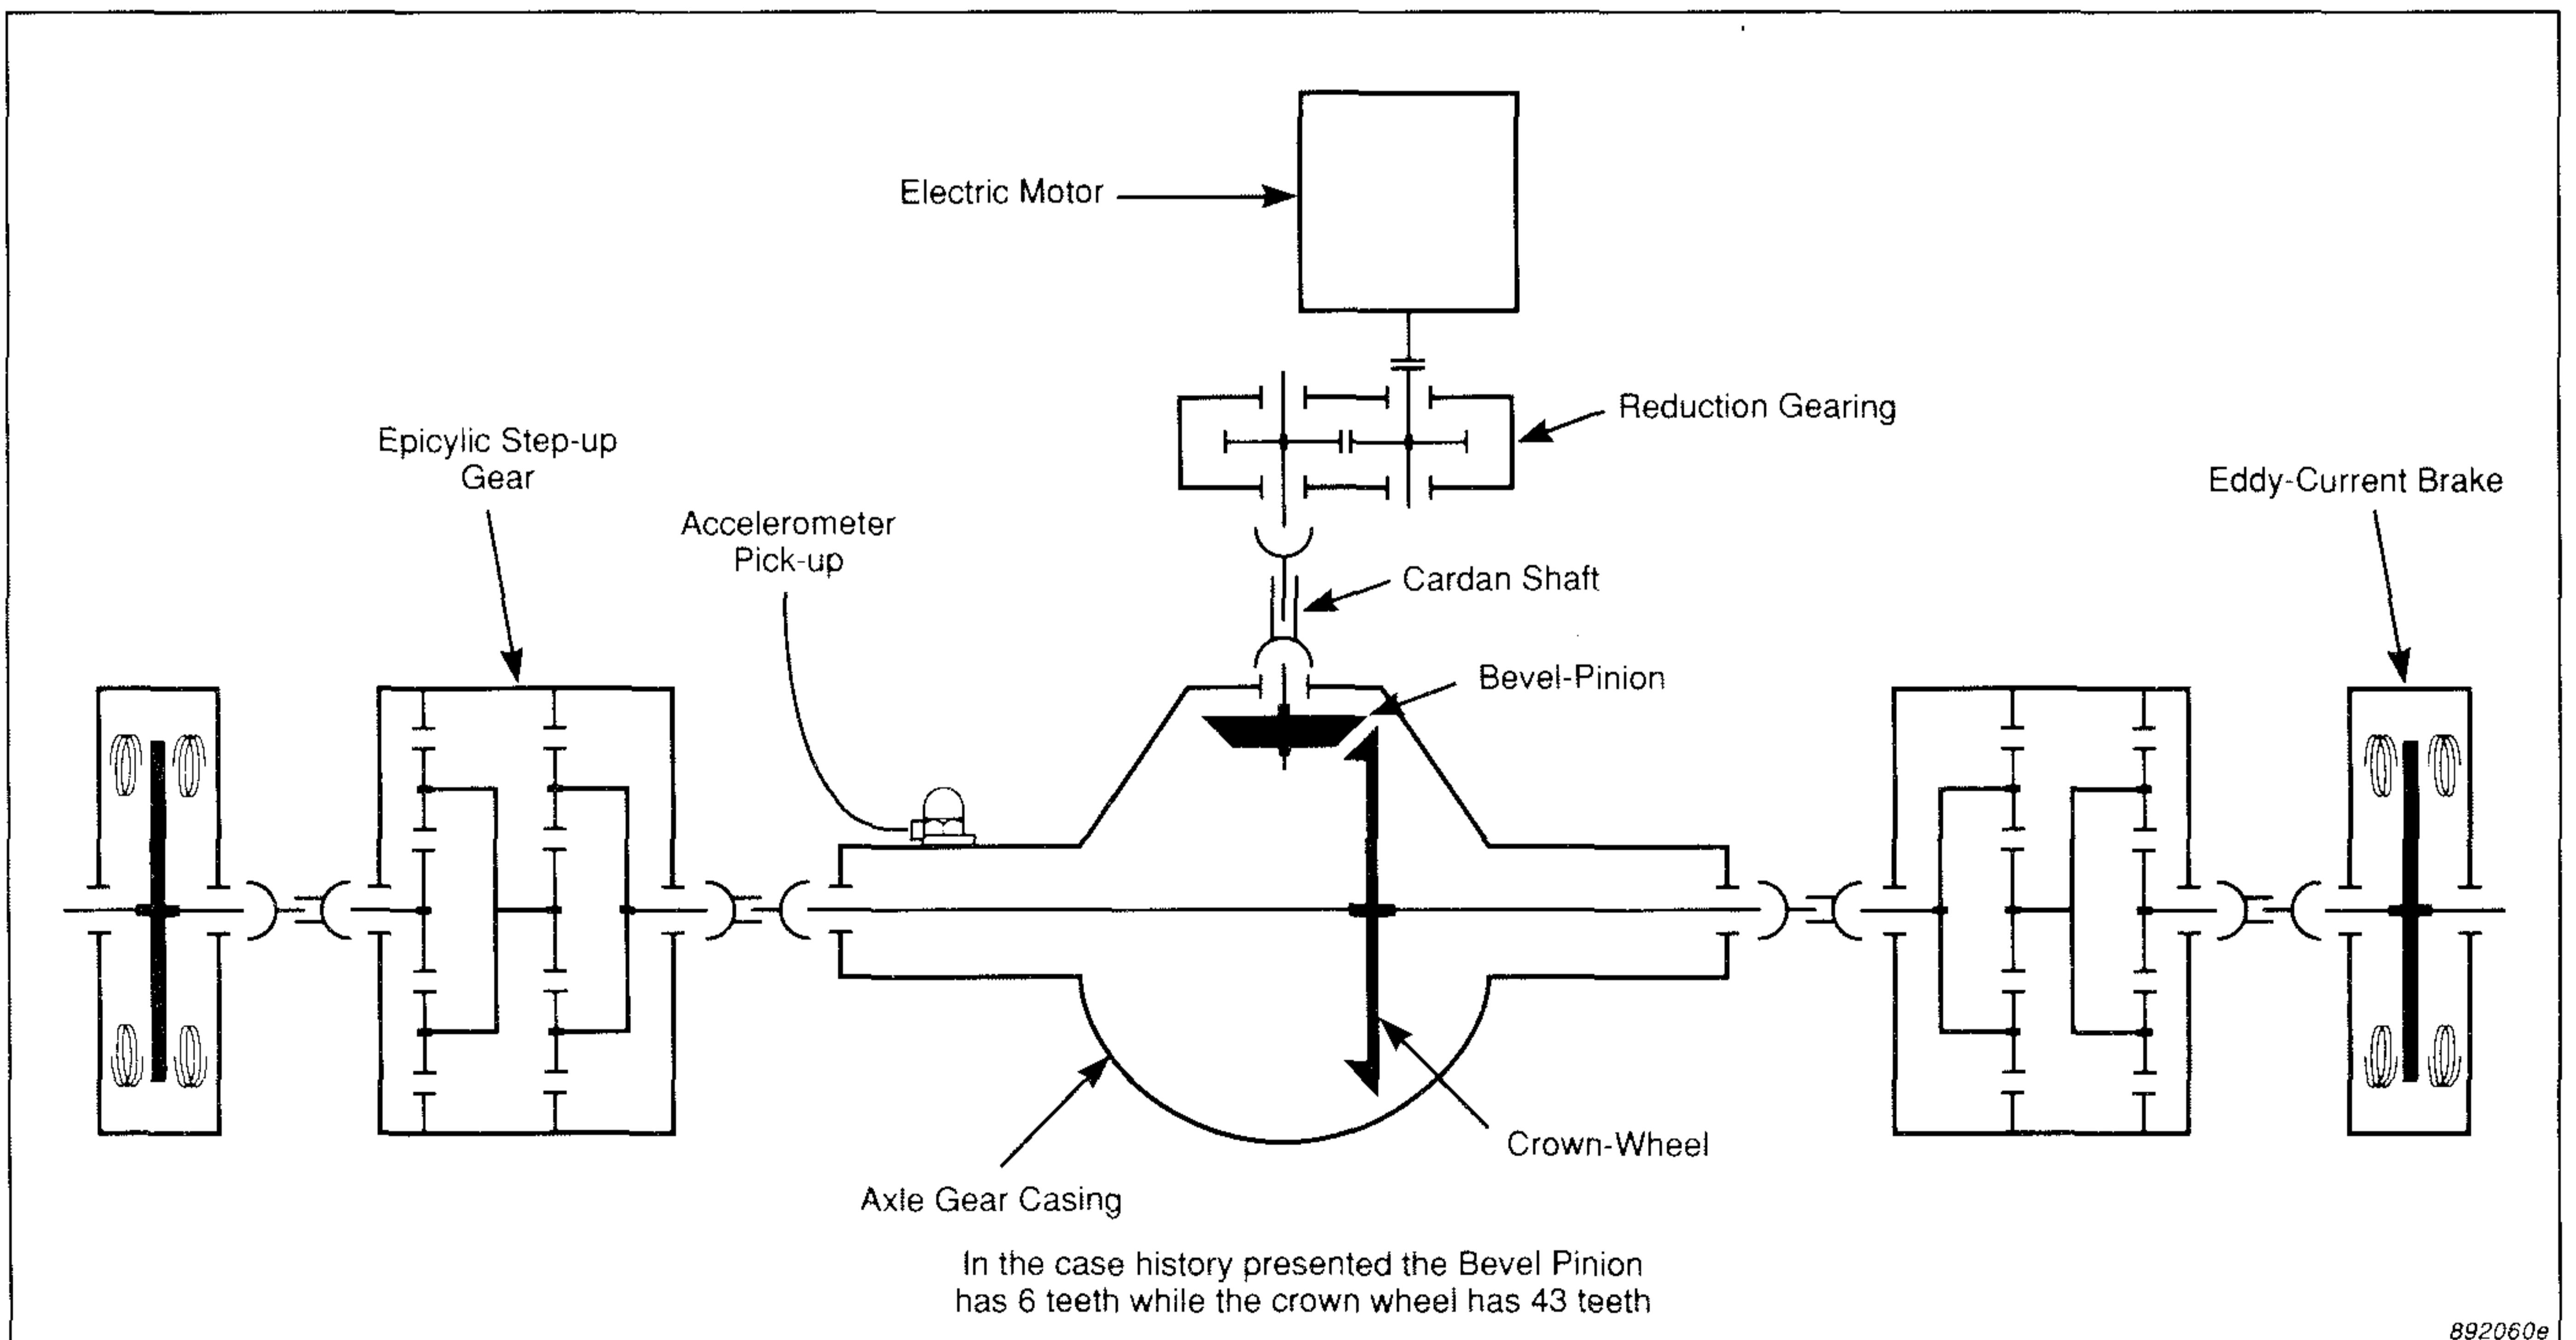
Fig. 1. Photographs of the test stand and schematic of the arrangement identifying the component parts

A special test stand is used to drive the axle gears at constant speed and high load. The arrangement can be seen in the photographs in Fig. 1, which also shows the schematic layout of the test stand, as used for all the tests.

A single accelerometer is used to measure the gear vibration and the mounting of this can be seen from the close-up photograph of the axle in Fig. 1. The mounting position was selected carefully after trial-and-error mounting of accelerometers in various locations on the axle. The position chosen allows all the expected tooth-mesh frequencies¹, especially those from the bevel-pinion and the crown-wheel, to be measured quite satisfactorily with the single accelerometer.

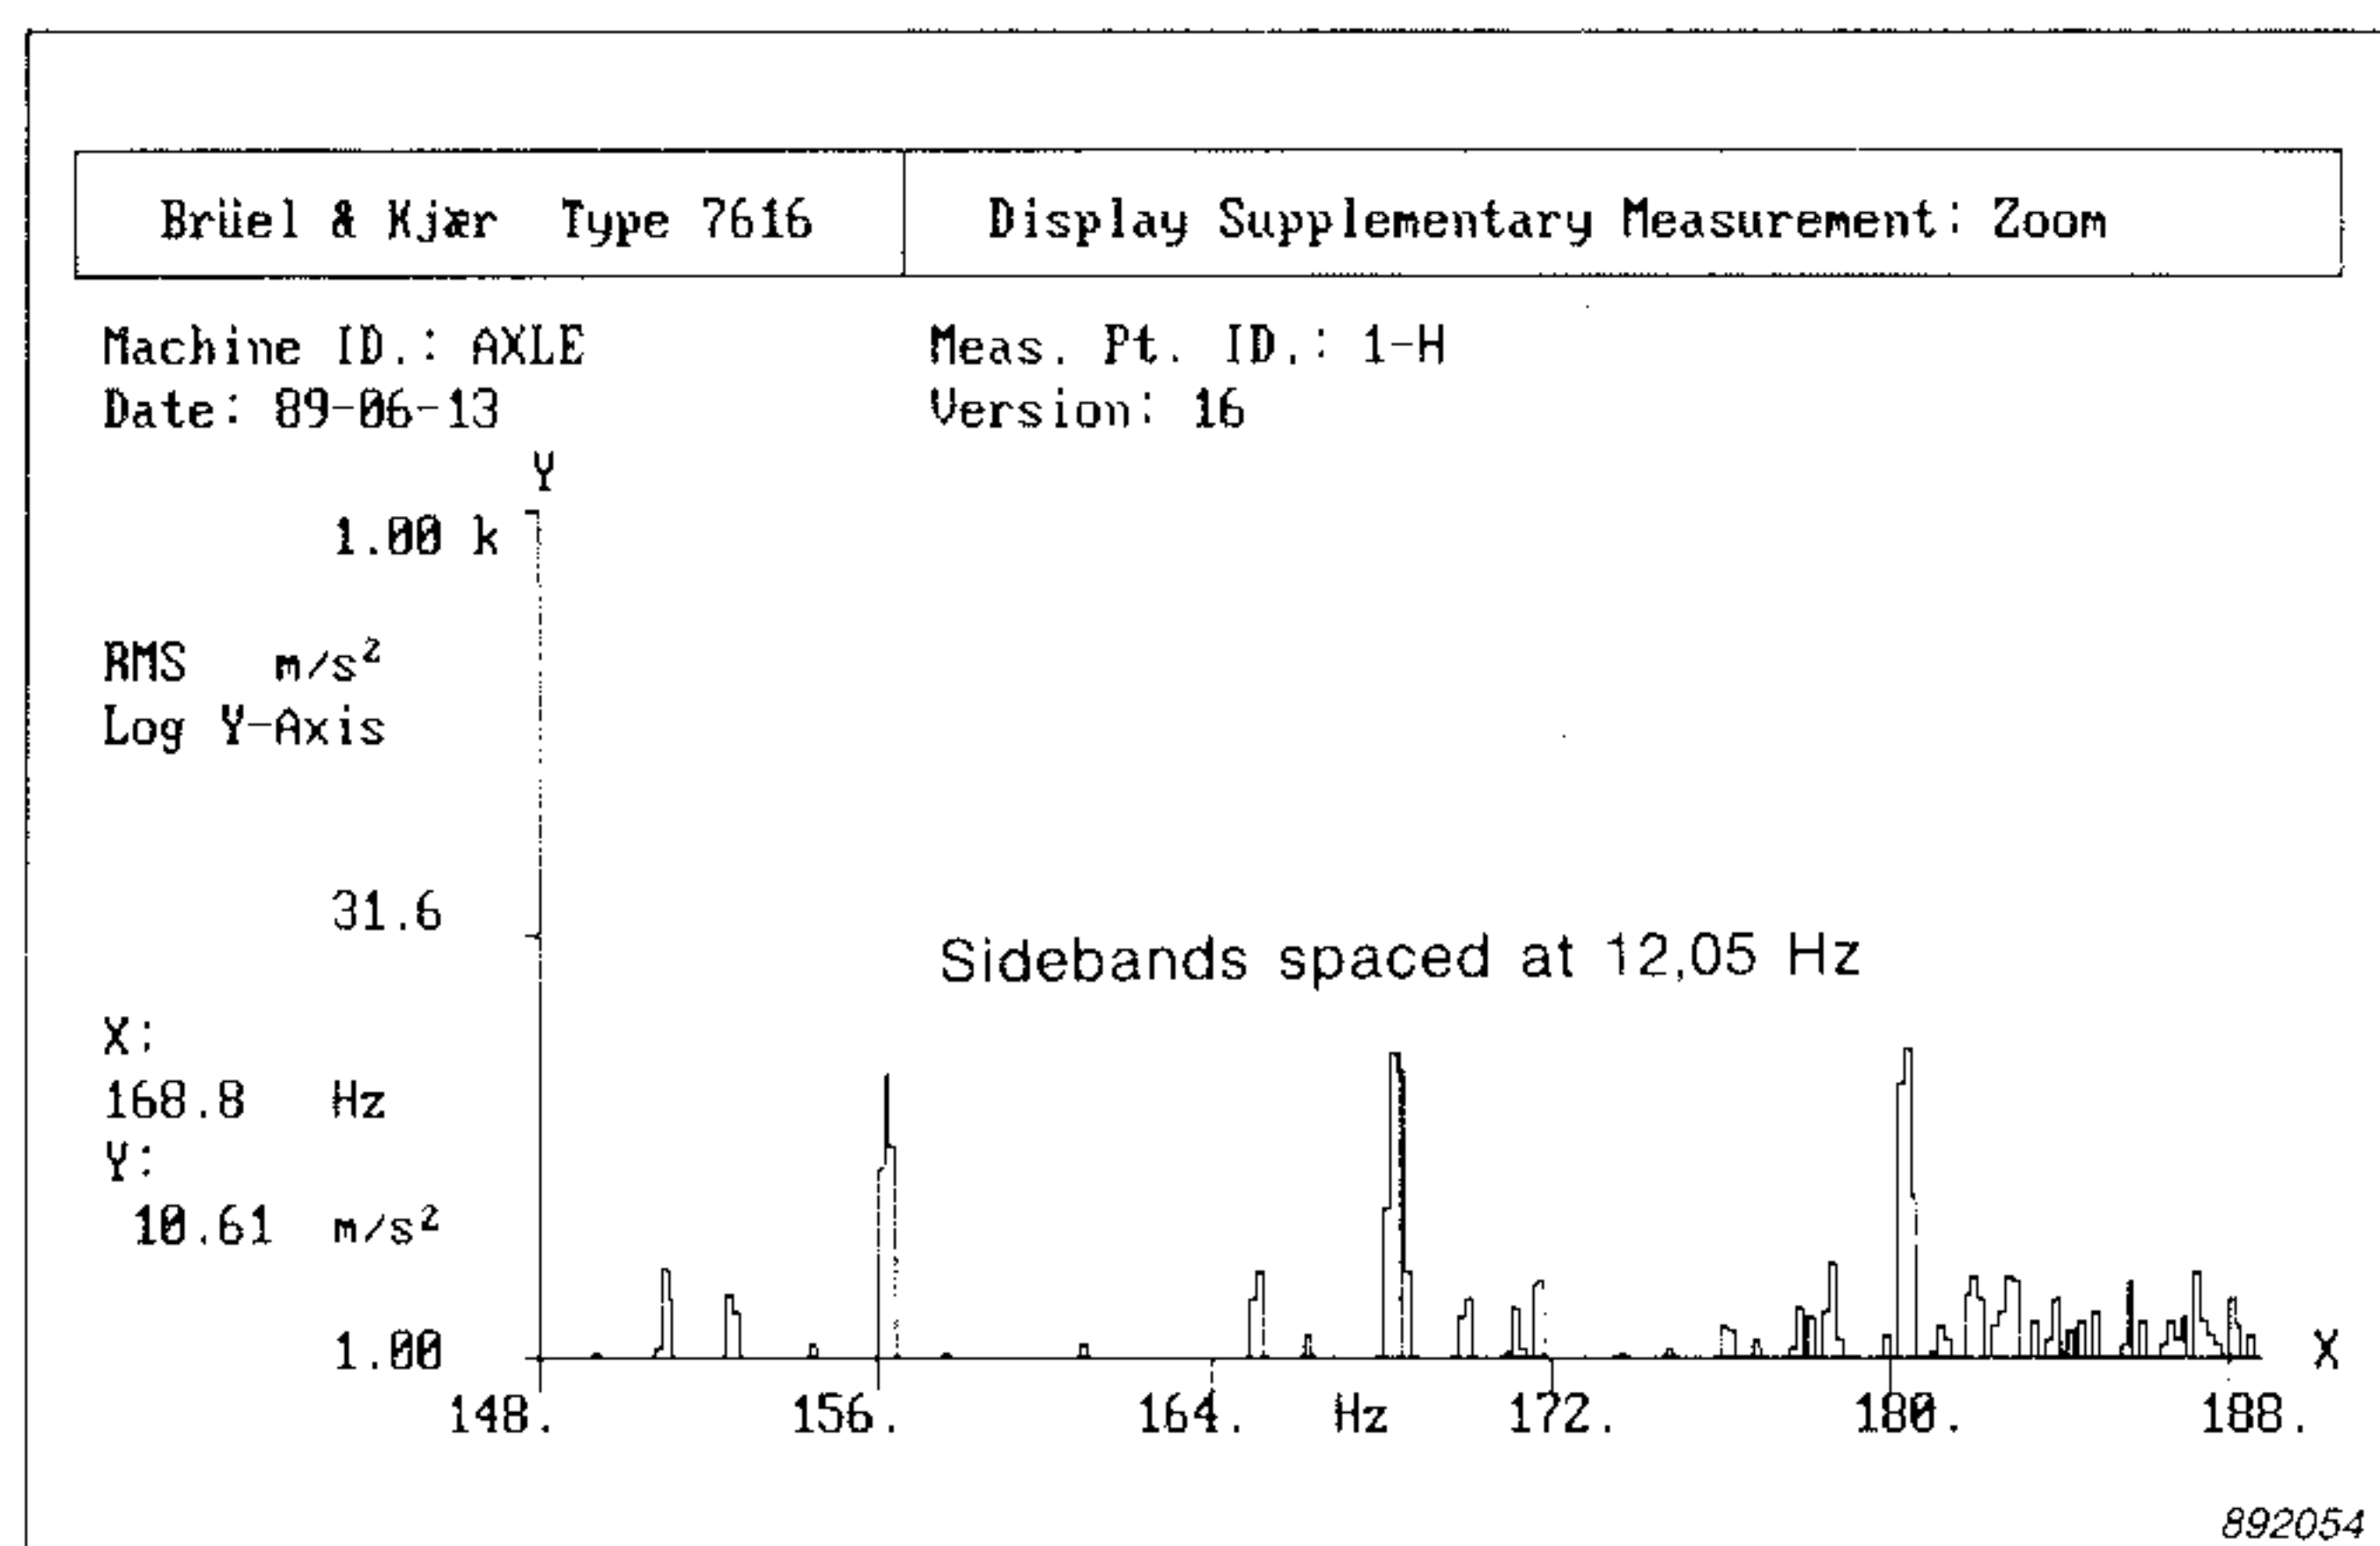
Fig. 6. Baseband, zoom and cepstra taken at the 5th and 10th records in the columns to left and right respectively, showing the growing sidebands as pitting spreads from one to more teeth on the 6 tooth bevel-pinion

The test was stopped after the 5th spectral record and the pitting on one of the teeth visually examined. This was repeated after the 10th record, where the pitting was observed to be much more widespread. Baseband, zoom and cepstra taken at the 5th and 10th records are shown in Fig. 6. These plots clearly illustrate the growing sidebands.
