MODEL: CR-180

No. : DP17-0301E

Service Manual Supplement (MY8-13A0-000)

Supplemental information for the CR-180 Service Manual

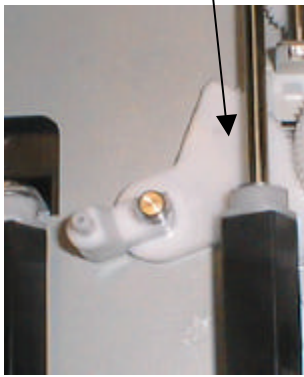
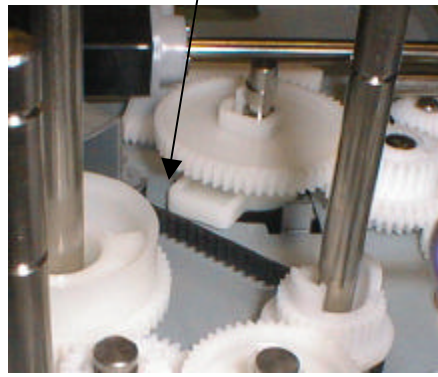
</div> <div style="text-align: center;"> <div style="border: 1px solid black; padding: 2px;">Gear B</div>

</div> <div style="text-align: center;"> <div style="border: 1px solid black; padding: 2px;">Left stopper</div>

</div> </div> <p>All cables should be pulled out toward the front.</p>
