MODEL: **GP 605**

SUBJECT: **Possible Short Circuit**

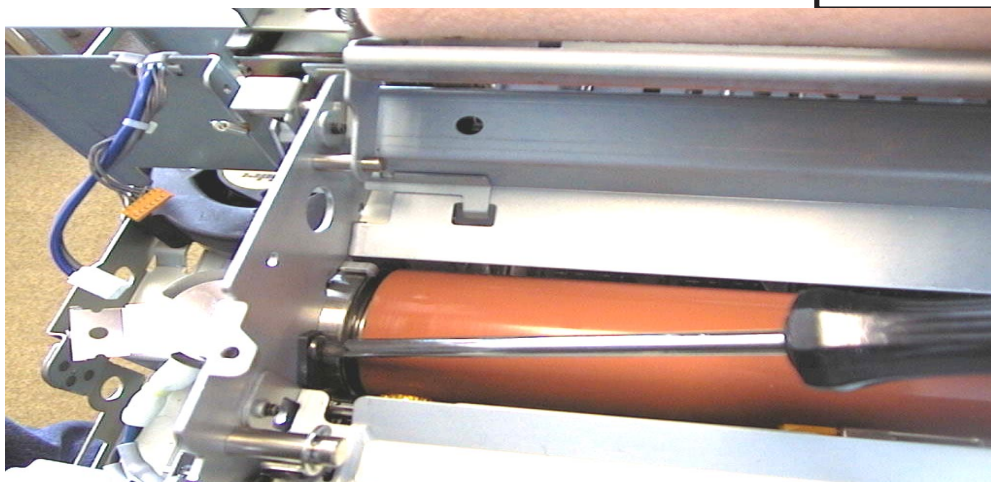
- ⑥ With a screwdriver fitted to the screw (XB1-2400-807), attach the nut (XB7-2100-409) then tighten it. While doing this prevent the screw from turning by holding the screwdriver stationary.

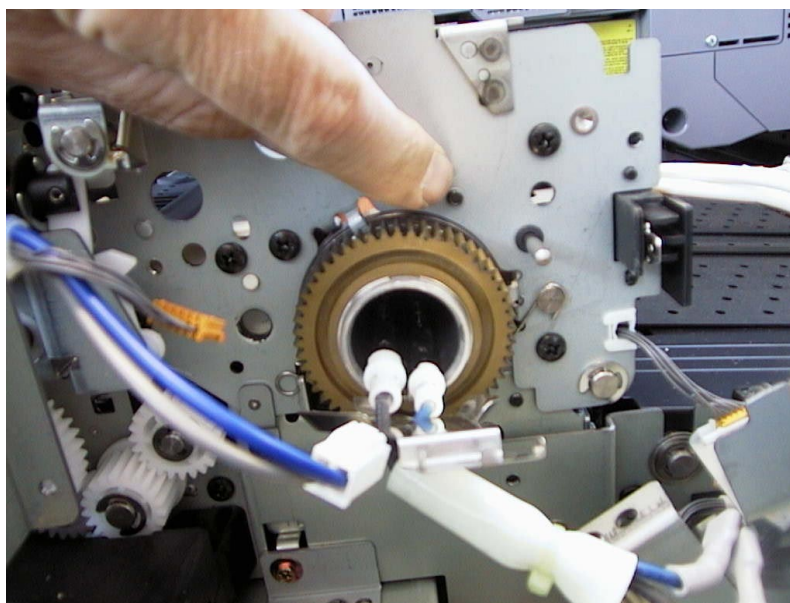
- ③ Ensure that the spring is removed as shown

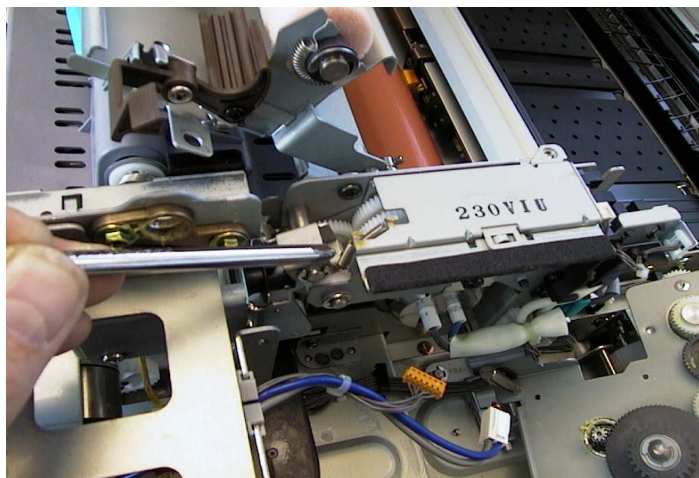
- ④ Remove heater cover plate from the front of the upper fixing roller, as shown.

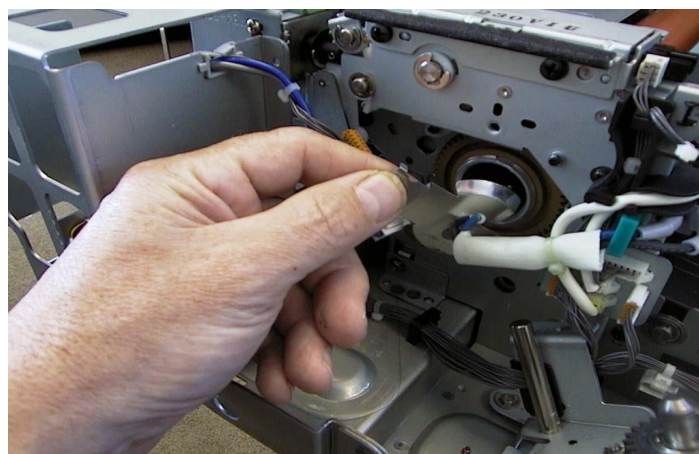
- ⑤ Remove the fixing cleaner belt drive assembly (two screws), this exposes the screw that holds the reciprocating shaft bushing in place.

This screw must be replaced with an 8mm long screw and locked in place with a nut.

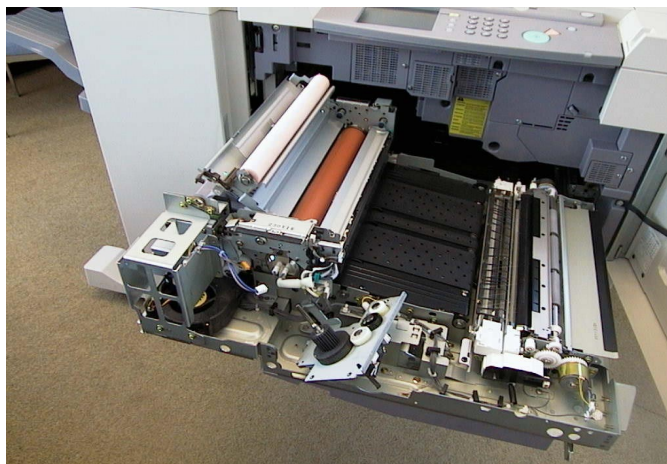
- ❶ Remove front cover, fuser cover, web and fixing drive motor as shown.

(There are two screws holding the motor assembly in place).

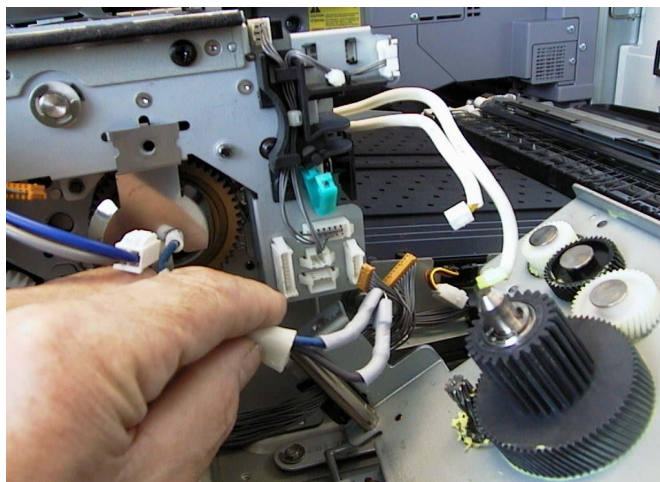
- ❷ Remove connectors from the assembly as shown
