MODEL: iR2200/ 2800 / 3300

SUBJECT: Instructions for replacement of Upper Ratchet Gear
(FB3-2856-000)

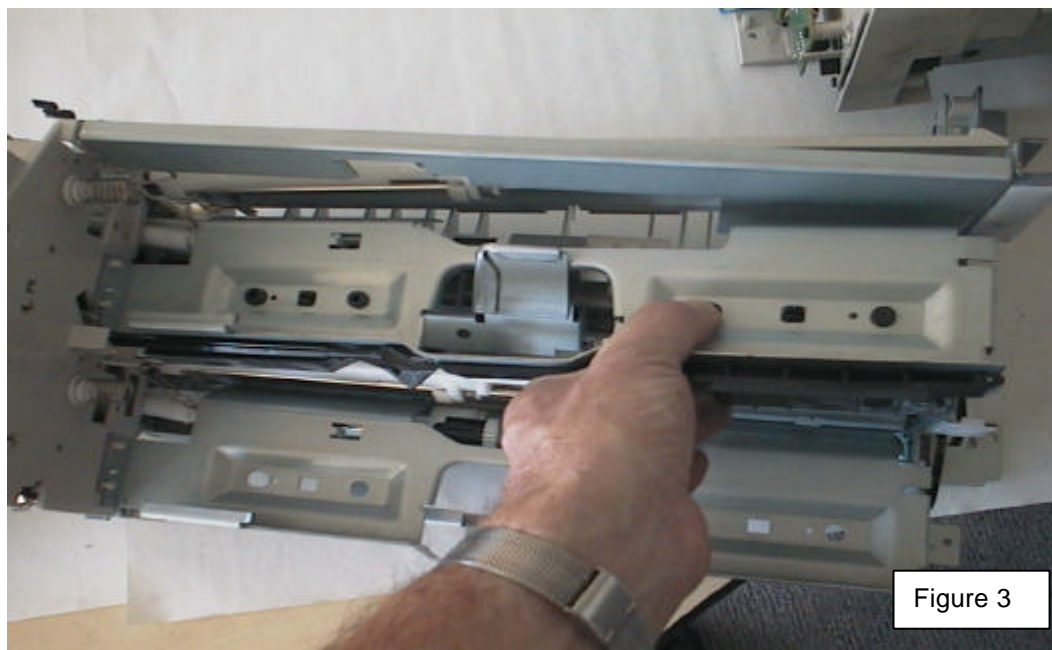
Lift the cross member as shown in figure 3, and remove both front and rear black plastic guides. Also remove the 'A' and 'B' feed rollers as per normal service procedure.

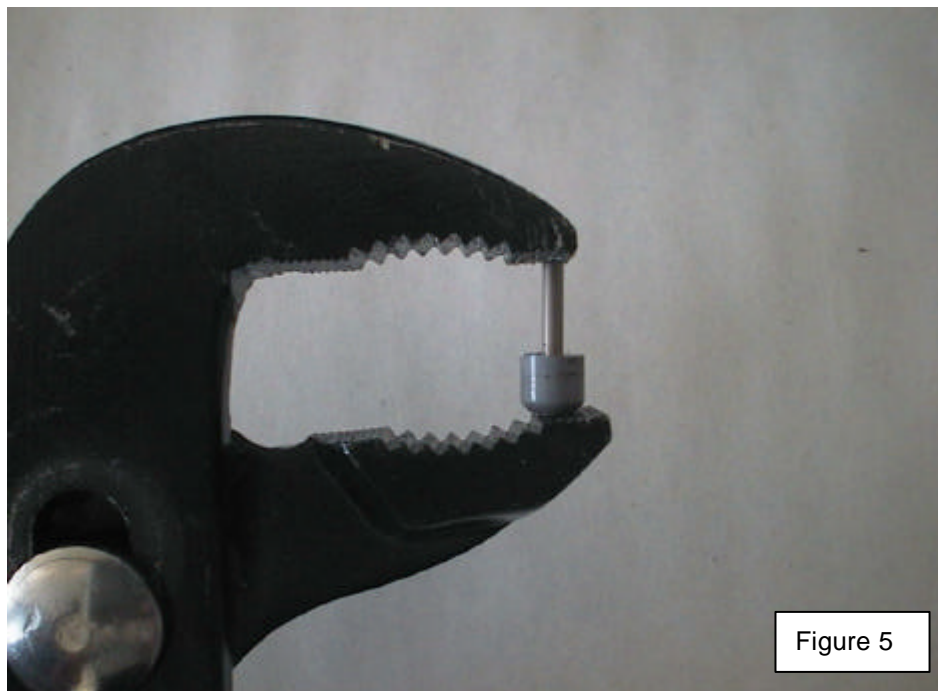
Insert the dowel (XD3-2200-122) pin into the cut portion of the peg previously removed as shown in Figure 5
