Model: Saddle Finisher-G1

Ref. No. : FF-T01-W-000170-01

Subject: Using a Different Stepping Motor (M2)

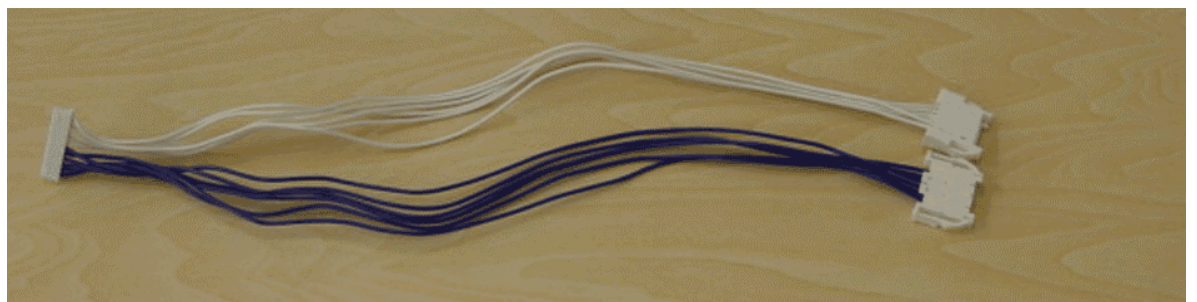
Figure 3

Stepping paddle motor cable (before change)

When replacing the existing motor with an M2 motor equipped with an anti-vibration member, be sure to replace the following 3 items at the same time: stepping motor, stepping paddle motor cable, bracket.

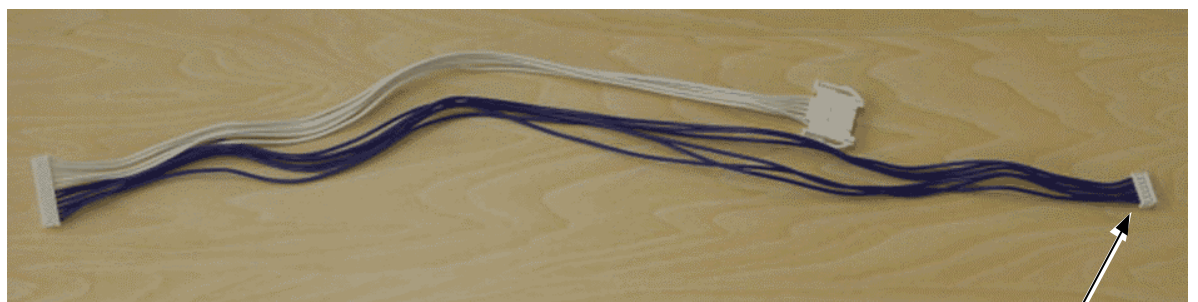
Figure 4

Cable for M2 motor connection

Stepping paddle motor cable (after change)
