Issued by Canon (UK) Limited

iR C6800C
iR C6800CN

iRC6800-009
(F2-T01-0M3-10025-01)

Replacing color developing assembly or starter

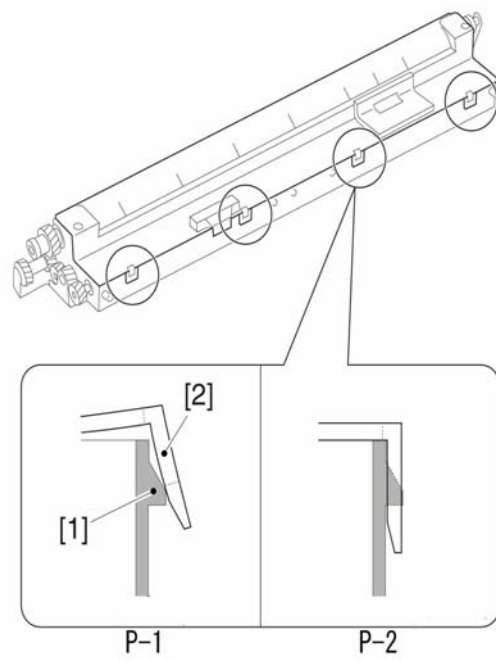
F-1

P-1: The lid of the developing container is lifted and is not secured.

P-2: The hooks of the developing assembly are correctly engaged with the mounting holes on the lid of the developing container.

[1] Hook of the developing assembly

[2] Mounting hole on the lid of the developing container

When mounting the color developing assembly to the machine upon replacement of the color developing assembly or starter, be sure to verify that the 4 hooks [1] of the developing assembly are firmly engaged with the 4 mounting holes [2] on the lid of the developing container. (See P-2.)

If the color developing assembly is mounted to the machine as the lid of the developing container is lifted, (See P-1.) it may cause fogged image or toner scattering inside the machine.
