S300

SIMPLIFIED MANUAL

(QY8-1377-000)

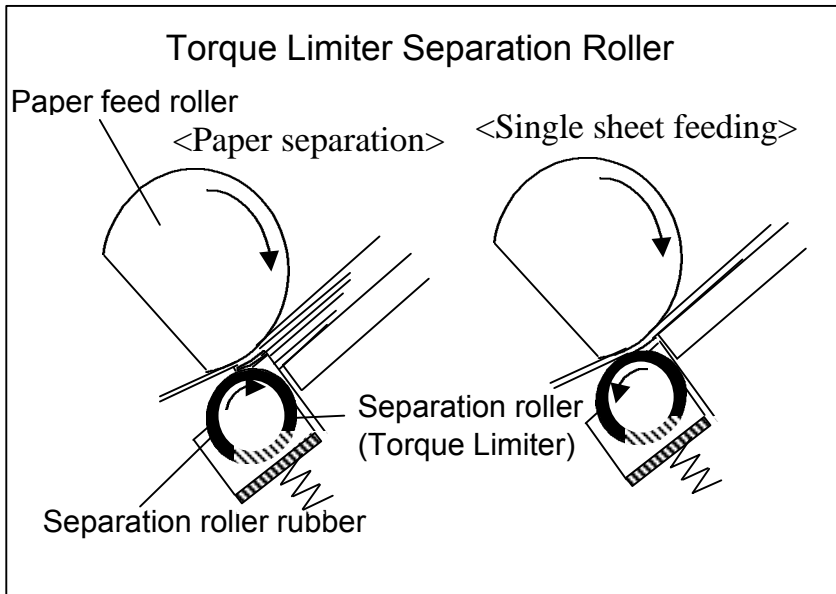
New ASF Torque Limiter Separation Roller System

New ASF system with improved paper pick-up capability (paper separation ability)

->Reverse rotation of the coil spring of the separation roller (Torque Limiter) works instantaneously.

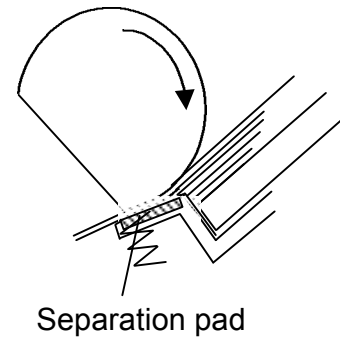
Paper feeding system of the S600
(Duplo method)

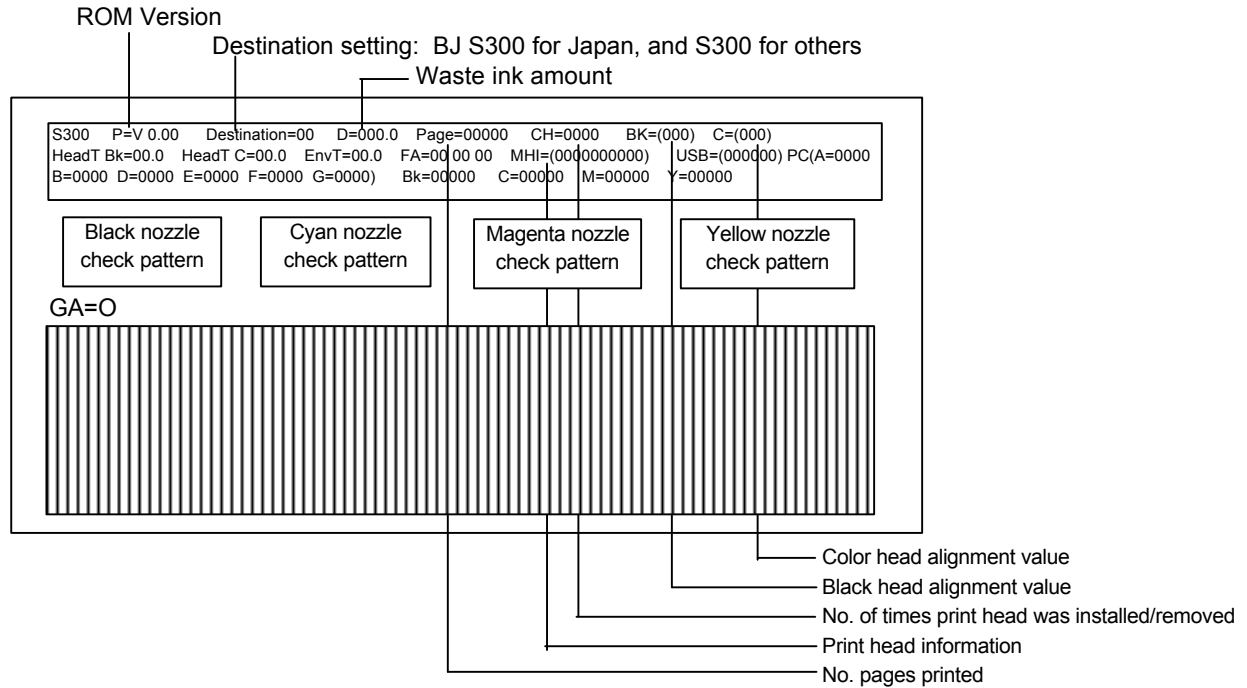
*1 Shipment inspection pattern print sample

EEPROM content can be confirmed by a print of the shipment inspection pattern.

- 1 Shipment inspection pattern printing
 - a While the printer is powered off, hold down the RESUME button, then press the POWER button.
 - b When the POWER LED lights up, hold down the POWER button, and press the RESUME button twice.
 - c Release both the POWER and RESUME buttons, and the service mode is entered.
 - d Press the RESUME button once.
 - e Press the POWER button.
==>Shipment inspection pattern will be printed.

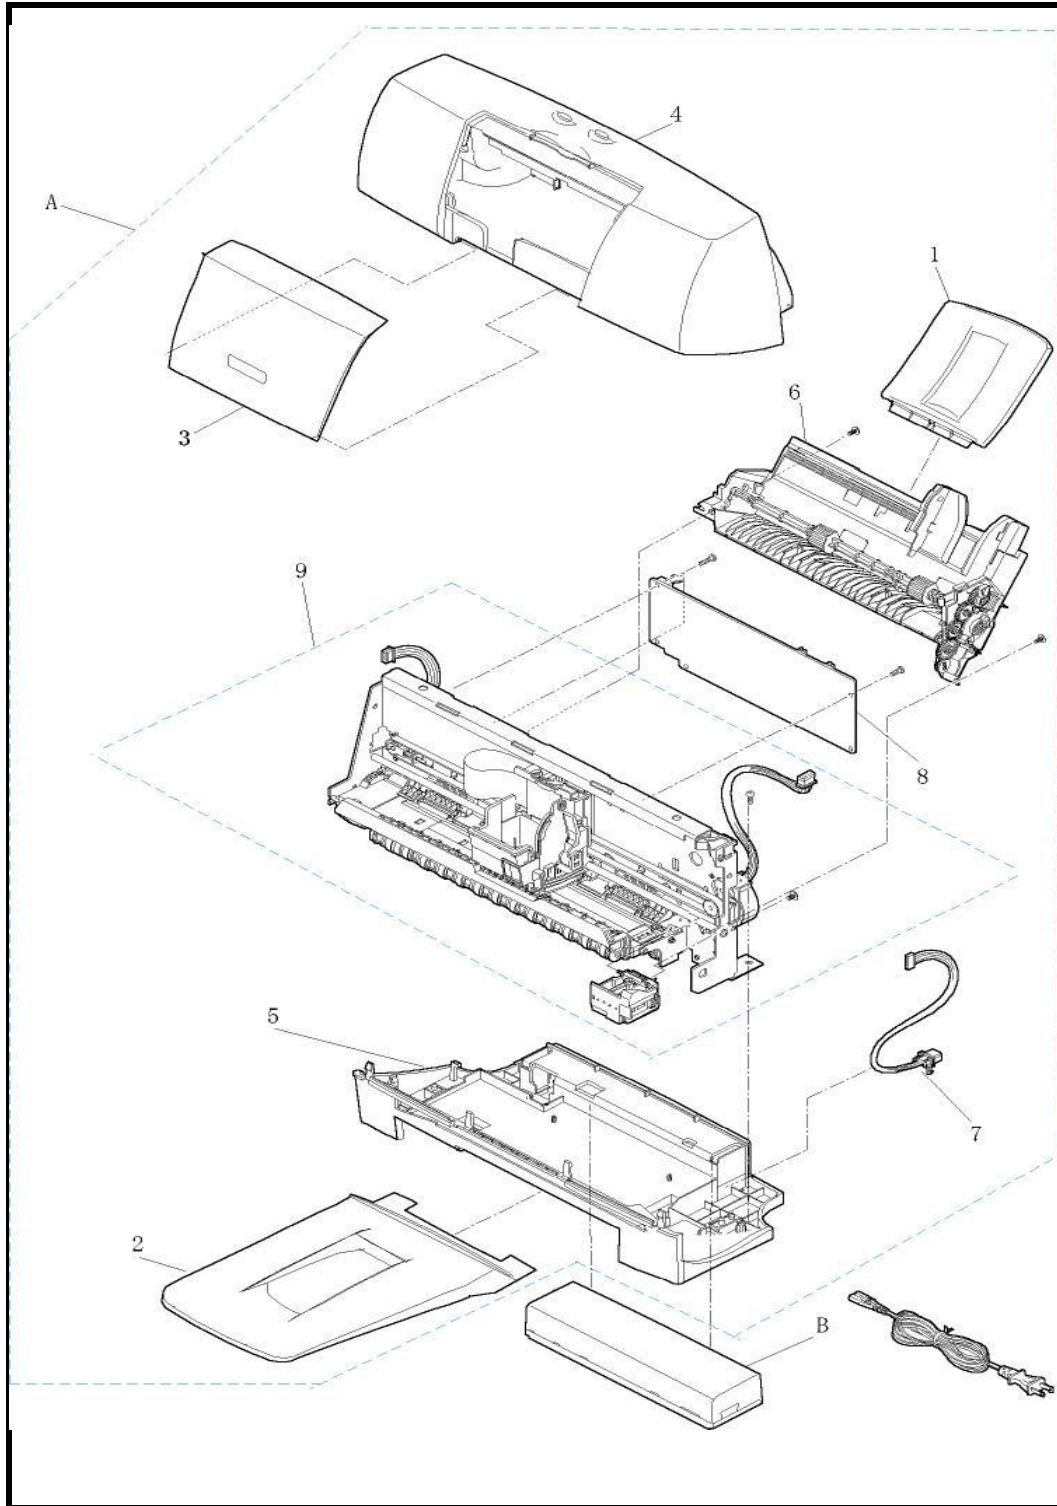
5. EXTERNAL VIEW AND PARTS LIST

Parts List

Key	Part Number	Rank	Q'ty	Description	Remark
A	Q10-1002-710	N	1	WHOLE UNIT, W/O POWER SUPPLY UNIT	
B	QH3-3471		1	AC Adapter 100/120V 50/60HZ	LV(USA,CAN,JPN)
	QH3-3477		1	AC Adapter 220/240V 50/60HZ	HV(EUR)
	QH3-3478		1	AC Adapter 220/240V 50/60HZ	HV(CHN,ASIA,AUST)
	QH3-3474		1	AC Adapter 100/120V 50/60HZ	LV(TWN)
	QH3-3479		1	AC Adapter 220/240V 50/60HZ	HV(KRN)
		QY6-0037		1	Print Head

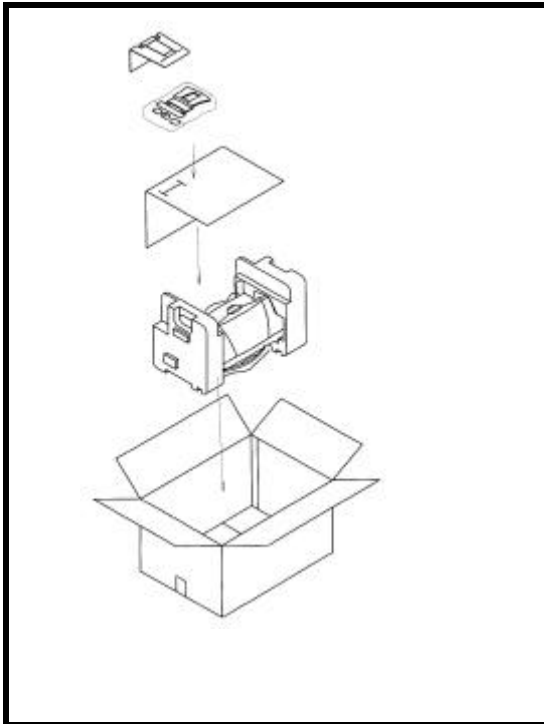
Configuration of Service Part Printer Unit (WHOLE UNIT, W/O POWER SUPPLY UNIT)

Service part printer unit components:
Printer unit (without model name and AC adapter)
Paper feed tray
Paper delivery tray
Product name label
Packaging foam

- 1 Remove the AC adapter from the returned printer unit.
- 2 Connect the removed AC adapter to the new printer unit.
- 3 Attach the name label on the new printer. (The name label is packaged with the new printer.)
- 4 Set the destination. (For the setting method, refer to "SERVICE MODE".)

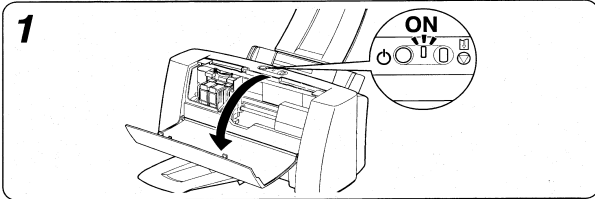
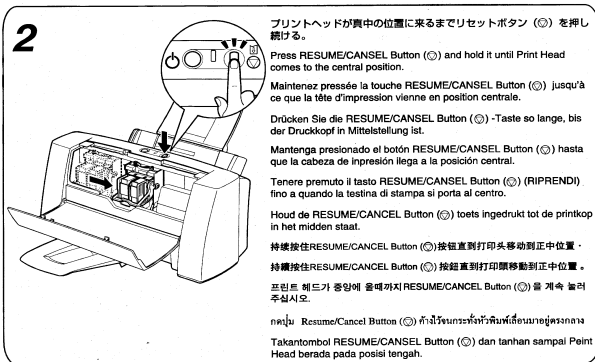
<Print Head Replacement Method User's Manual>

<p>プリントヘッドの交換方法 How to Replace Print Head Comment remplacer la tête d'impression Austausch des Druckkops Cómo cambiar la cabeza de impresión Modalità di sostituzione della testina di stampa</p>	<p>Vervangen van de printkopo 更換打印頭的方法 更換打印頭的方法 프린트 헤드 교환 방법 วิธีการเปลี่ยนหัวพิมพ์ Cara mengganti Print Head</p>
---	---

プリントヘッドを交換した後は必ずかんたんスタートガイドを参照しプリントヘッドの位置調整を行ってください。
 After replacing the Print Head, be sure to refer to the Quick Start Guide and align the print head.
 Après avoir remplacé la tête d'impression, veuillez vous reporter au Guide de démarrage rapide et aligner la tête d'impression.
 Nach dem Ersetzen des Druckkopfs schlagen Sie in der Erste Schritte nach und richten den Druckkopf aus.
 Después de sustituir el cabezal de impresión, lea sin falta la Guía de Iniciación Rápida y alinee el cabezal de impresión.
 Dopo aver sostituito la testina di stampa, far riferimento alla Guida rapida e allineare la testina di stampa.
 Nadat de printkop vervangen is, dient u de Aan de slag-gids te raadplegen en de printkop uit te lijnen.
 更換打印頭后，請務必參閱快速安裝指南，調整打印頭的位置。
 更換打印頭後，請務必參閱快速安裝指南，調整打印頭的位置。
 프린트 헤드 교환 후에는 반드시 사용자 설명서를 참조해서 프린트 헤드의 위치를 조정하십시오.
 หลังจากการเปลี่ยนหัวพิมพ์เสร็จแล้ว ควรจะดูคู่มือผู้ใช้ที่แนบมาเพื่อปรับตำแหน่งหัวพิมพ์ให้ถูกต้องตามคู่มือ

In User Mode: Open the front cover, and hold down the RESUME button for 3 seconds. The carriage will move to the center position for print head replacement. (In the User Mode, after the initial print head installation, the carriage stops only at the left of print head replacement position, that is, at the ink cartridge replacement position.)

In Service Mode: Open the front cover. The carriage will move to the center position.

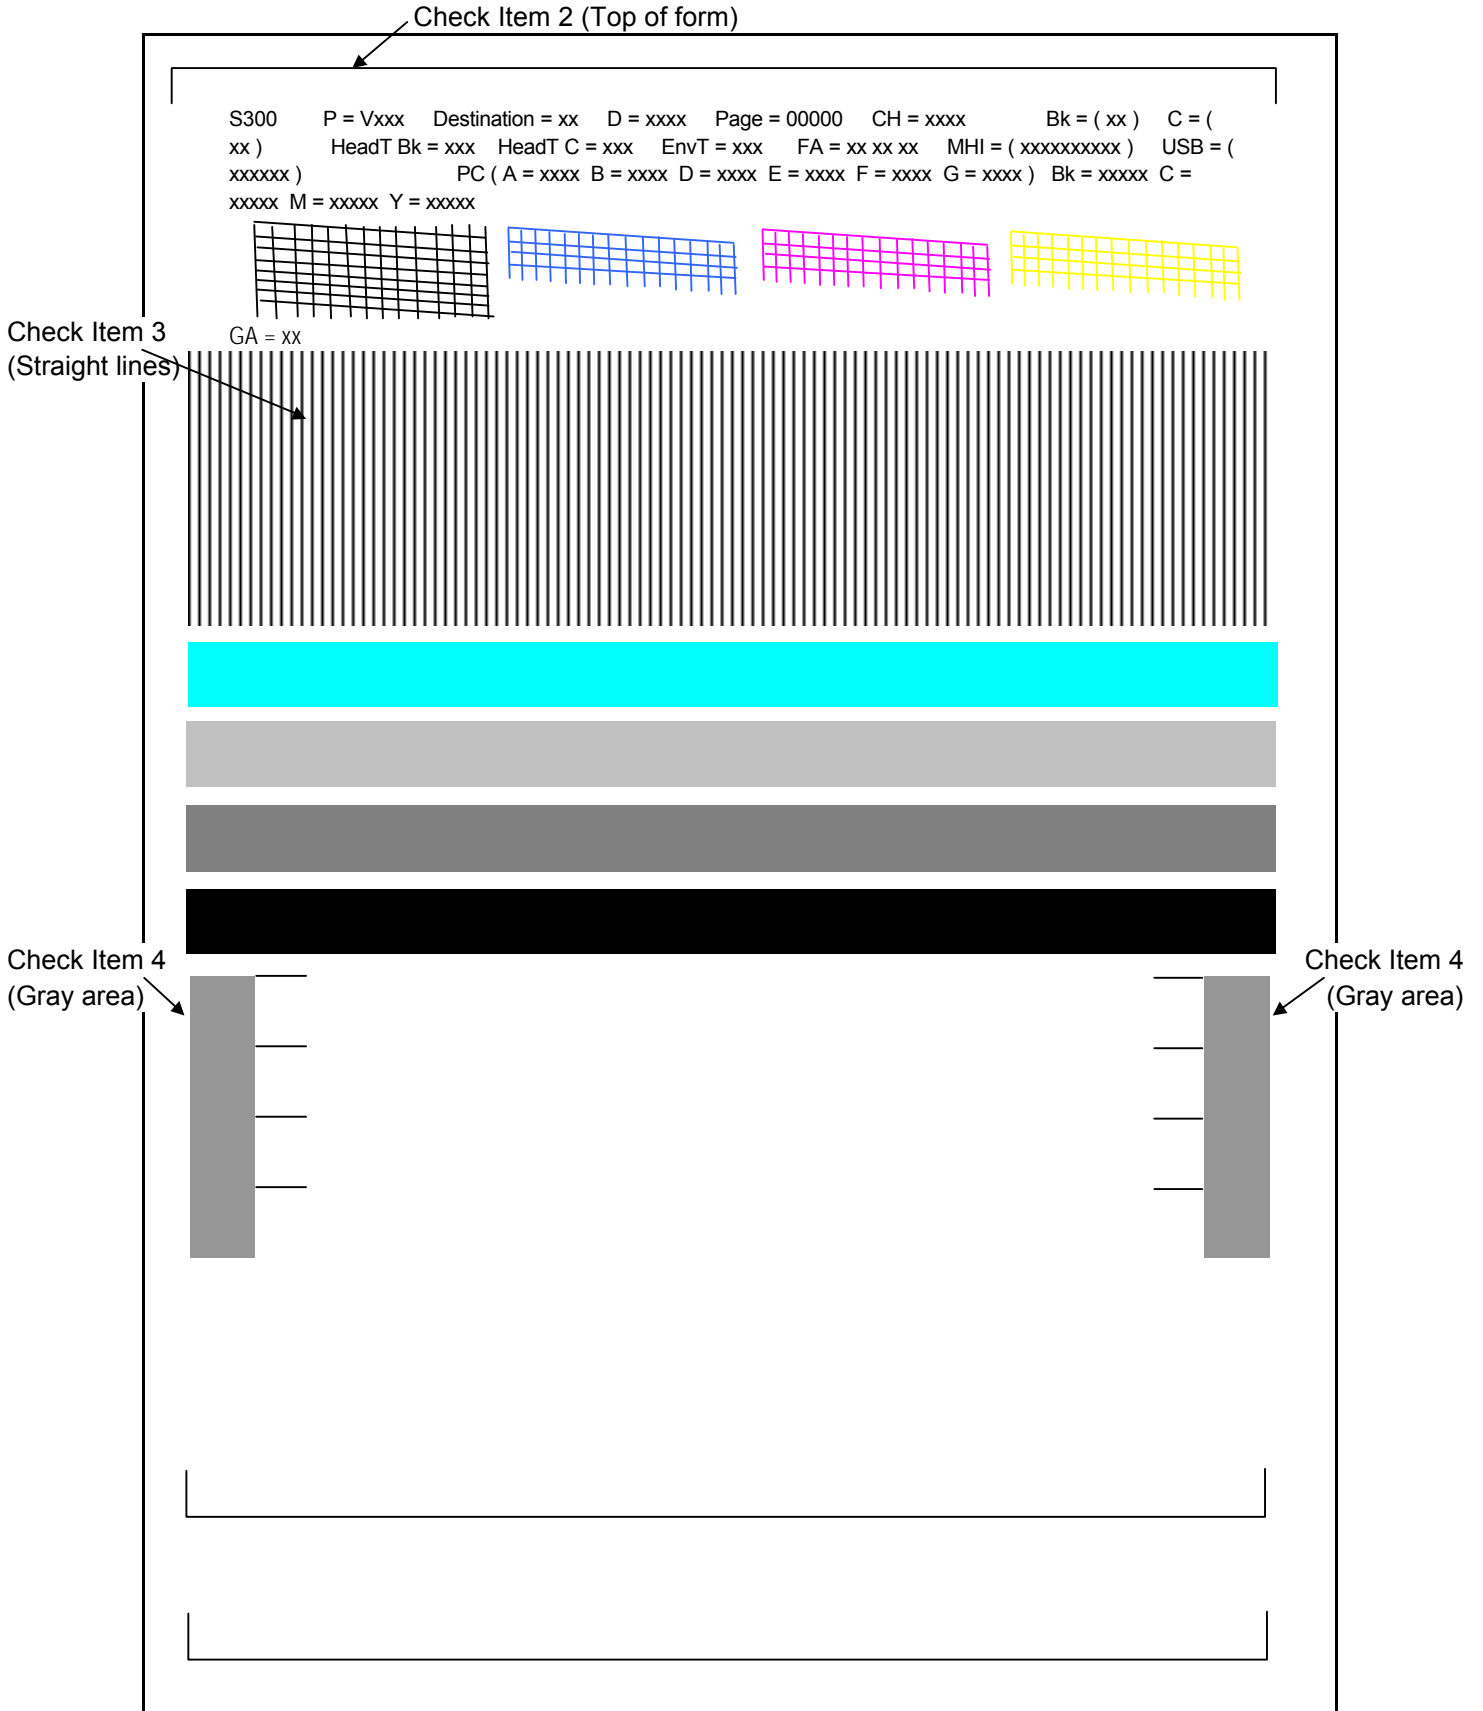
APPENDIX: SHIPMENT INSPECTION PATTERN

Check Item 1 (Non-ejection of ink): Whole Print
