# Eddystone Users Group

ISSUE NO. 10.

November / December 1991.

Featured Model this issue - EC10.

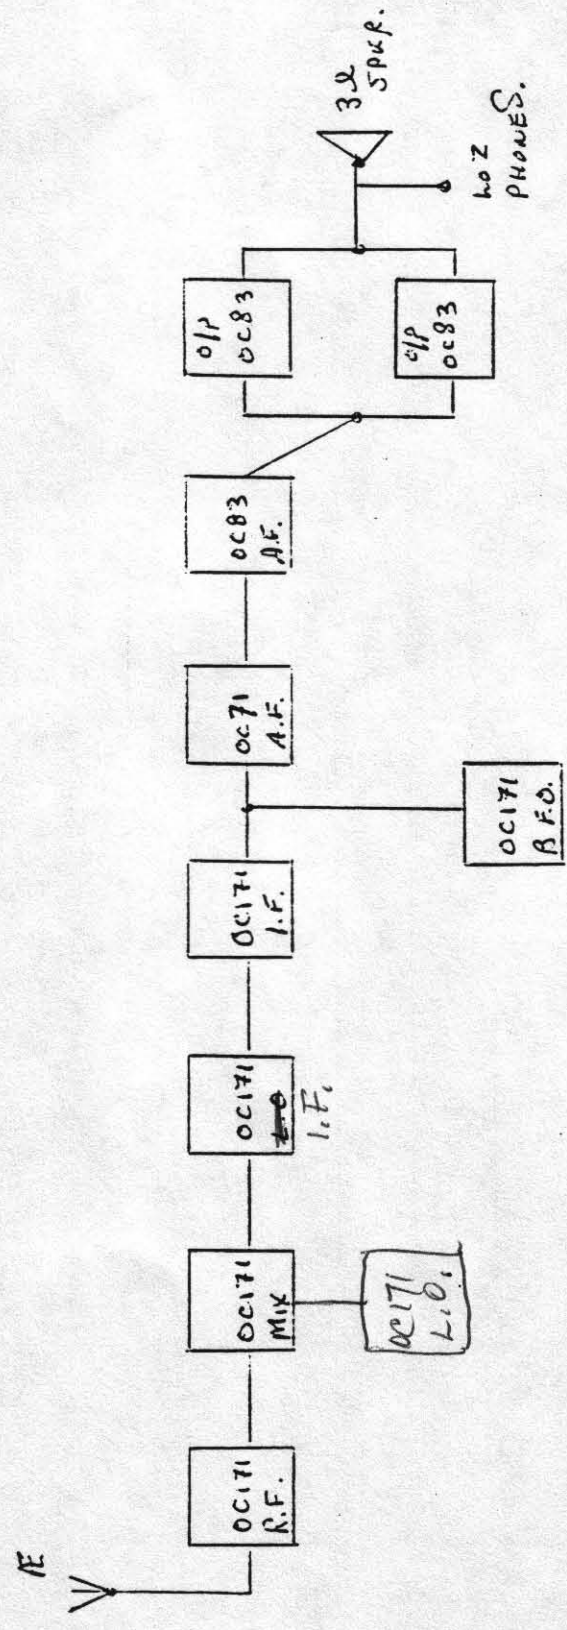
MODEL EC 10. - MINI COMMS RCVR.

10 TRANSISTOR, 5 BANDS, 550 KC/S TO 30 MC/S.  
 I.F. 465 KC/S.

\* POWER SUPPLY # 924 FOR  
 240V. TO 9V. OR  
 6 x "D" CELLS IN  
 BATT. BOX.

- This is one of the so-called baby Eddystones, similar in styling to the models we are all used to but about two-thirds size. At 6 2/3 x 12 1/2 x 8 inches and weighing 14 pounds with either internal battery box or mains power supply, it is an ideal travelling communications receiver. Don't be put off by it's diminutive size, as front panel controls include separate RF & AF gain pots. BFO, five band range switch, main tuning, power switch, phone jack, AF filter switch, AVC switch, and a push on dial light switch. The cabinet and front panel are of solid steel construction with a typically Eddystone slide rule dial of eleven inches, clearly marked out over the range of 550 Kc/s to 30 Mc/s. A logging scale & micro logging dial in conjunction with the 110 to 1 ratio tuning mechanism allows very close resetting accuracy at all frequencies. The usual Eddystone flywheel tuning mechanism with its silky smooth operation and no backlash are just as effective as on the other full size models. Reception of AM, CW, & SSB are catered for by the ten transistor plus three diode circuitry. The zener diode serves to stabilise the supply to the RF, LO & BFO stages. This also helps provide sensibly constant performance with falling battery voltage when running from dry batteries. A variety of aerial types are catered for by the different sockets on the rear panel. A telescopic whip, a random long wire, or a doublet type can be used. Output is to a built in 5 inch speaker, to an external 3 ohm speaker, or to low impedance phones. 900 milliwatt at maximum of 10 percent distortion is the rated output. The audio filter is fixed tuned to 1000 c/s and for CW reception it provides 6 db bandwidth at 100 c/s. For an early 1960 model the AVC response is quite acceptable, an 80 db change in input signal gives less than 12 db change in output. The five ranges cover 550 to 1500 Kc/s, 1.5 to 3.5 Mc/s, 3.5 to 8.5 Mc/s, 8.5 to 18 Mc/s, & 18 to 30 Mc/s. The IF is 465 Kc/s and there are 5 tuned circuits at this frequency providing adequate selectivity. At 9 volts from six 'D' type cells or from the type 924A power unit, the current drawn is 36 mA quiescent or 77 mA at 50 mW output. At 500 mW output the consumption does go up to 180 mA. Aerial impedance on the four HF ranges is an approximate 75 ohms whilst on the LF range it is about 400 ohms. Sensitivity is better than 5 microvolt for 15 db S/N ratio on the four top ranges whilst it is 15 microvolts for the same ratio on the LF band. IF selectivity is given as better than 6 db at 5 Kc/s off and 40 db at 25 Kc/s off. IF breakthrough is never less than 85 db down. Image rejection is 20 db at 18 Mc/s and 50 db at 2 Mc/s, the calibration accuracy is better than 1 percent with a stability of 1 part in 10,000 per degree centigrade. The RF section comprises 3 off OC171 transistors as RF amplifier, local oscillator and mixer stages. IF amplification is catered for by two more OC171 types, TR4 & 5, three double wound IF transfos provide a high degree of adjacent channel selectivity at 465 Kc/s. An IF

4  
reflector wave trap is fitted in the aerial input circuit. For CW & SSB work the BFO oscillator is another OC171 and this is injected into the detector stage, as a locally generated carrier. This is fed by the zener stabilised supply at 6.5 volts as is the RF & LO. The 1Kcs audio filter is a high Q resonant circuit and may be switched at will, in or out, between TR7 the AF pre-amp and TR8 the AF driver stage. The push-pull AF output stage operates in class 'B' to keep the quiescent current consumption to a minimum for battery use. Two OC33 types are used in this stage. All transistors are PNP types as was normal in the early sixties, and a positive earth supply is used. Either the supplied battery box may be fitted internally or, when this is removed the mains power unit takes its place. This caters for 120 to 240 volts operation. A type 945A PSU can be bought which will run the EC10 from 12 or 24 volt DC supplies. Ideal for mobile or marine operation. The production of this model ran from late 1964 for the early basic EC10 to 1974 for the EC10 Mark II, and the EC10M which was a MIMCO special model. All told 8 variants are known and these cover table or rack mount, with or without speaker, with switched crystal position and the MIMCO badged model number 6689.

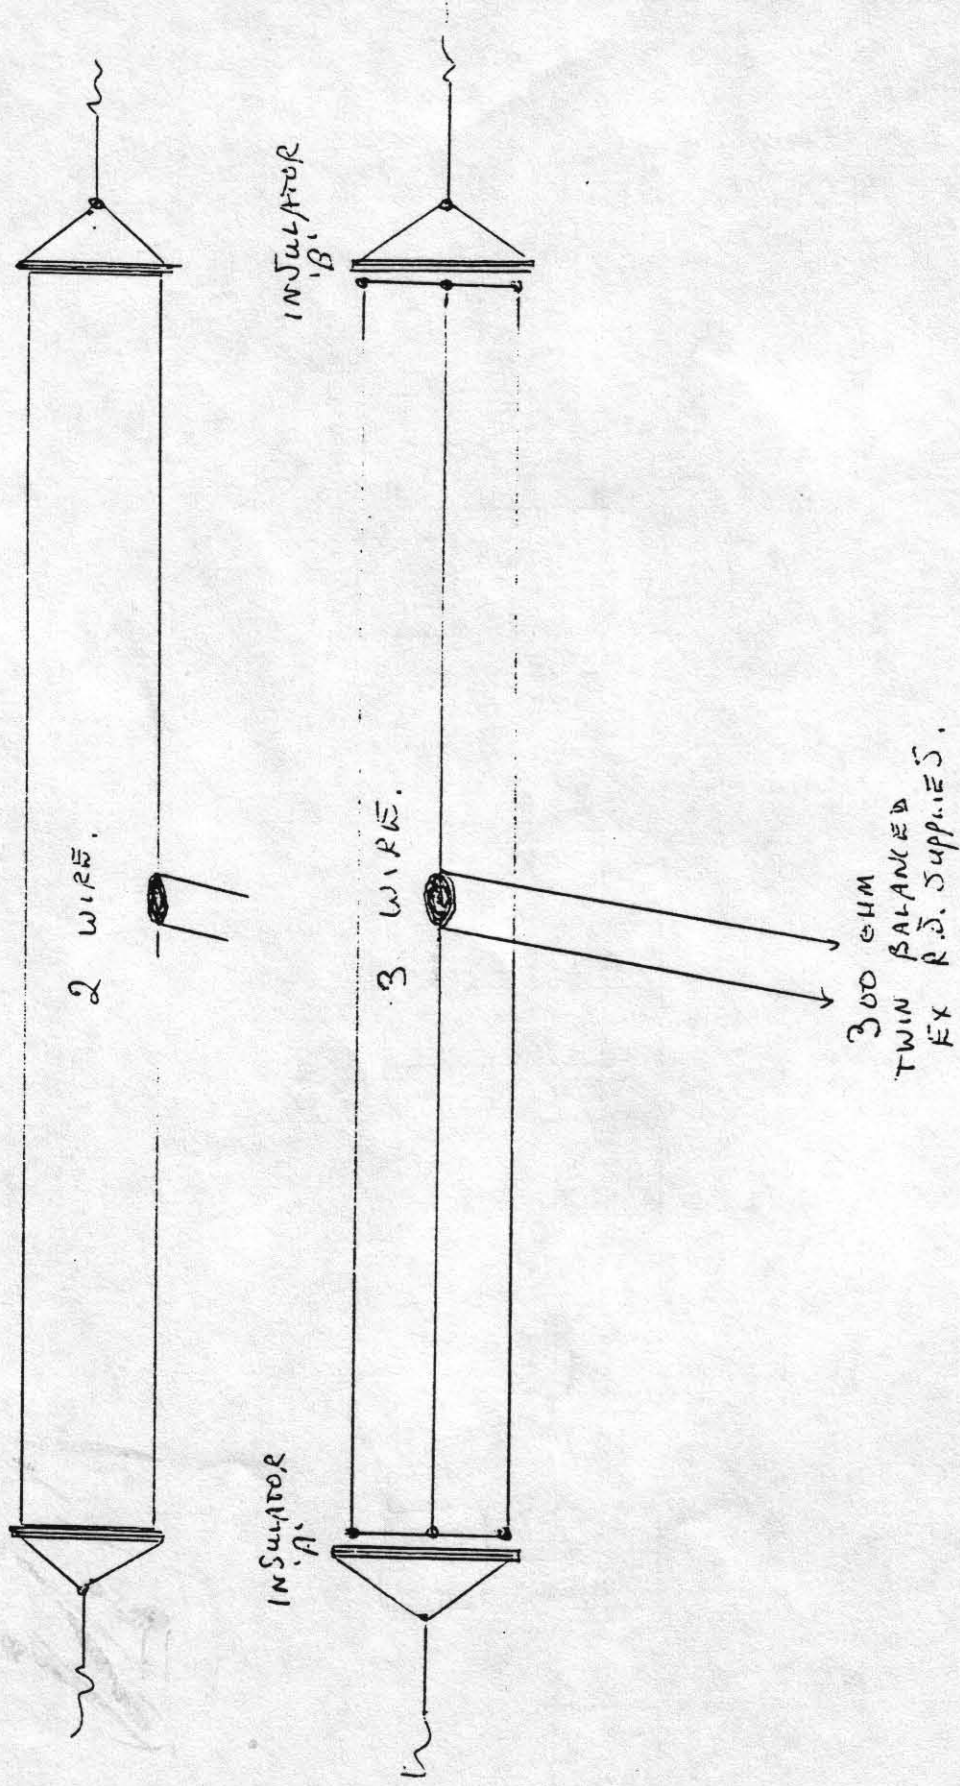
WIDE-BAND FOLDED DIPOLES,

SEE TEXT THIS ISSUE.

- A type of aerial not seen often these days is the three, or multi, wire dipole which may conveniently be fed by 300 ohm twin balanced downlead. (Yes it is easily obtainable, it is stocked by RS Components.) The spaced triple doublet type of aerial is ideal for coupling to the balanced input of an Edystone, ensuring that locally generated LRM is balanced out in the input stages of the receiver. If fed through a balanced AFU unit it is possible to arrange switching for the two downleads to be paralleled so as to use the aerial as a 'T' configured system. In this case the connection between E & AE must be made. Dipole directivity is much less noticeable with these wide band doublets. A sketch for a typical type of three wire doublet is in this issue.

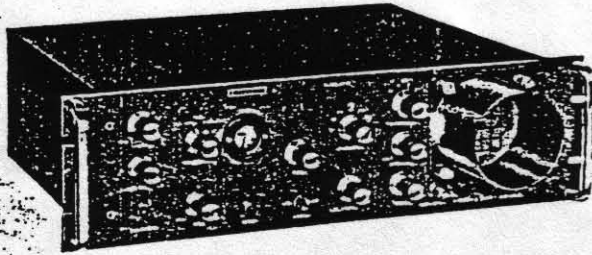
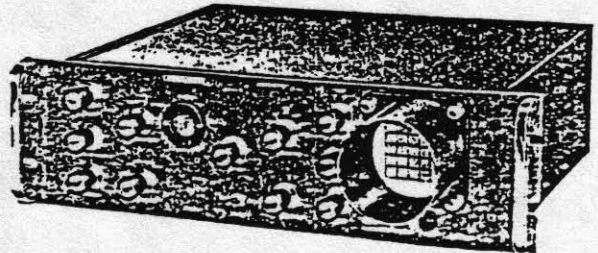
## PANORAMIC DISPLAY UNITS

- EP14 : 5.2 Mc/s (1 Mc/s bandwidth) and tunable 6.2 to 60 Mc/s.  
 EP15 : 100 kc/s (30 kc/s bandwidth) and tunable 400 to 800 kc/s.  
 EP17R : Fixed input at 5.2 Mc/s.  
 EP20 : Fixed input at 100 kc/s.

- Four selectable speeds are available:—  
 EP14 and EP17R : 5, 10, 20 and 40 sweeps per second.  
 EP15 and EP20 : 0.2, 0.4, 0.8 and 2 sweeps per second.

- EP14 and EP17R variable from 3 kc/s to 1 Mc/s.  
 EP15 and EP20 variable from 100 cs/ to 30 kc/s.

- EP14 and EP17R .. 2 kc/s at optimum settings.  
 EP15 and EP20 .. 50 c/s at optimum settings.

Similarly, the EP15 and EP20 units will operate successfully with the majority of HF receivers. The EP15 has tunable input and the EP20 a fixed input frequency of 100 kc/s.

Brief details of the specifications are given opposite and full information is available in separate folders. It should be noted that frequency converters are offered (see page 12) for matching receiver intermediate frequency outputs to panoramic unit inputs cover wide limits.
