Restoration of an Eddystone EC10 MkI Solid-State Receiver (Part 2) - by Gerry O'Hara, G8GUH/VE7GUH

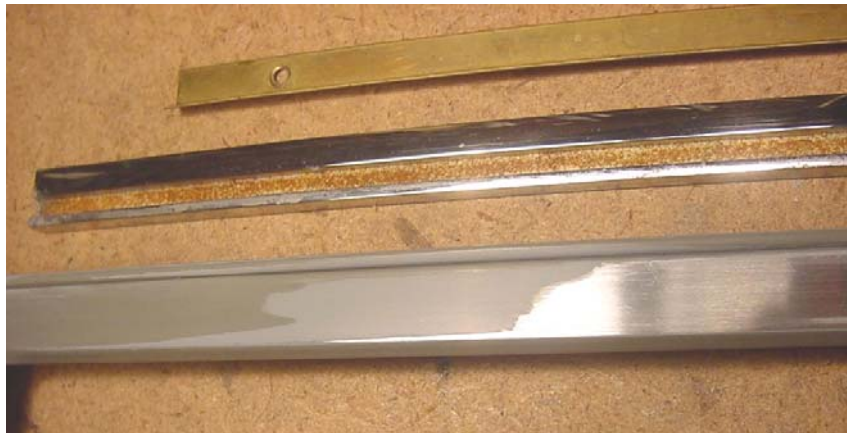
Above: the front panel casting in preparation for painting: loose paint chipped off and sanded (note large paint flake on the bench to the left of the panel). The scale glass mounting hardware and that all-important Eddystone badge are shown above the panel. Below: top edge of the panel showing feathered edge of the original paintwork and underlying aluminium casting

I prepared the surface of the panel by chipping off the flaked paint areas (I had glued them on during my temporary re-finish work), chasing these back to where the original paint was adhering well to the underlying aluminium. I then used 600 grit 'wet and dry' sandpaper with a little water to clean the exposed aluminium, roughening the remaining original paint and feathering the edges of the existing finish - photos above.

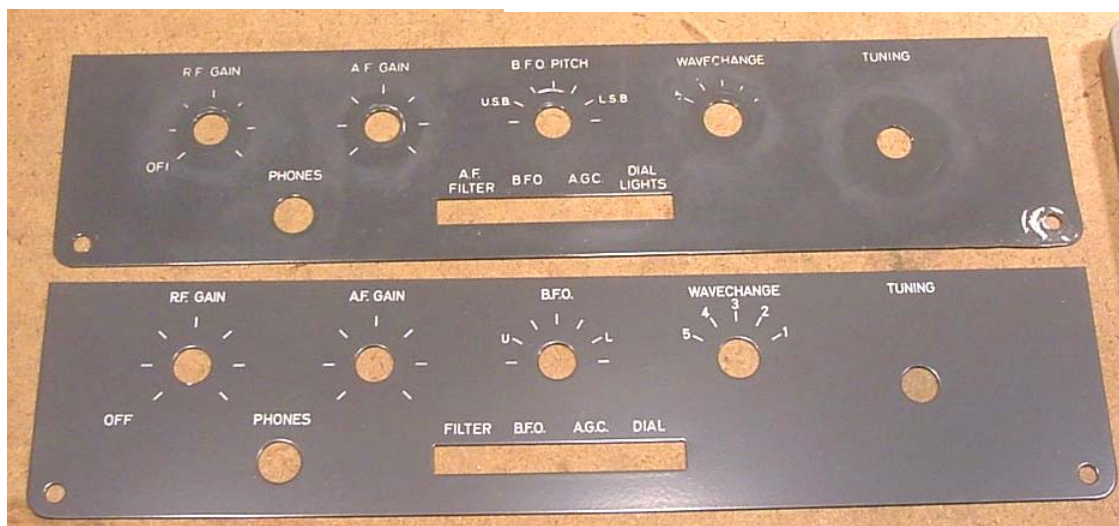
Below: the old and new fingerplates – both MkI, but note the differences on the BFO and switch bank markings

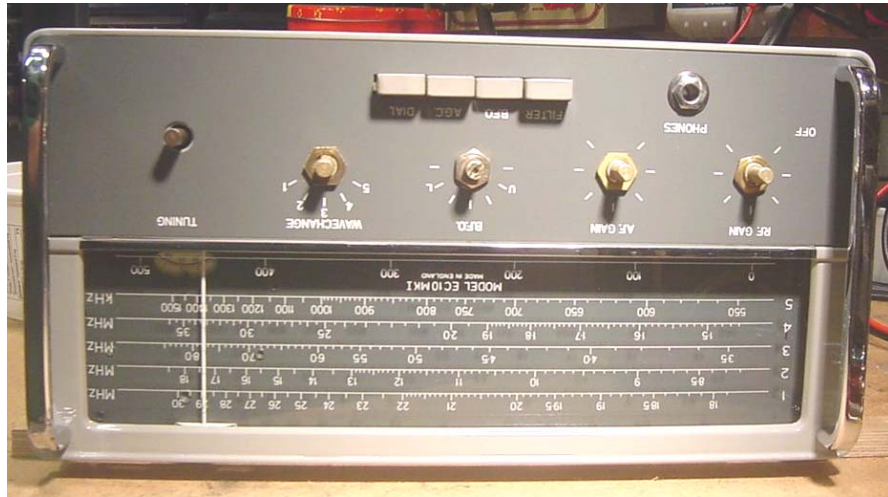
Above: Fitting the new fingerplate – take care when tightening those shaft nuts!

- Remove the chrome handles, place the fingerplate onto the front panel, replace the chrome handles and secure the controls in place with shaft nuts, taking care not to score the fingerplate (preferably use a nut spinner and a guard washer cut from a piece of Teflon sheet - as used to line baking trays, or even thin cardboard or stiff paper), making sure the flats on the control pots are orientated properly so the knobs can be fitted in their correct alignment with respect to the panel markings (grub screw seating in the flat). For the wavechange switch, rotate it until the switch contacts are in the Band 3 position and the flat on the control shaft is at the bottom for correct alignment – when tightening the shaft nut (a brass collared affair), ensure that the detent plate does not rotate
- Fit the knobs and your done

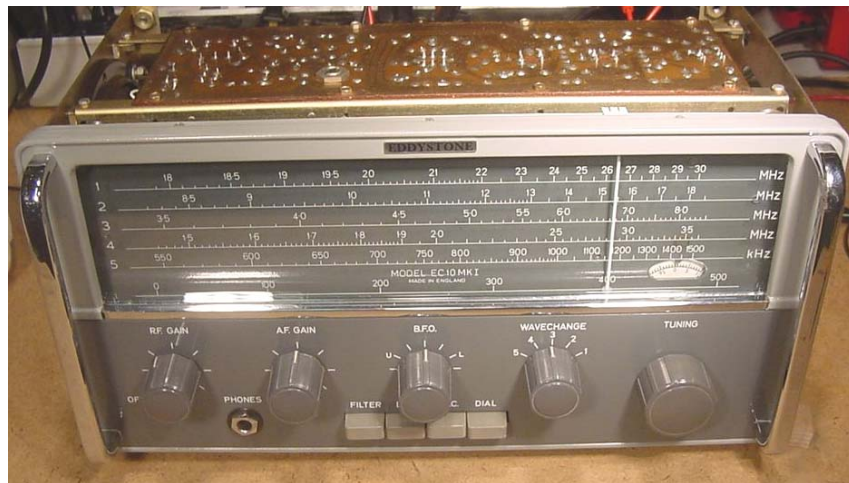
Above: The re-assembled set – looking good, if not all-original!

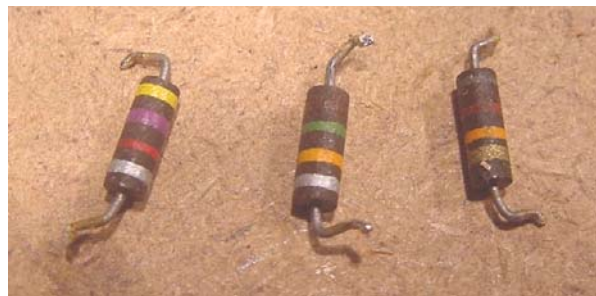
On switching the set on again after it being on the shelf for a few months in bits awaiting for the spare parts to arrive, I noticed an increase in the previously-noted background noise that was not affected by the AF gain control. Over the couple of days I was working on the set this seemed to get even worse and eventually sounded like eggs frying. Suspicion was on the first AF stage of course – comprising an OC71 (TR7) and its four carbon composition bias resistors

(R37, R38, R39 and R40). There is also a resistor (R41) that forms part of the supply line decoupling to the first audio and driver stage. As both R39 and R40 are bypassed to ground with large (100uF) electrolytics, C75 and C77 respectively, it is unlikely that any noise originating in these components would be present in the collector circuit of TR7. Hoping it was not the OC71 that was causing the problem, I changed out R38 first (15kohms) and the bad

Above: resistor temporarily tacked into place to see if a change-out is warranted (only because I would have preferred to leave the originals in for cosmetic purposes). Below: the three culprits that were removed from the first AF amplifier

crackling vanished but there was still some significant noise present, so I decided to also change out R37 (82kohms) and R40 (4.7kohms). This cured the problem, with only some remnant and quite acceptable minor hiss, typical of an OC71 audio amplifier. As always, exercise great care in removing components from these older Paxolin printed circuit boards – at least the tracks are a good width so they tend to remain in place. Quick component removal is assisted by using a small hooked tool as shown in the photo, left.

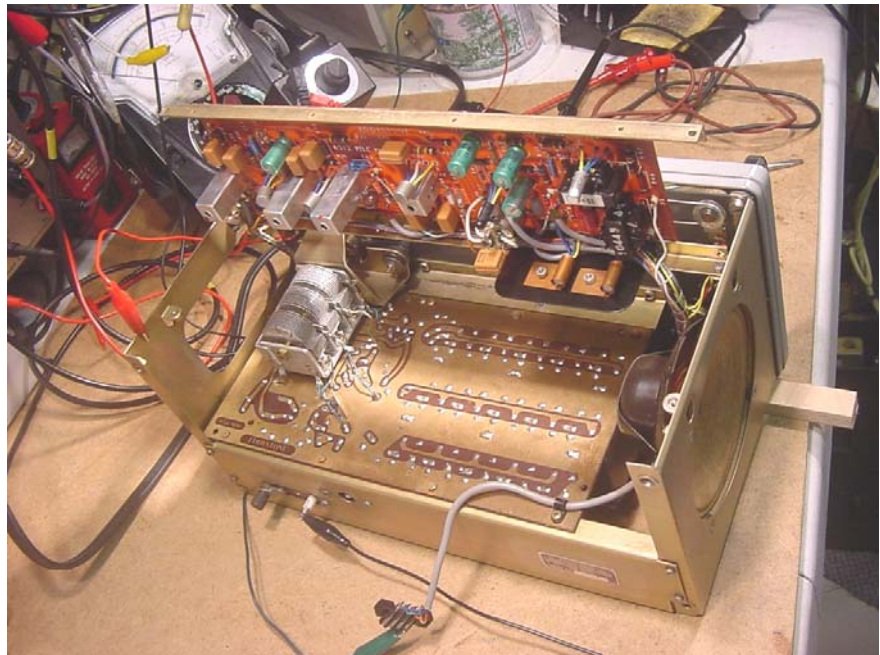
Well ok, I know it does not contain valves and its performance is somewhat lacking (not in the same league as my trusty S.750 when I had them side-by-side on the desk for a while), but it is still an Eddystone radio: it is easy to service (photo, right), looks like a miniature

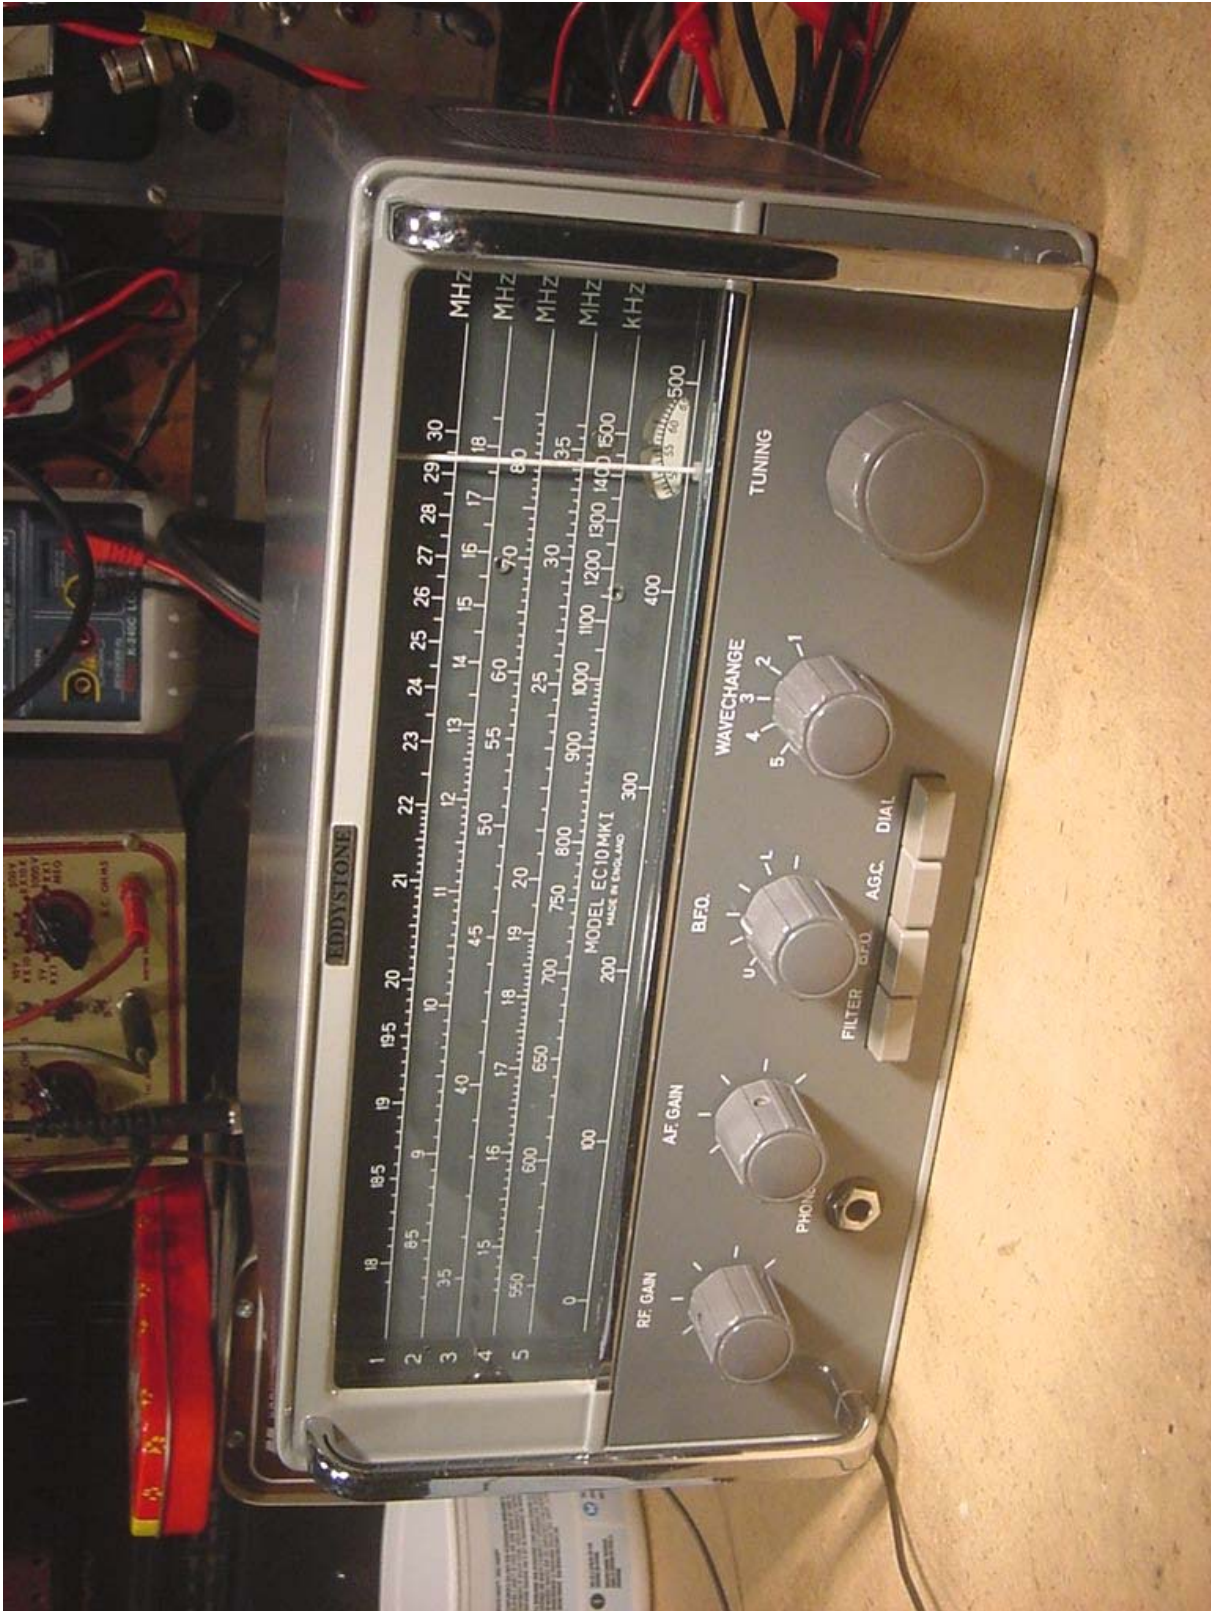
Above: the EC10 MkI finally boxed-up after the restoration work was completed – the new knobs and fingerplate were worth every penny – as good as new - and of course this is probably the only EC10 MkI in the world that tells folks that it is a MkI (and very proud to be so!)

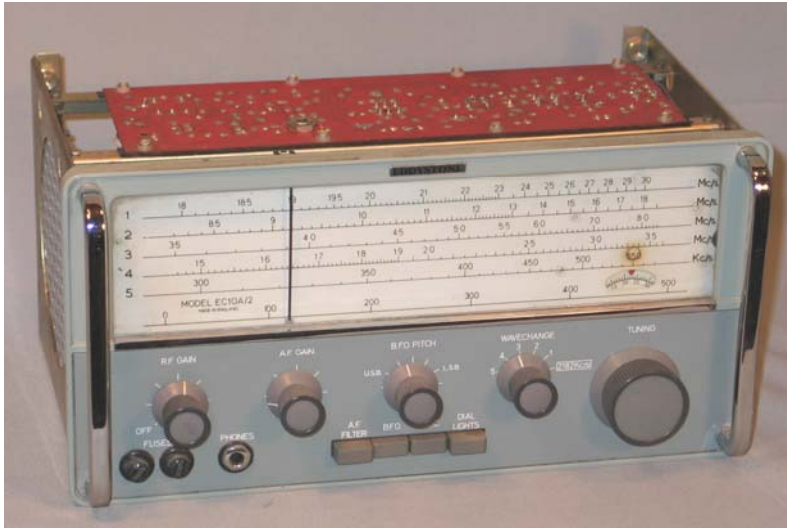
In the 'Context' section of Part 1 of this article I provided a summary of the EC10 'family', including the EC10A, EC10A2 and EC10A/2 (photo, left). Most of the information in my article came from Graeme Wormald's excellent QRG document, Eddystone data sheets, Lighthouse articles and manuals downloaded from

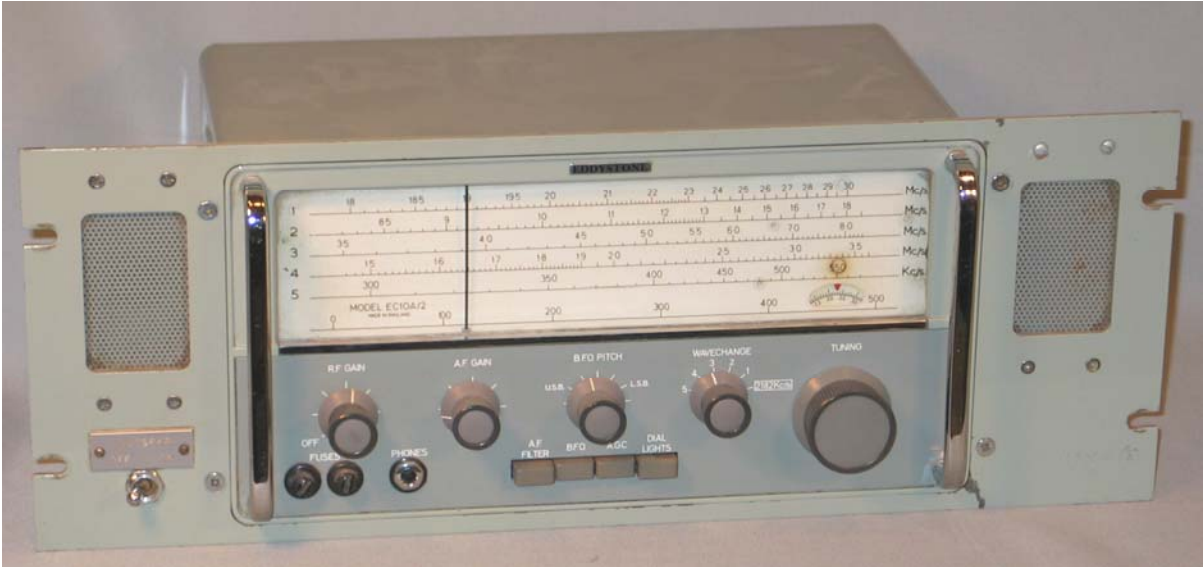
The leaflet on EC10A2, which is reprinted in Part 1 of the article dates from 1970, however in both pictures of the receivers you can read the name 'EC10A/2' – photos above and on Page 14.

In summary, the receivers and the important details in the handbooks are named 'EC10A/2', but the leaflets and some front pages are marked 'EC10A2'. Tor comments that he shall keep referring to this receiver by the name on its scale plate, ie. 'EC10A/2', until a receiver with the name 'EC10A2' turns up.

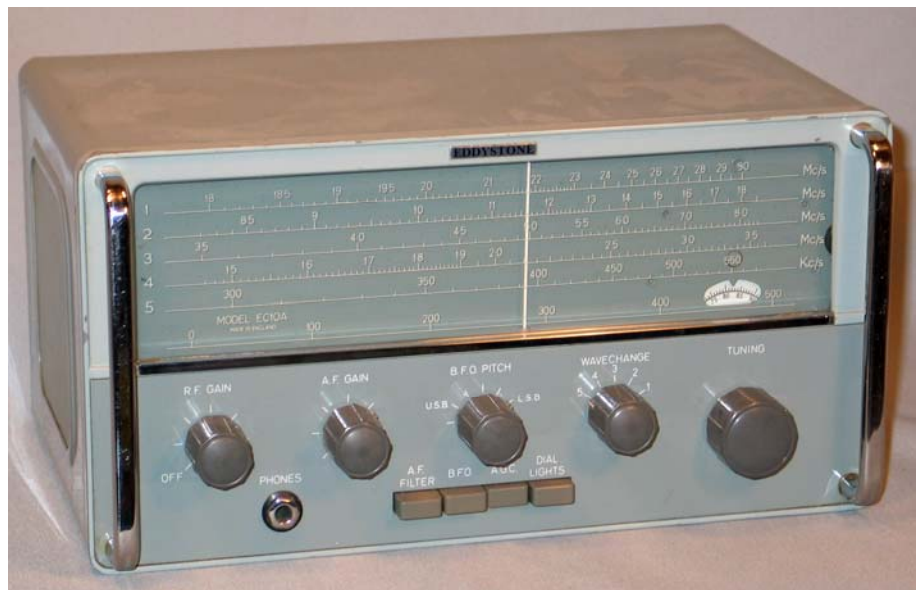
In his correspondence with me, Tor notes that he retains the role of 'collector' rather than 'manufacturer' or 'customer' for the sets and contends that the collector's first encounter with the EC10A series of receivers must be the type designation as given on them. A good example of this is to be seen in the photo, right. The EC10A is clearly

marked on the scale glass as being 'Model EC10A'. However, the name-plate at the rear says that this is type 'EC10', serial no. CP 0986. From this, Tor believes that the EC10As were numbered in the same series as the EC10s, so there is not a separate number series for the EC10As.

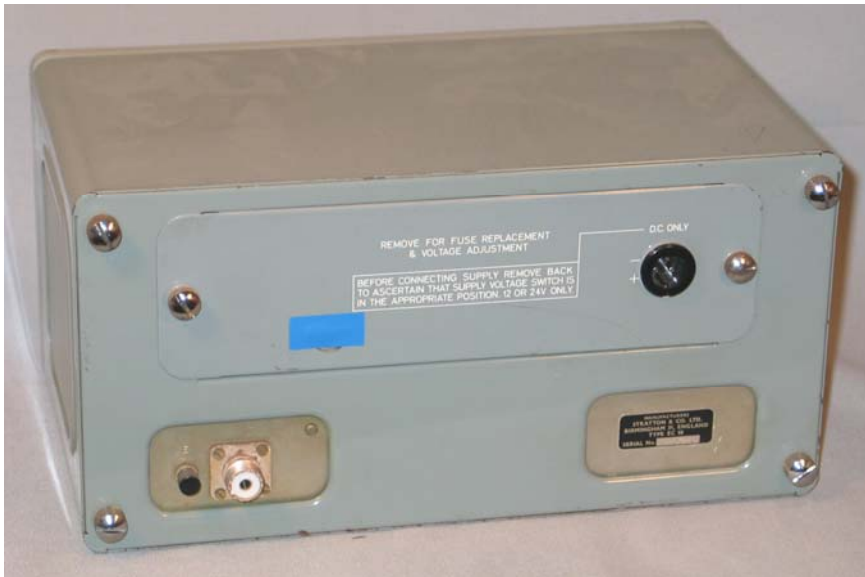
Left, top: Power supply switching unit from an EC10A/2

Left, centre: rear view of an EC10A

Left, bottom: rear view of a rack-mounted EC10A/2

Tor also points out that the power connector to the first EC10A and the later EC10A/2 are different, the one for the EC10A is equal to the ordinary EC10. So the EC10A/2 cannot use the battery or mains power unit (see photos on the next page).
