Serendipity - Restoration of an Eddystone S.358X for the SPARC Museum Collection, by Gerry O'Hara, VE7GUH/G8GUH

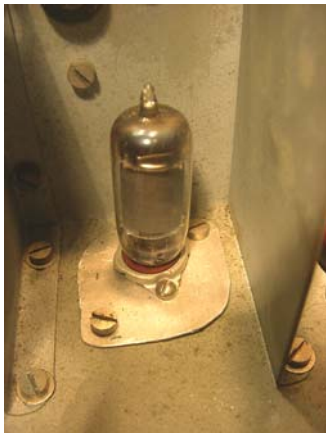
- Octal RF stage valve (EF39) changed to a miniature type (6BA6) and associated passive components changed (photo, left);
- Un-tuned RF stage fitted (missing a valve - 6BA6?) – located in the space on the chassis behind the original RF stage (photo, below);

Having got rid of the extra bits, the next job was to reverse the modifications. The RF stage was the first – I removed all the components, including the B7G valveholder and (very-homebrew) adapter plate, installed an International Octal valveholder and then rebuilt the stage using all-new parts (630v

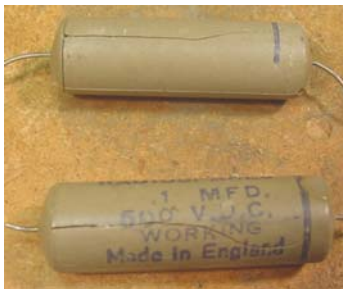
- Replaced many of the 0.1uF by-pass capacitors with 0.01uF parts of varying appearance, quality and voltage (photo, below, right). Several resistors had been replaced with whatever had been a ‘near-enough’ replacement from a junk box likely filled with bits rescued from old TV chassis etc..., and not forgetting the *RadioSpares* capacitors with deep splits in their cases (photo, below) – altogether, not a pretty sight;

- Replacement of some wiring with ‘modern’ plastic-covered types of varying quality, along with some very thin cloth-covered wire in the AGC, HT and

- phones circuits;
- The flexible drive to the crystal filter switch was broken – the switch now being accessible only by lifting the lid on the case; and
- Missing under-chassis screen covering the detector/AGC/1st audio stage.

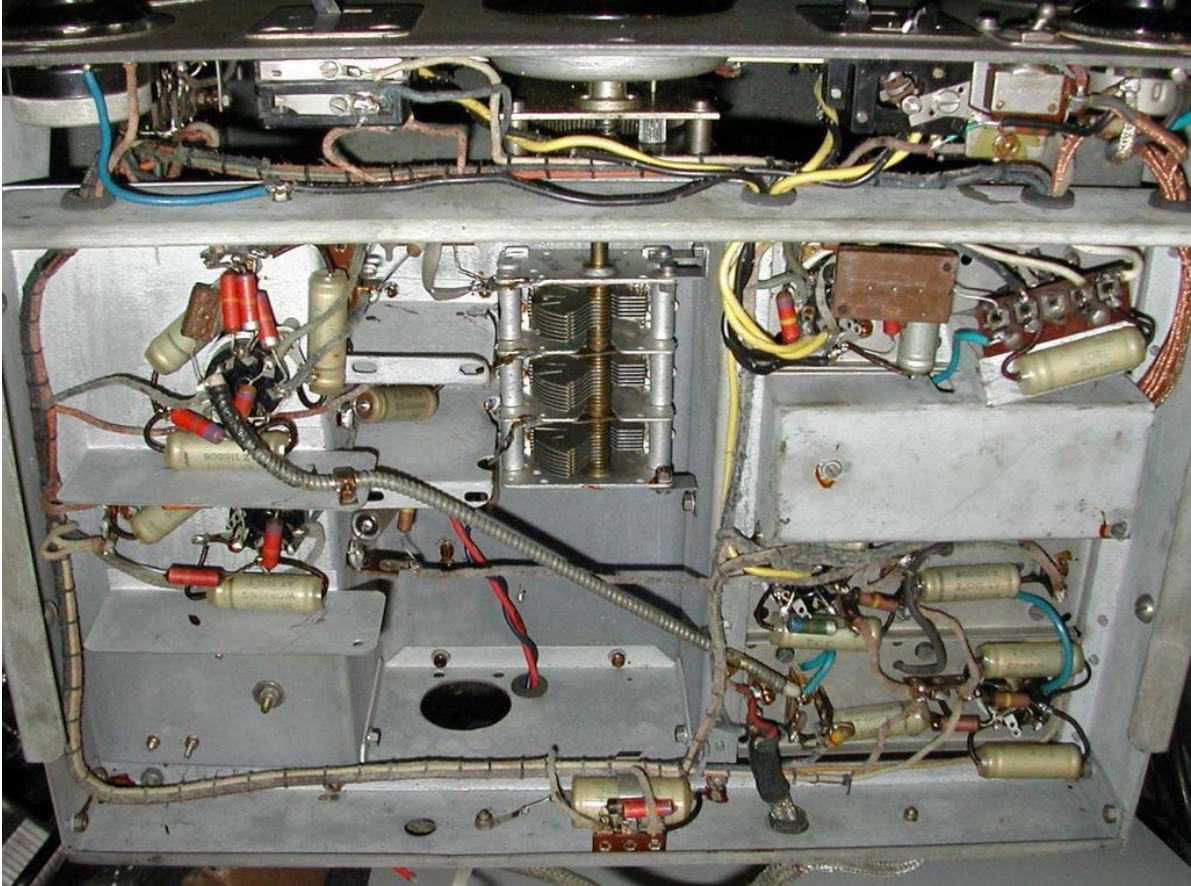
Above: under-chassis view of one of Alan Ainslie's S.358X sets in (almost) ex-factory condition. Not the screen covering the detector stage on the right (missing on the SPARC museum's set) and all those large 0.1uF by-pass capacitors

In order to retain a semblance of how the set looked originally, I asked Alan Ainslie⁴ if he could take some detailed photos of an S.358X in reasonably original condition (photo, above), which he most kindly did (thanks Alan!). These photos were very useful during the restoration, however, I must admit to using some 'artistic license' in dressing components, particularly where smaller replacement parts allowed shorter grounds etc.

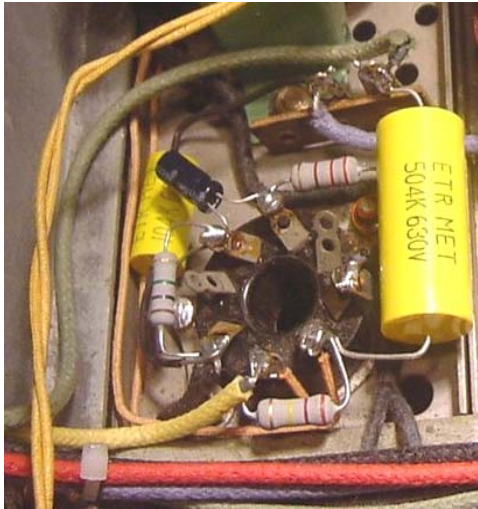
rated metalized poly film capacitors and metal-film 1 Watt resistors) – photo, right.

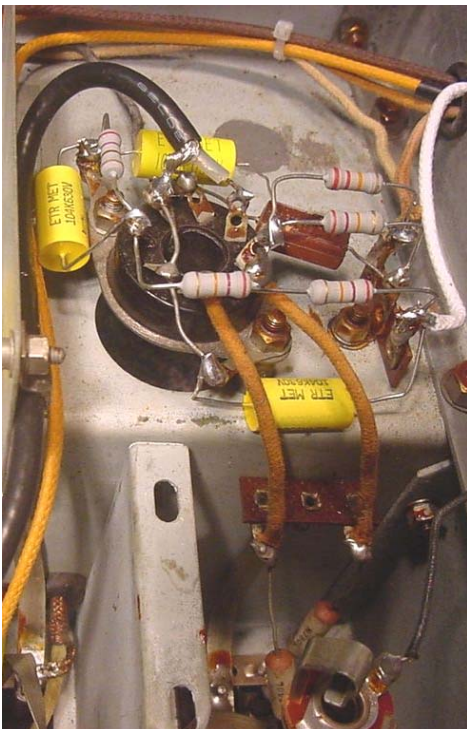
I then decided to start the main electronic component replacement work, together with re-wiring where needed. Having already completed the RF stage work, I started on the mixer/local oscillator stage (photo, left), working my way back through the set towards the audio output stage (which I had also already completed). I took my time, carefully dressing the components and wiring to be at least as neat as the original would have been when 'Bath Tub fresh'. Once the main under-chassis component replacement work had been

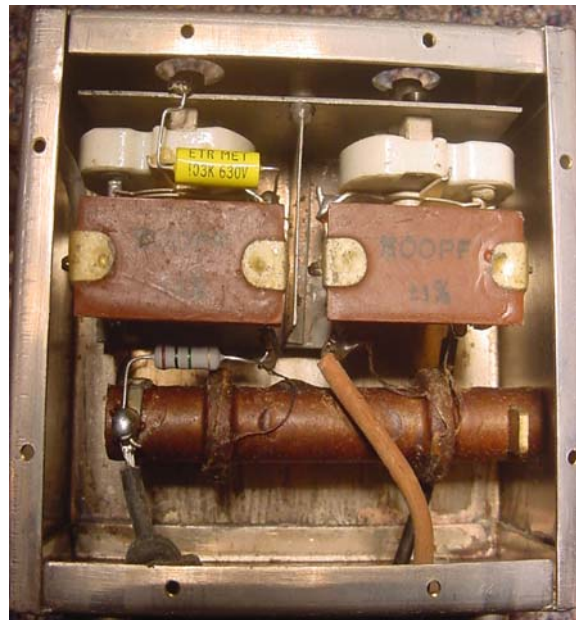
completed, I removed the 2nd IF transformer (photo, below right) and removed the side off the 1st IF transformer (photo, below left), as these units house several passive components that I wanted to test/replace. Just as well, as there were also a couple of dry joints in the 1st IF box, as well as the crystal filter switch to clean (De-Oxit, applied with a Q-Tip). Not too bad a job to gain access into these units and well-worth the effort.

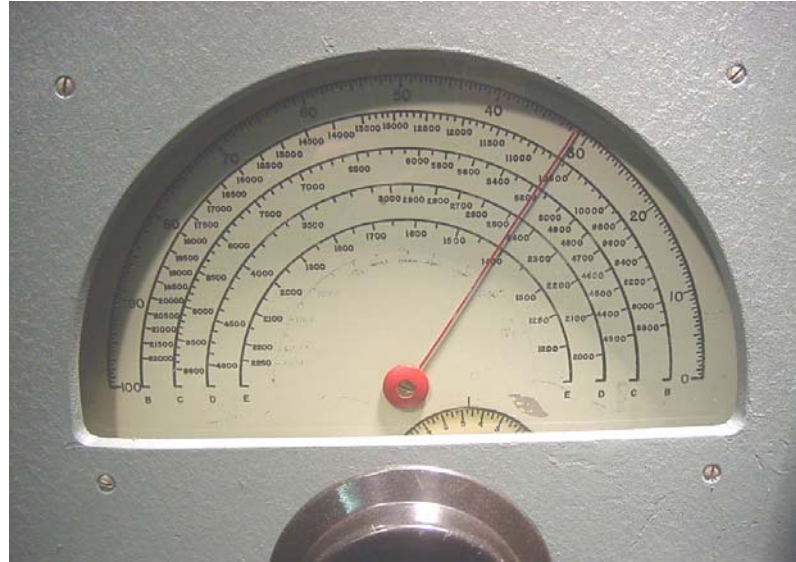
The (rather thick) dial glass was cleaned using lens-cleaner fluid and the scale cleaned using warm soapy water and a cotton wool pad. Unfortunately the scale has had two additional ranges scratched into it: most of the Broadcast Band (Range 'F'), on the inside of the five factory-engraved ranges ('B' through 'E' plus logging scale), and Range 'A' (21 MHz to 32MHz) to the outside of

the logging scale engraving. I decided to leave these 'as-found', along with a scuff mark present near the bottom of the scale plate that had removed the paint. In my opinion, the only really satisfactory remedy for this degree of damage to such a highly-visible part of the set would be to remove all the original paint from the scale/engraving and repaint the entire scale white, along with re-filling the engraved markings with black enamel paint. I decided that the visual appearance as-found was more acceptable than risking making a mess of such an extensive cosmetic job – at least for the time being.

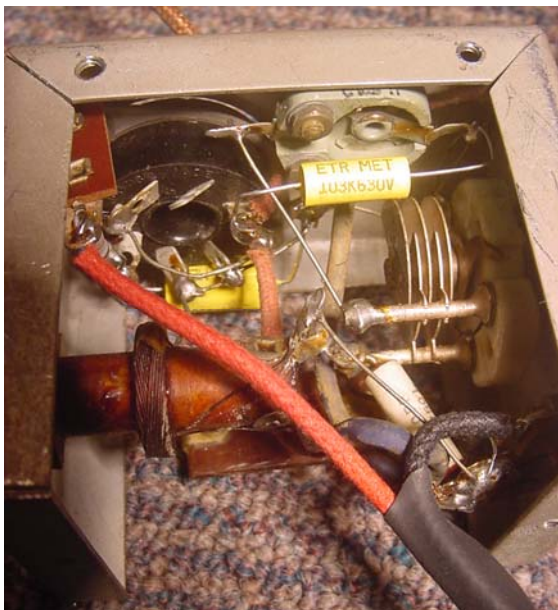
Above: BFO unit with new resistors and capacitors fitted. Note new flying leads

The BFO is housed in a separate compartment (box), mounted on the front panel. This was opened-up and resistors/paper capacitors replaced, along with the heater and HT flying leads. The variable capacitor was cleaned with De-Oxit, adjusted to mid-travel and the shaft marked such that I knew what setting the capacitor was at once re-assembled.

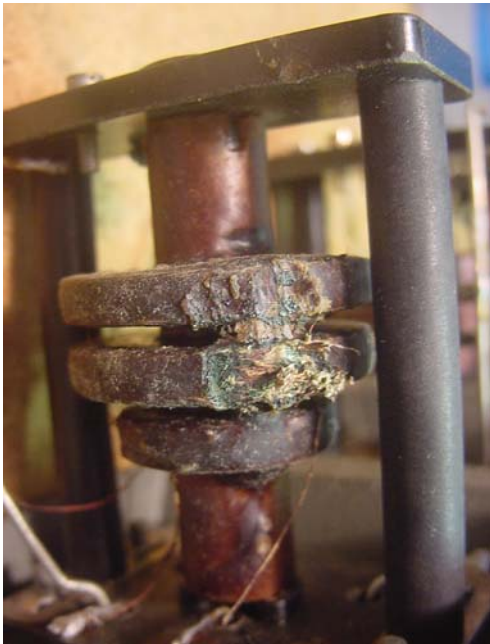
where I found the aerial tuned circuit trimmer missing (a ceramic type) – it had simply been removed and no attempt made to bridge-over the tuned circuit with a capacitor had

been made – I concluded that someone had 'robbed' the part to replace a trimmer in one of the more-frequently used coilpacks, and that they had not been interested in using Range 'I'. Then I opened-up the Range 'J' coilpack, only to find that all of the tuned circuit trimmers (except the padder) had been removed. Nothing was found that was an exact match for these ceramic trimmers in my junk box, but I tried some

air-spaced ones as a stop-gap – these just squeezed in between the coil formers and the upper housing of the coilpack when re-assembled. In addition, I noted that one of the prongs was broken off the 5-pin aerial plug (one of the aerial connections). To fix this I removed an adjacent earth prong (not really essential) and relocated it in the correct position, gluing it in place with epoxy. I then noticed that the aerial coil had been damaged (photo, left) by someone attempting to drill the old prong out at some point (aaargh! was there no end to that maniac's ineptitude?) – of concern was that there were several of the extremely fine Litz wires sticking through the damaged section of coil – virtually impossible to repair – so I decided to just

leave it and see what happened when I tried to tune the circuit (the aerial coil could be bypassed if needed, making the RF amplifier grid circuit aperiodic – probably not a big deal at these low frequencies);

probably not a bad thing as it allowed for a visit to the SPARC museum where I found some suitable ceramic 7 – 45pF trimmers in the ‘spares warehouse’. These were an exact fit, so the (now very) temporary air-spaced ones were removed and the ceramic ones fitted to the Range ‘I’ and ‘J’ coilpacks (photo right);

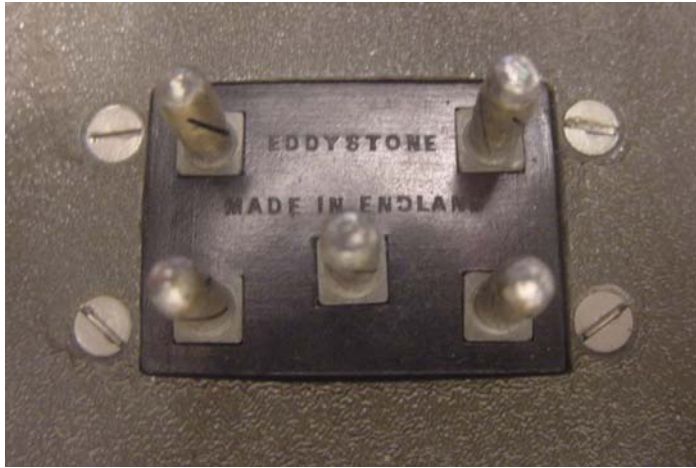
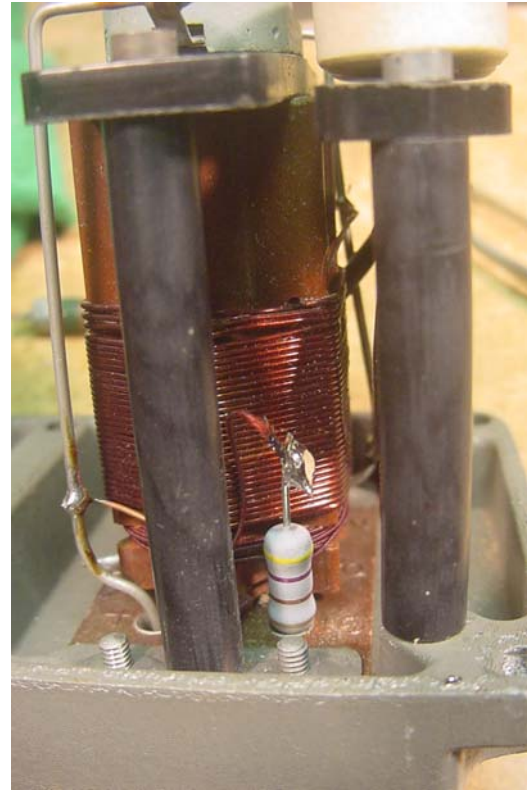
Above left: Five-pole plug on coilpack – proudly displaying ‘Eddystone Made in England’. Above right: New resistor fitted into local oscillator section of a higher-frequency coilpack. Left: broken coil former in same coilpack. Below left: chassis under repair – note LCD monitor behind – very useful tool in front of you in the workshop for pulling up schematics, manuals and photos of the set. Below: Rubberized insulation in the screened cables was in poor condition – replaced with new cloth-covered wire pushed into the original braided copper screen.

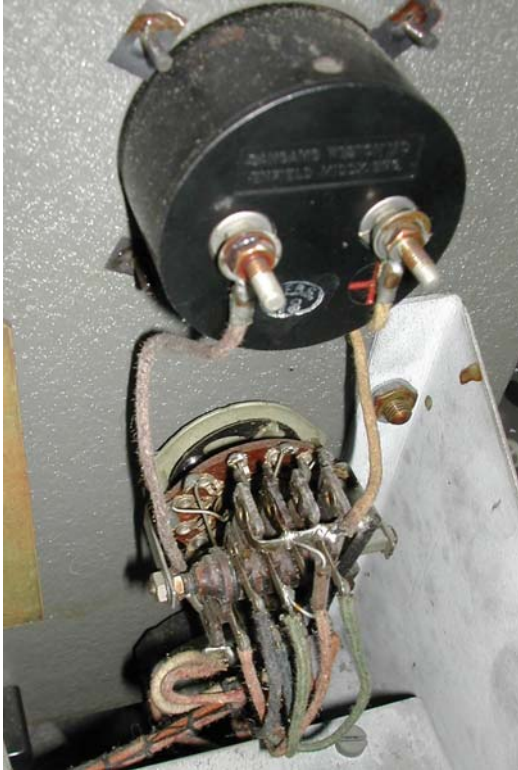
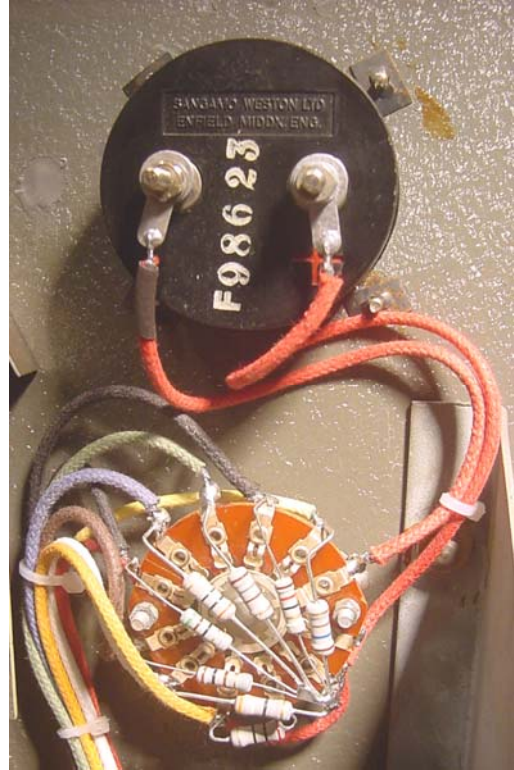
Above left: original meter shunts and switch (per Alan Ainslie's set), Above right, replacement meter shunt circuits in the SPARC museum set built using standard components. Below left: original detector/AGC/1st audio stage module (beneath the shield per Alan Ainslie's set), Below right: replacement components in the SPARC museum set

The next job was to restore the original anode metering wiring, switching arrangement and shunt circuits. The switch was missing, so I needed a single-pole, 8-way Yaxley type as its replacement. Not finding anything suitable in my junk box, I checked-out the parts store at SPARC. I did not find exactly what I needed, but managed to cobble-together a suitable switch using the indent mechanism from one switch and a 12-way wafer from another, installing a stop (a 6BA screw and solder tag) through the indent mechanism at the 8 way point. Now, what about those shunt resistors – the originals had been bespoke wire-wound types and not easy to replicate. A trip down to one of the local electronics stores on Main Street in Vancouver solved this – I managed to obtain stock value 5% resistors that were very close to the original values (some non-preferred values that they, luckily, had in stock) – all sold in packs of 10, so I was able to hand-select resistors even closer to the original fitment values. The finished arrangement is shown on the photo, right. Note that I used cloth-covered wire in various colours (obtainable from Radio Daze or Antique Electronic Supplies) for the new wiring harness, as well as for other re-wiring in the set, including replacement of the nasty plastic-covered assortment and some original fitment rubber-covered wiring. I used standard plastic cable ties to hold things together neatly temporarily (this also allows for changes to be made easily), but plan to eventually lace the wiring to get a more original look.

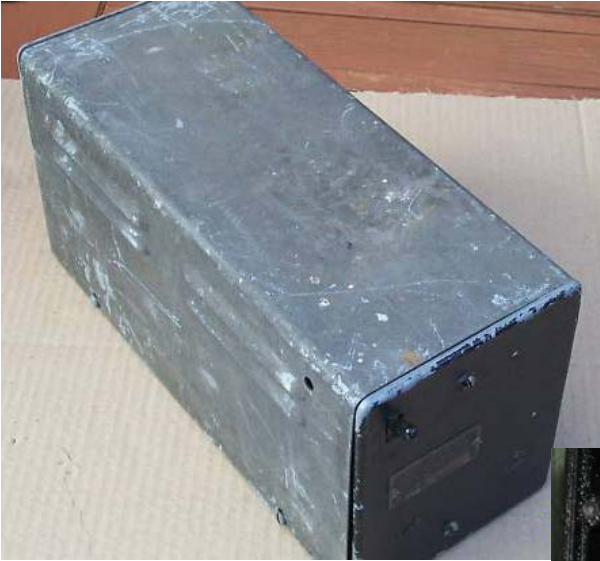
Two different power supply models were available for the S.358 series: the S.390 was the standard issue. Cosmetically, this is a no-frills utilitarian design (see photo, left from a

recent Ebay auction, where it is described as an S.451, although looks identical to the S.390B model in the manual, there described as a 'replacement unit' with the same electrical characteristics as the S.390. The S.451 is not mentioned in the manual or the QRG) – externally a steel box with louvers for ventilation, a power switch and indicator lamp. The circuit was equally no-frills, though the HT was well-filtered by two chokes and three capacitors.

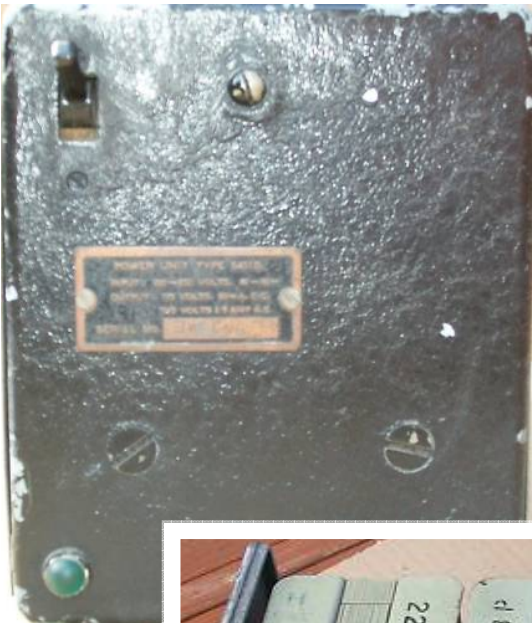
Above left: Power supply external appearance. Left: power switch and indicator lamp (bottom left), Above right, under chassis view (Alan Ainslie's set) – triple smoothing capacitor unit to the right, Below: above chassis view – power transformer to the right, rectifier (5Z4G) centre and smoothing chokes to the left.
