Restoration of a ‘Basket Case’ Eddystone S.640 – the Bath Tub’s first post-WWII set Targeted at the Radio Amateur and Short Wave Listener Market, by Gerry O’Hara, G8GUH/VE7GUH

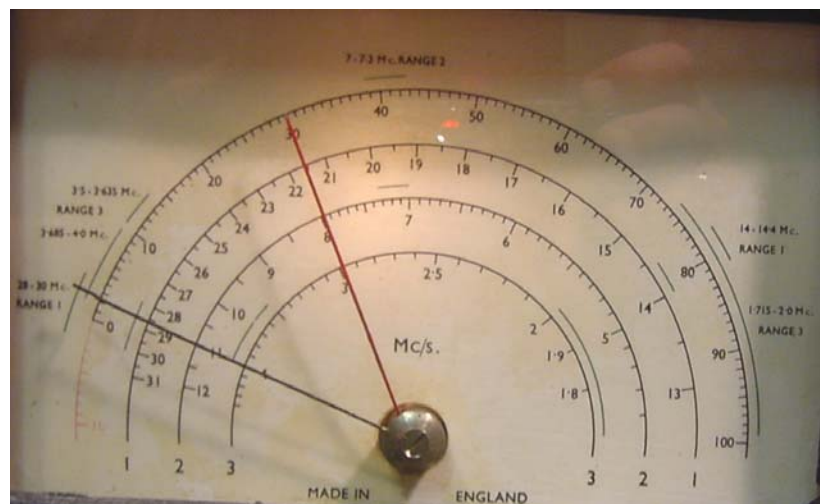
Tuning is 'reversed' (photo of scale, right), ie. the higher frequencies are attained when the dial pointer is rotated anti-clockwise, as per the S.680/2 I recently restored². The bands are selected by rotating a chrome-plated lever fitted beneath the left-hand ('bandsetting') tuning knob.

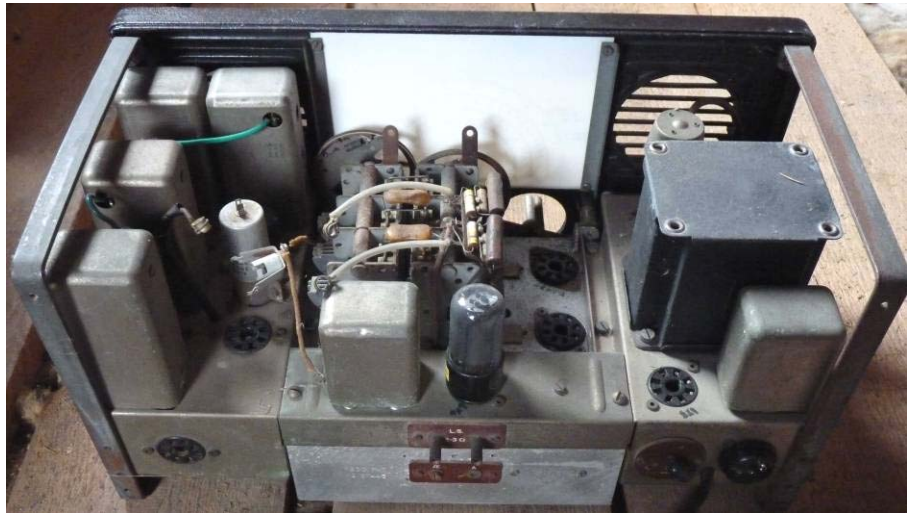
The S.640 prior to shipping to Canada – looking a bit sad

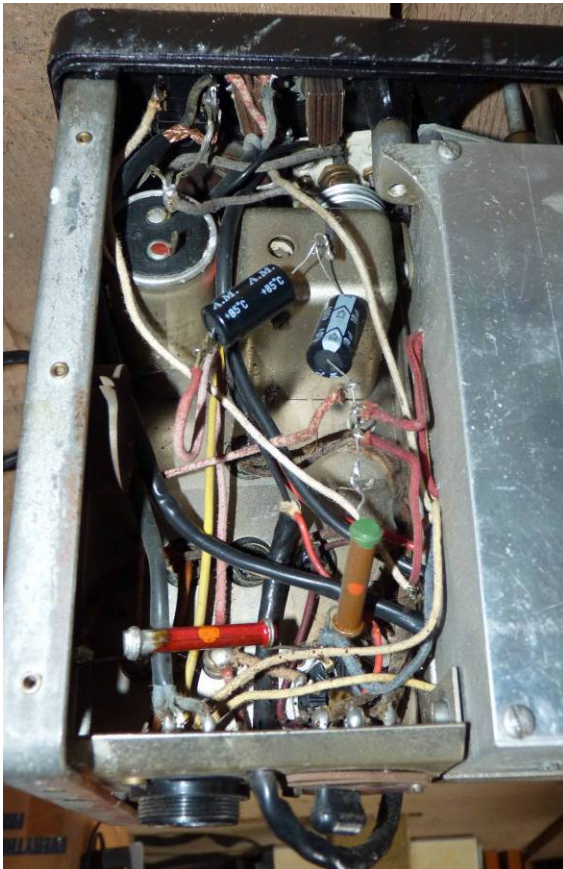
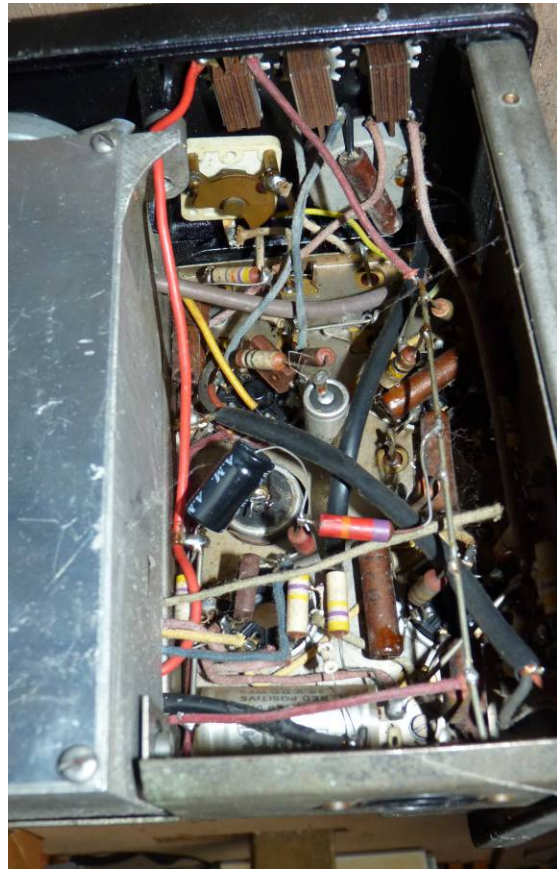
Below: under-chassis views of the power supply/BFO sub-chassis (left) before shipping to Canada and of the IF/1st AF sub-chassis (right) – both a bit of a ‘rat’s nest’ of tired-looking components... note the replaced filter capacitors ‘hanging loose’

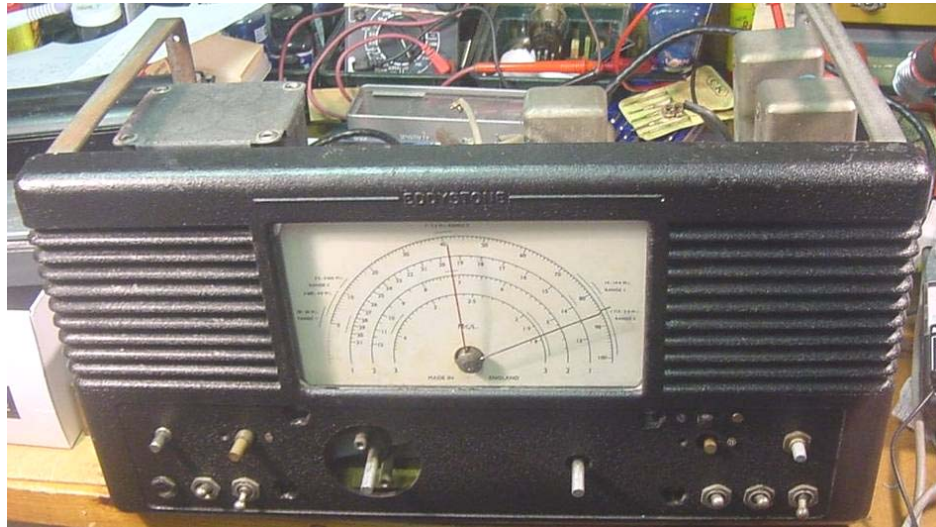
Above: the S.640 on arrival at the VE7GUH shack – front panel not in bad shape but, er, a few vital things are missing...

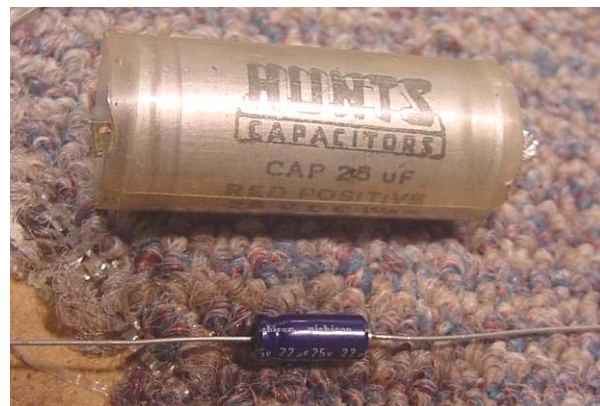
The audio sub-chassis was tackled first – removing the oversized Hunts 25uF 25vw electrolytic opened things up considerably (it tested open circuit) – the diminutive replacement electrolytic looked minute in

comparison. Three of the resistors in this unit were well-within tolerance and therefore left in circuit. The moulded mica capacitors were ok, so only the waxed paper 0.01uF

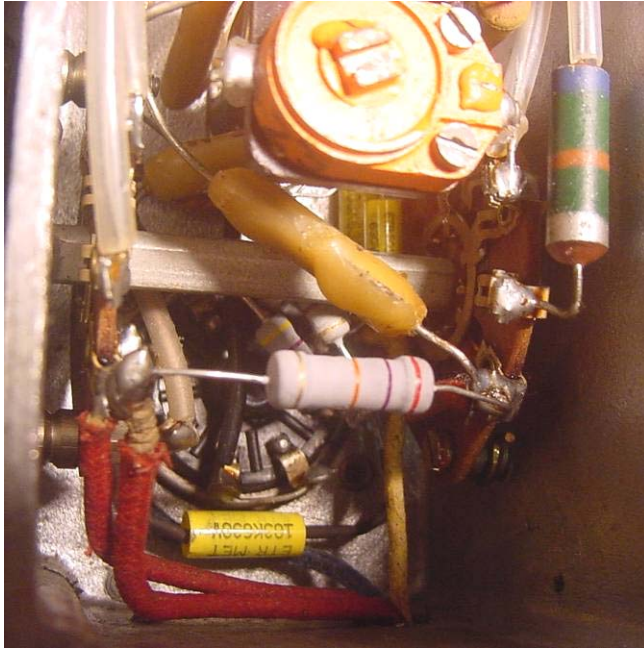
Above: mixer section of the coilbox after replacing paper capacitors and (most) resistors – not nearly as bad to work on as it looks (honest!)

Next, I worked on the coilbox – much more straightforward in this set than in some later, more complex sets (eg. the S.940), but still requiring some thought as to sequence and what to remove/detach temporarily to allow good access for snips, pliers, tweezers, hemostats and soldering iron. I changed-out all paper capacitors and all but three low-value resistors which were well within tolerance. The silver mica capacitors tested were right on the marked value and not leaky (it is very unusual to encounter a leaky silver mica capacitor – they do go open circuit though and can contract 'silver mica

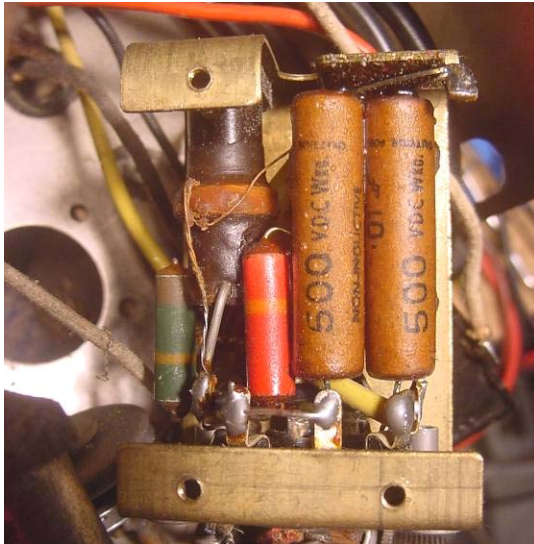
Above: BFO unit – before and after replacing the wax-paper capacitors and resistors

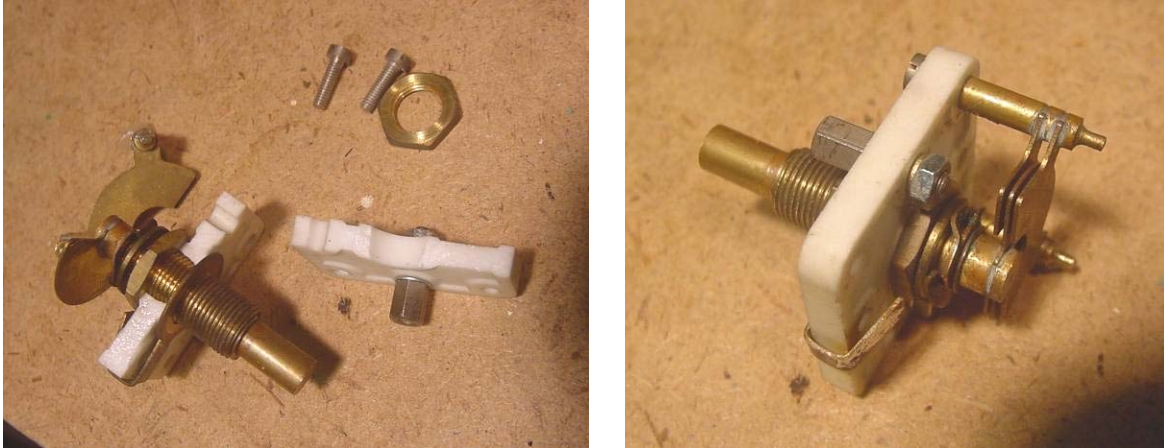
Above: BFO capacitor repair – careful cleaning, a few drops of super-glue, and two 6BA-tapped spacers carefully cut to the correct length and its as good as new

The switches, others controls and their wiring were then checked-over. The BFO tuning capacitor had not been mounted on the front panel on arrival – it was hanging loose on its connecting wires. On close inspection it was found that the ceramic mounting plate was cracked and had been glued together (poorly). I removed the capacitor and cleaned/ repaired it before fitting two new (6BA tapped) spacers between it and the front panel (photos, above). The length of these spacers is rather critical – too long and the capacitor fouls the two aluminium drive cord pulleys located on the chassis immediately behind. The crystal phasing switch and capacitor was checked next – interesting, as the (non-original) wiring was incorrect: the switch was wired such that when switched into circuit, one side of the crystal was earthed (not much use). I corrected the wiring and cleaned/serviced the capacitor before re-fitting to the front panel (this unit had its original spacers fitted – these are longer than those needed for the BFO capacitor). The RF gain and AF gain pots were checked and found (amazingly) to be in pretty good shape, so these were left as-found. All switches worked ok.

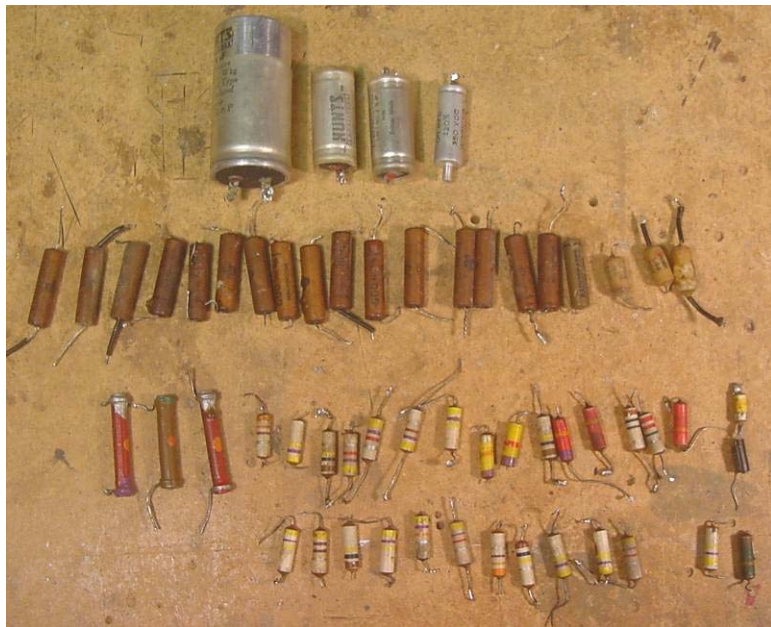
Having replaced all the waxed-paper capacitors, a cylindrical metal-sleeved paper capacitor and three electrolytic capacitors, all but six resistors (photo, right) plus the odd bit of wire here and there, it was time for initial power-on checks:

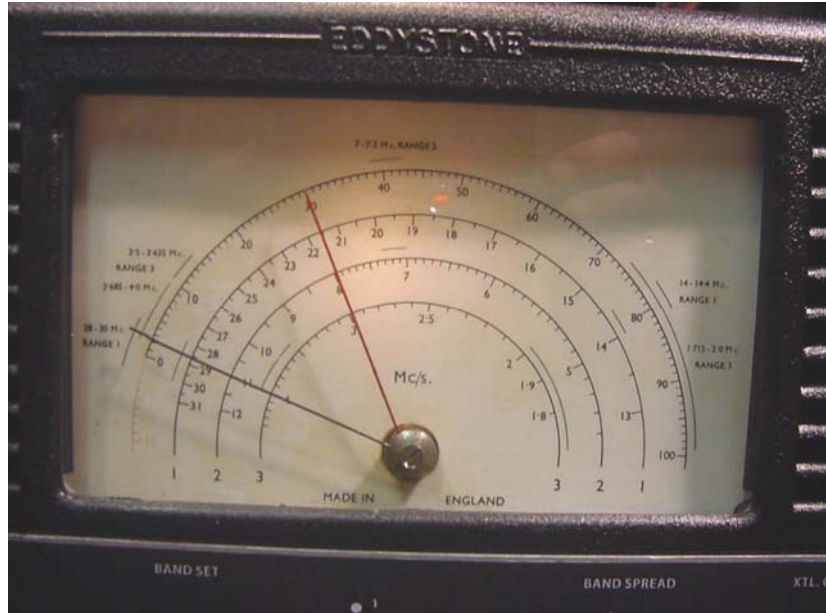
The S.640 scale is fabricated on a piece of white translucent plastic. On close examination, it too had unfortunately been given a 'protective' coat of (then) clear varnish – using an old paintbrush I would say. Looks ok at a distance, though a bit of a mess close-up, but after a clean-up with warm soapy water it will do the job until a reproduction one I ordered from Ian Nutt arrives.

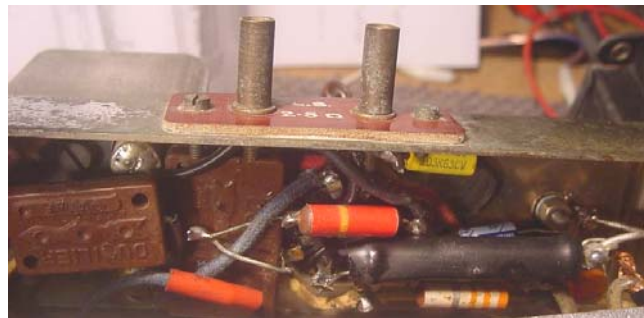
Above: AF output stage sub-chassis after replacing the 25uF bypass capacitor and 0.01uF waxed paper capacitor (other components test ok) – no transmitter lurking in here as far as I can tell...

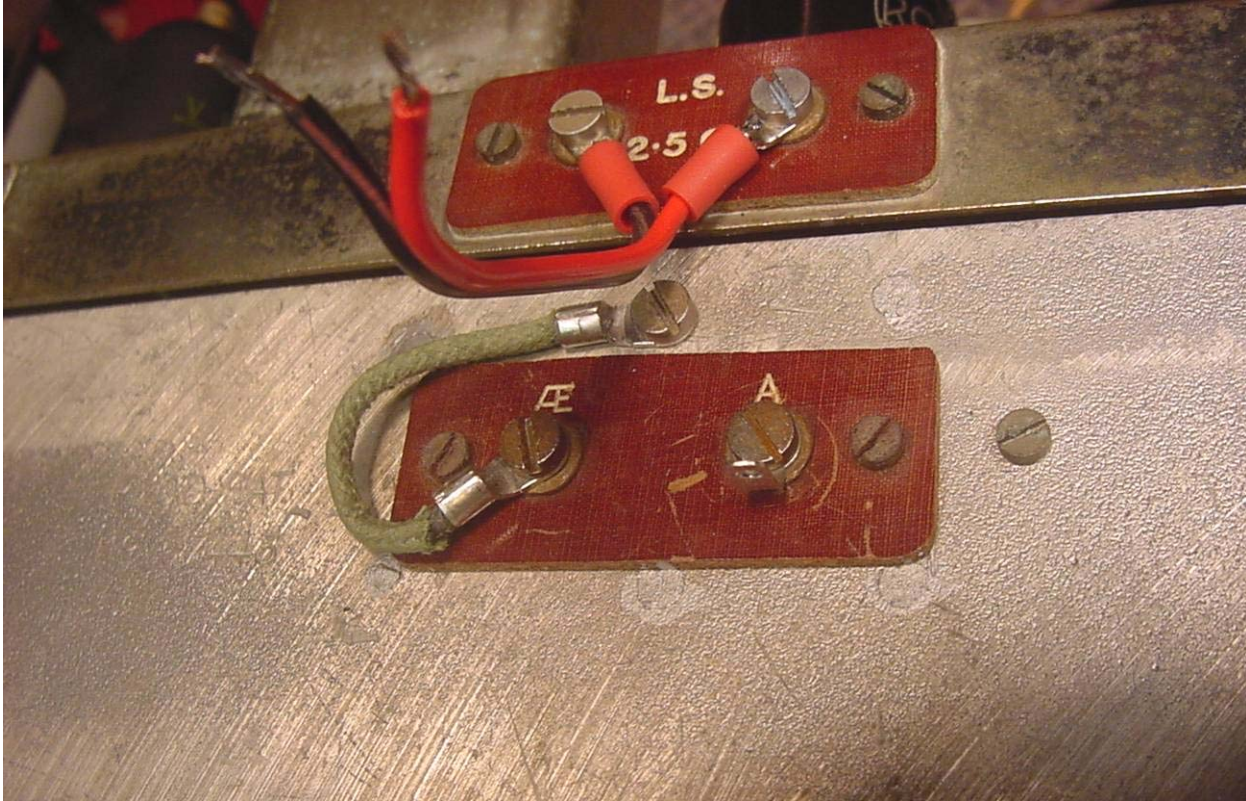
Above: aerial/ground connection strip. The few extra holes that had been drilled through the cast-aluminium coilbox for a PL259 socket, etc. were filled with JB-Weld and touched-up with a silver marker pen ('Sharpie'). Below: front panel removed before commencing work on component replacement – needed for access to the tuning drive pulleys during re-stringing

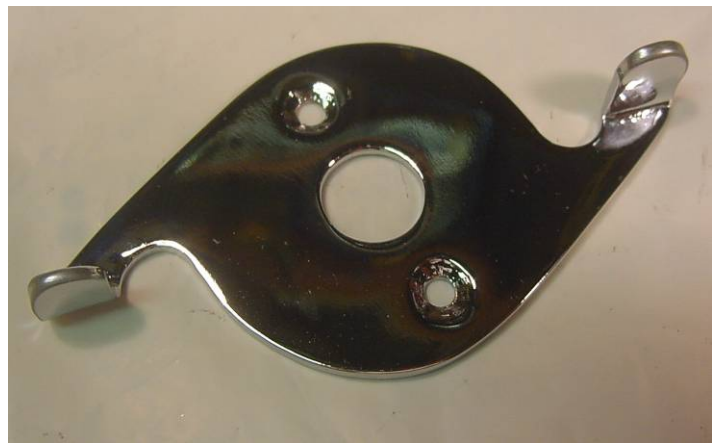
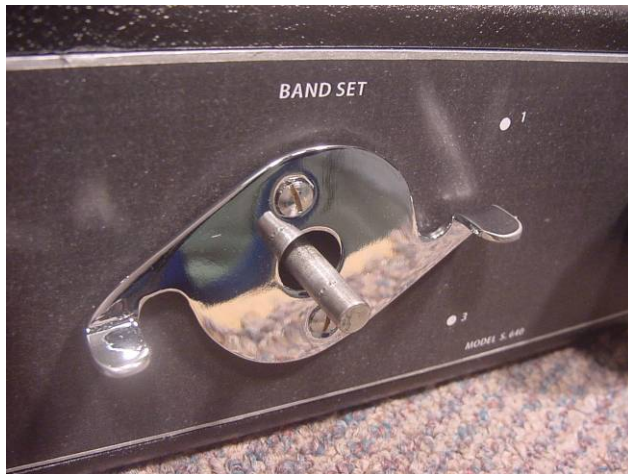
Left: the reproduction bandchange lever fitted to my S.640 using a couple of chrome-plated tapered-head 4BA screws from my junk box

Right: and finally the NOS bandset tuning knob is fitted. It is much better with this lever installed - I had to poke around behind the front panel with my index finger to change bands before!

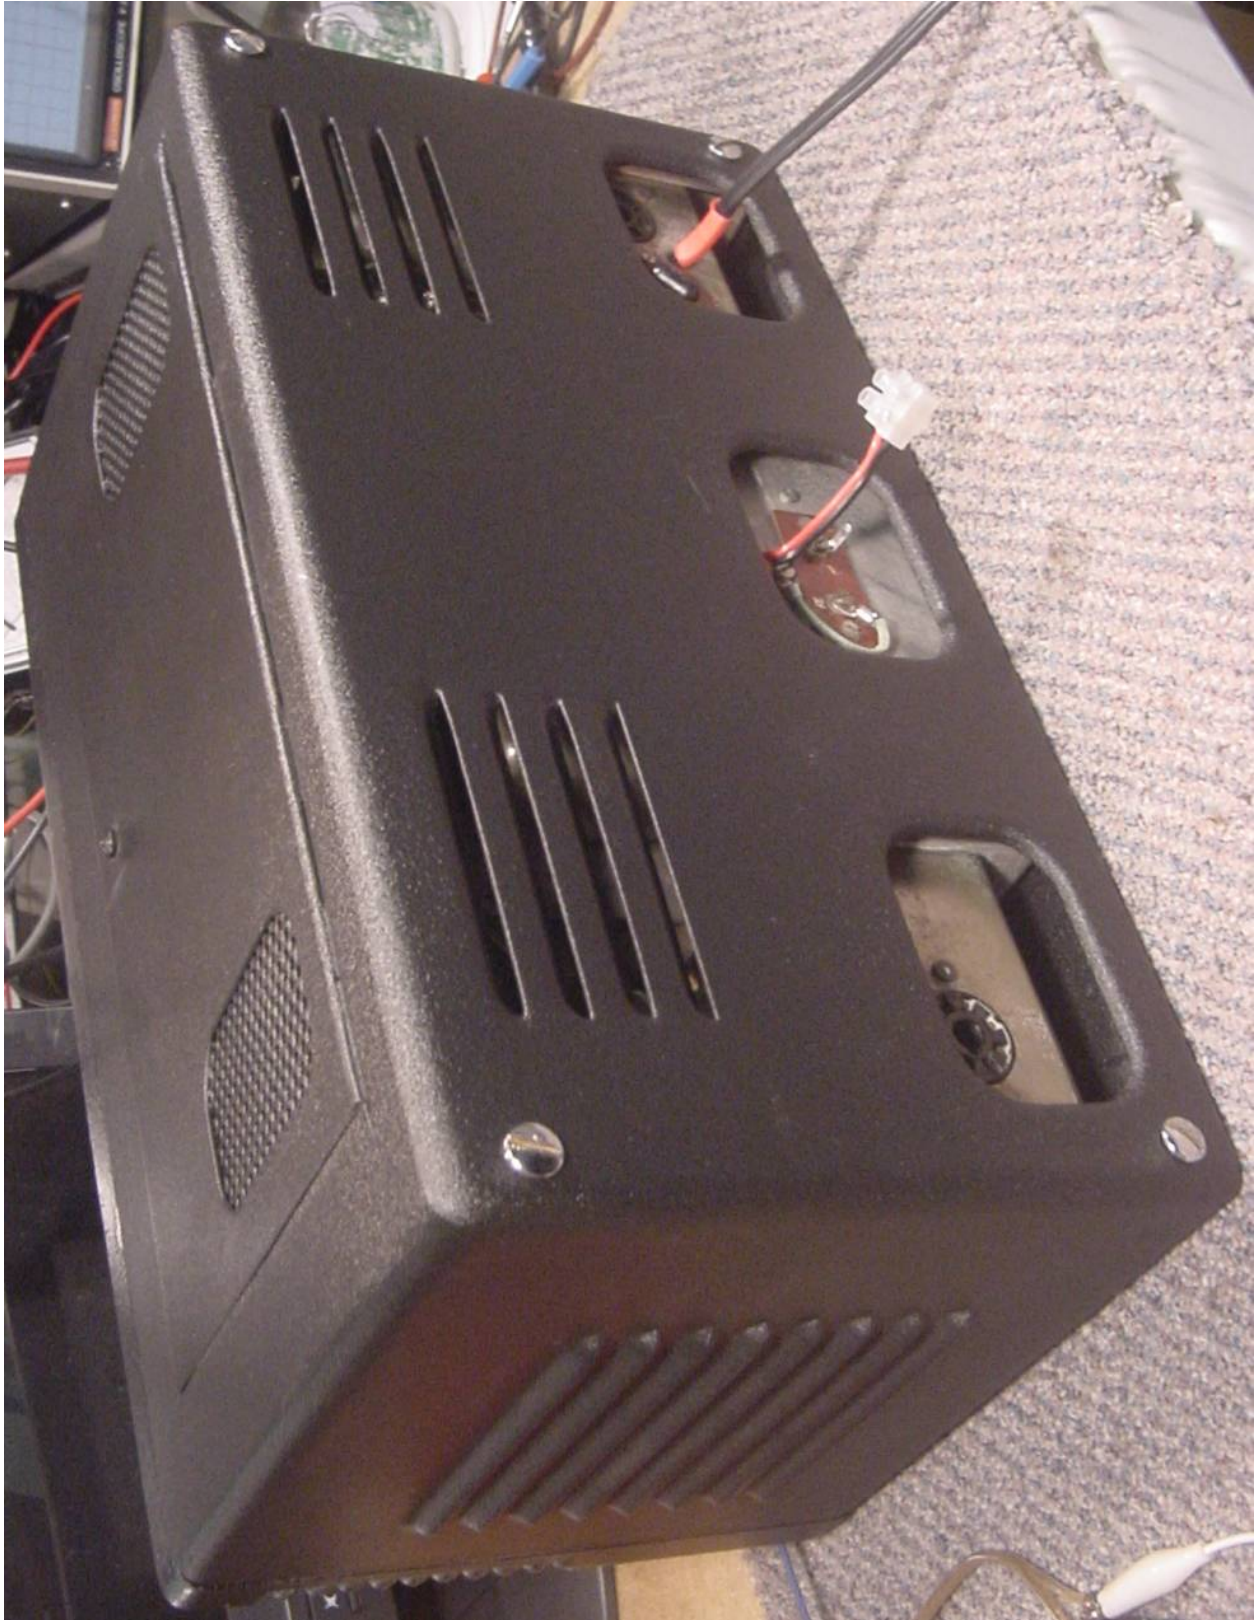
Above: Rear view of S.750 case fitted to the S.640 – note the speaker ‘pigtail’ (here terminated in a connection block) needed to allow connection to be made to a loudspeaker

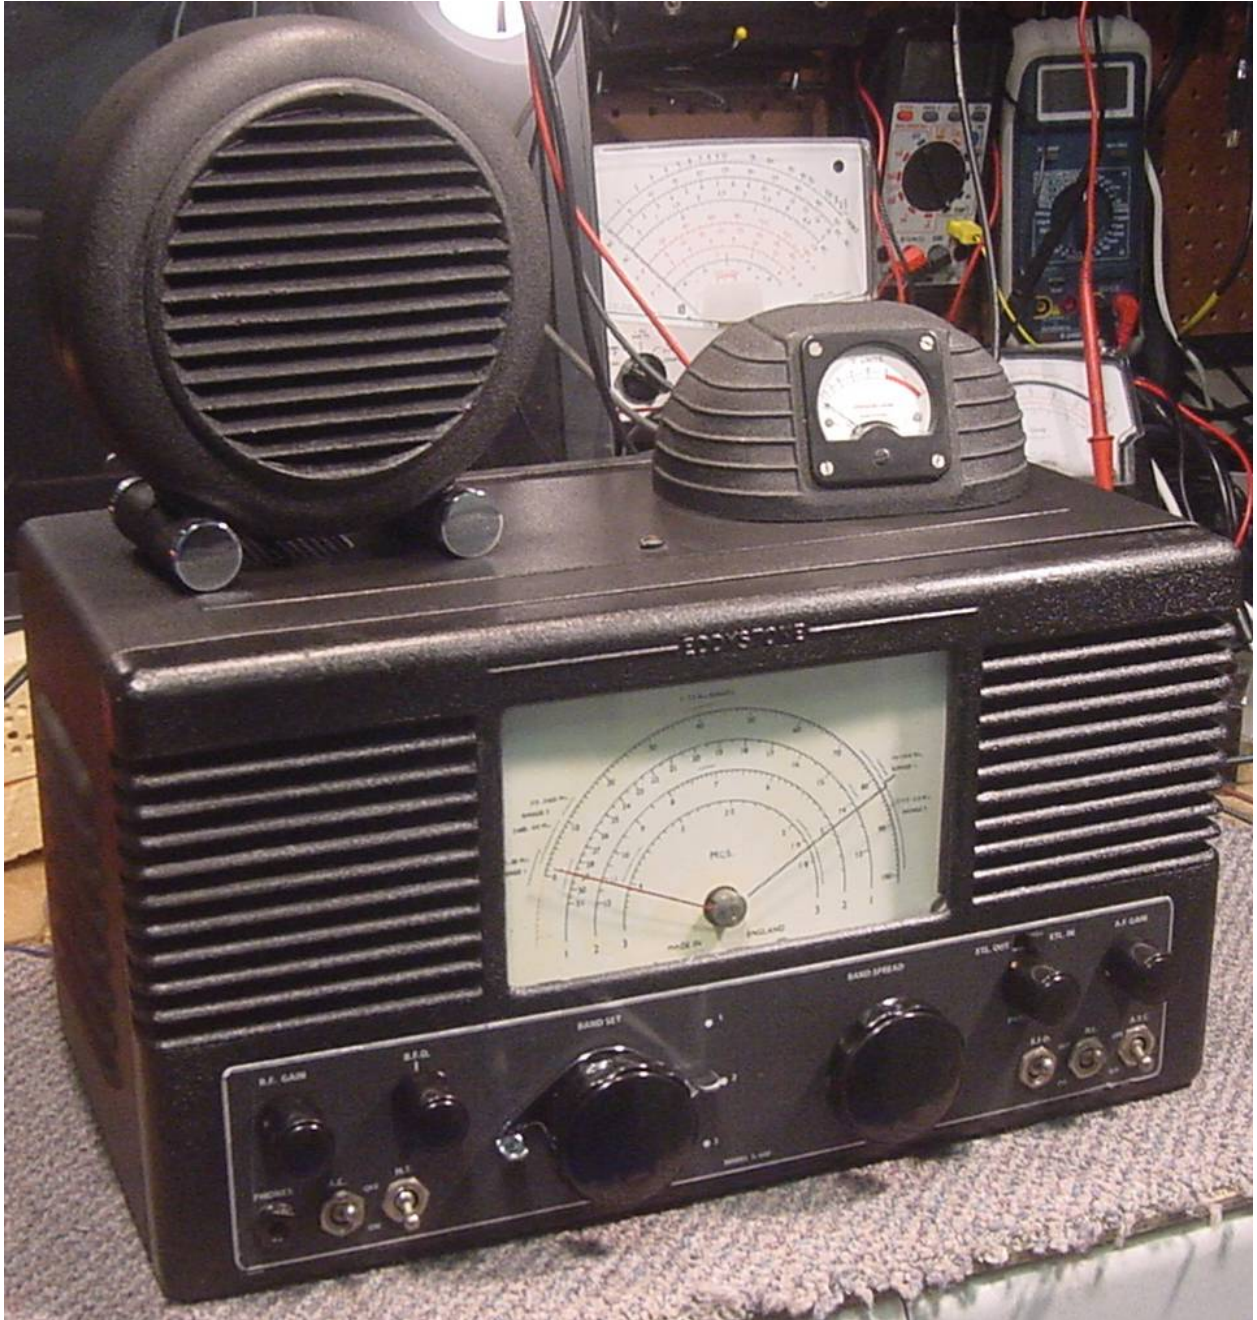
Above: Restored S.640 with matching 7" loudspeaker (Model 688) and Signal Strength Meter (Model 669). Below: serial number stamped on the IF/1st AF sub-chassis.
