Restoring an 830/4 – by Gerry O’Hara, G8GUH

Basic Preparation and Safety Checks

Electronic Testing and Repairs

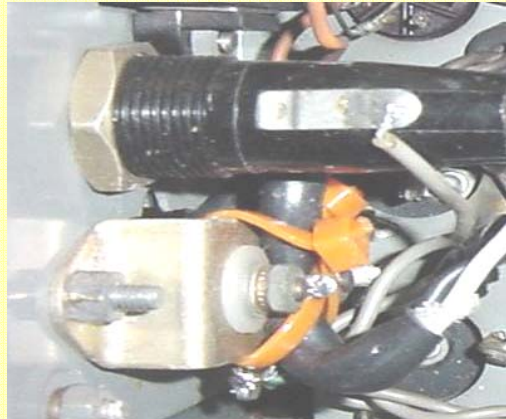
Replacement Mains Connector

I do not like using older electrical connections if they are the least suspect (eg. frayed or perished insulation). The 830/4 sported a ‘hard-wired’ mains cable tacked into the back of the original fitment chassis-mounted ‘kettle plug’. Although functional, from a safety point of view I do not believe this arrangement is acceptable, as the exposed ‘kettle plug’ pins are live when the set is plugged in.

As in the case of my S770R, a modern connector (male socket) was fitted into the set directly behind the chassis cut-out for the older (‘kettle’) connector.

Simply unsolder and remove the old connector and fit the replacement with a 4BA nut and bolt at the bottom and similar at the top, the latter with a large washer or plate cut to cover the small gap. Solder in the new male socket and that's it. You will find that the female connector (plug) fitted to the mains lead will fit snugly through the chassis cut-out and mate with the chassis connector.

- I do not like taking any chances with safety, so I decided to remove the chassis part of the ‘kettle plug’ and install of a ‘modern’ standard mains power connector (as found on modern rigs and computer psu’s, sometimes called a ‘euro’ connector – see sidebar). This can be done with no butchering of the chassis and works very well – it can also be reversed in the future quite easily. I also installed an in-line fuseholder into the mains transformer centre-tap as an extra protection for the power transformer. I also re-wired the mains transformer primary for 120v instead of the 110v it was set at on arrival (our mains is ~117v).

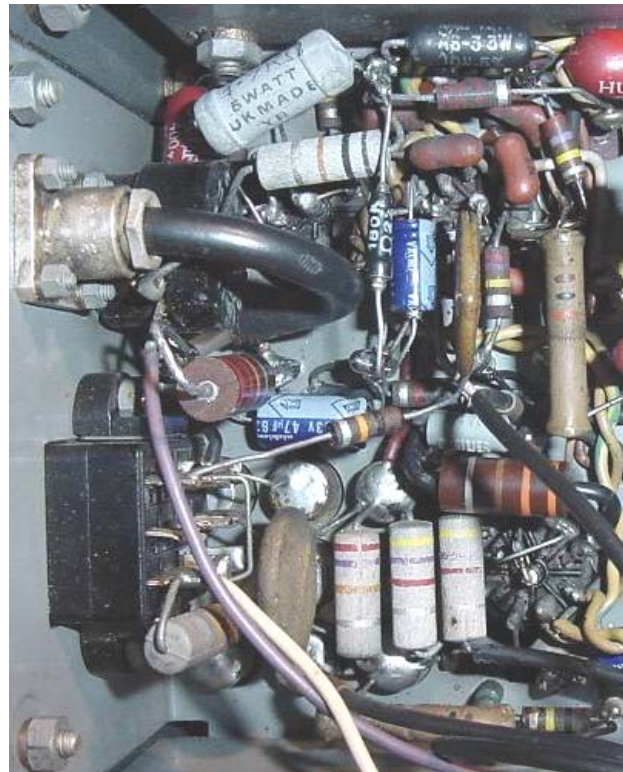
Replacement cathode by-pass caps and a few replacement resistors in the audio and IF cathode-follower stages

- I removed all valves, wiped them clean and cleaned up their pins with crocus paper and 'De-Oxit'.
- Cleaned up the valve sockets using 'De-Oxit'.
- I decided to tackle the noted faults as listed above.
- First the S-meter problem. This was traced to an out-of tolerance resistor in the bridge circuit (R34) – replaced this and the meter worked ok. That was too easy!
- Charged up with this early success, next up was that annoying inability to turn the audio fully down – it seemed like a straightforward issue to sort out. My first suspect was the cathode by-pass electrolytics (C114/115). Sure-enough, they were both open circuit and showed very low capacitance values. I replaced them both and also the cathode by-pass cap in the output stage for good measure:

much better, and it helped reduce the hum problem also, but there was still some audio present with the AF gain fully down. I checked the operation of the AF gain pot and whether it was grounded well – it was ok. The voltages around the 6AT6 dual-diode-triode valve were then re-checked. The anode voltage was slightly low. I decided to check all the passive components in that stage. The anode load resistor (R48) was found to be out of tolerance (high) and was replaced. No change in the audio problem, but the hiss and crackling noises stopped – that was something anyway. R50 was also out of tolerance (high) and was replaced. No other components were found to be out of tolerance. The remaining suspect was the 6AT6 itself or its socket. I checked the socket very closely and it appeared ok – no tracking marks etc. I then suspected that the 'gobs' of 100kHz IF 'floating about' in the vicinity of the 6AT6 wiring was resulting in leakage and rectification in its triode circuitry or even the output stage (my scope indicated over a volt of IF on the output stage grid!) – I tried additional screening and decoupling etc – not much improvement. I then tried replacing the 6AT6 – no change. By this time I was becoming extremely frustrated.... My final conclusion was that the 'fault' was actually caused by internal capacitance within the 6AT6 – a deficiency in the actual valve design. This suspicion was later confirmed by Graeme (G3GGL), who noted that 'all 830's do this – it is normal', and by comments in several articles in the EUG Newsletters/

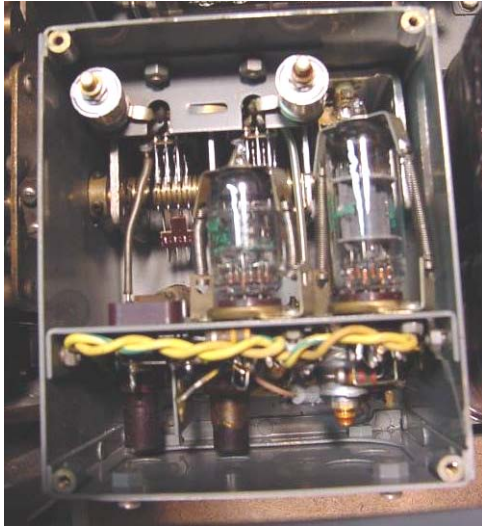
2nd Local Oscillator

- Next, I cleaned the IF/RF gain pots using De-Oxit – much better in just 30 seconds.
- The crackling/jumping incremental tuning was tackled next. I removed the cover on the 2nd local oscillator and closely checked the tuning capacitor, drive mechanism and mechanical linkages. I could not see any obvious reason for the crackling and frequency jumps. Starting with possible mechanical causes and noting that the mechanism was dirty and could have poor/intermittent grounding, I cleaned the drive gears and linkages, spraying contact points with De-Oxit. It worked – the crackling vanished and no more frequency jumps were noticed.

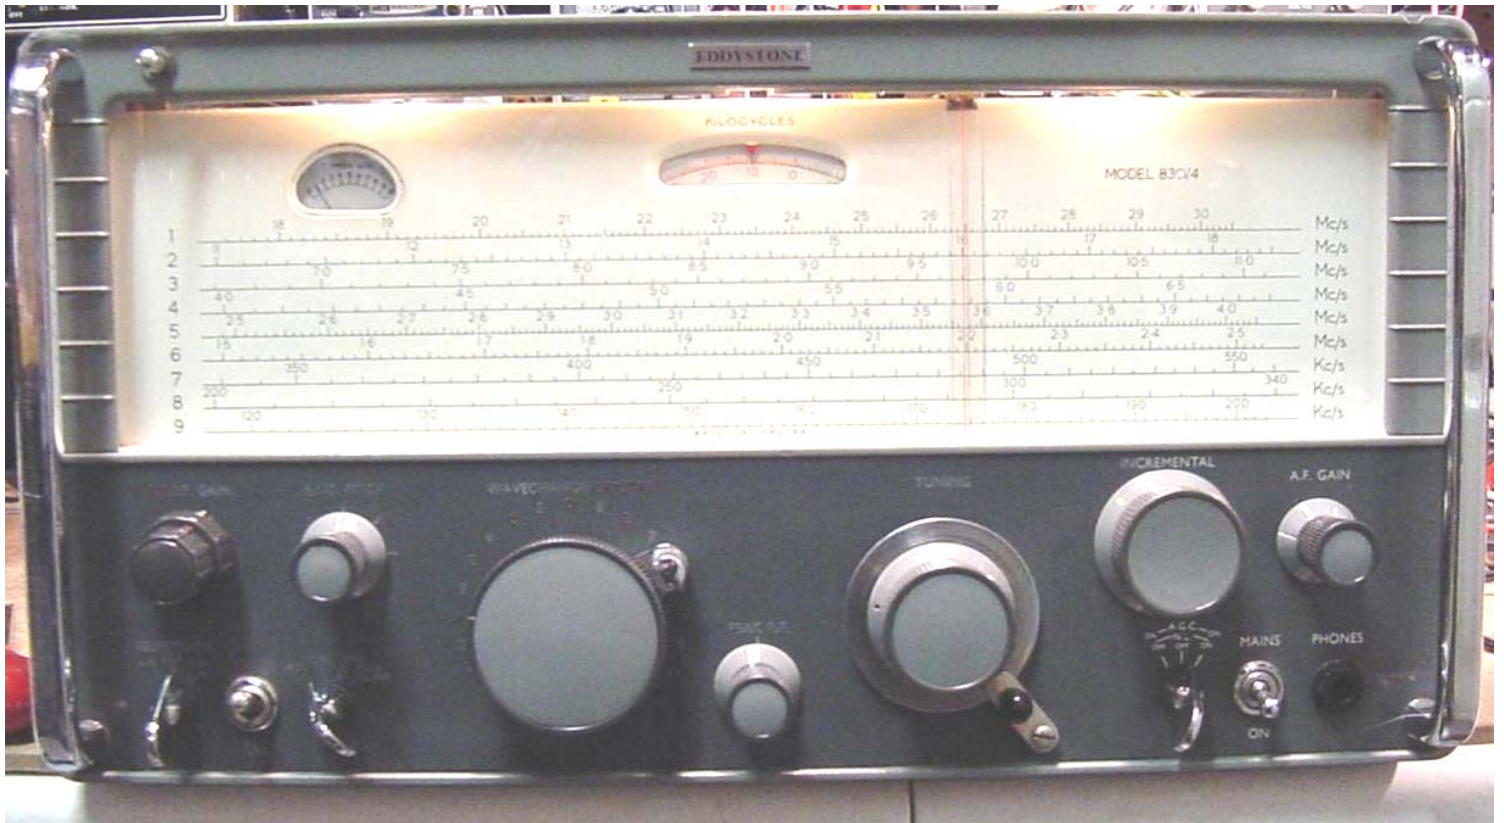
Starting too look good... (but see after the ‘Post-Postscript below!’)...

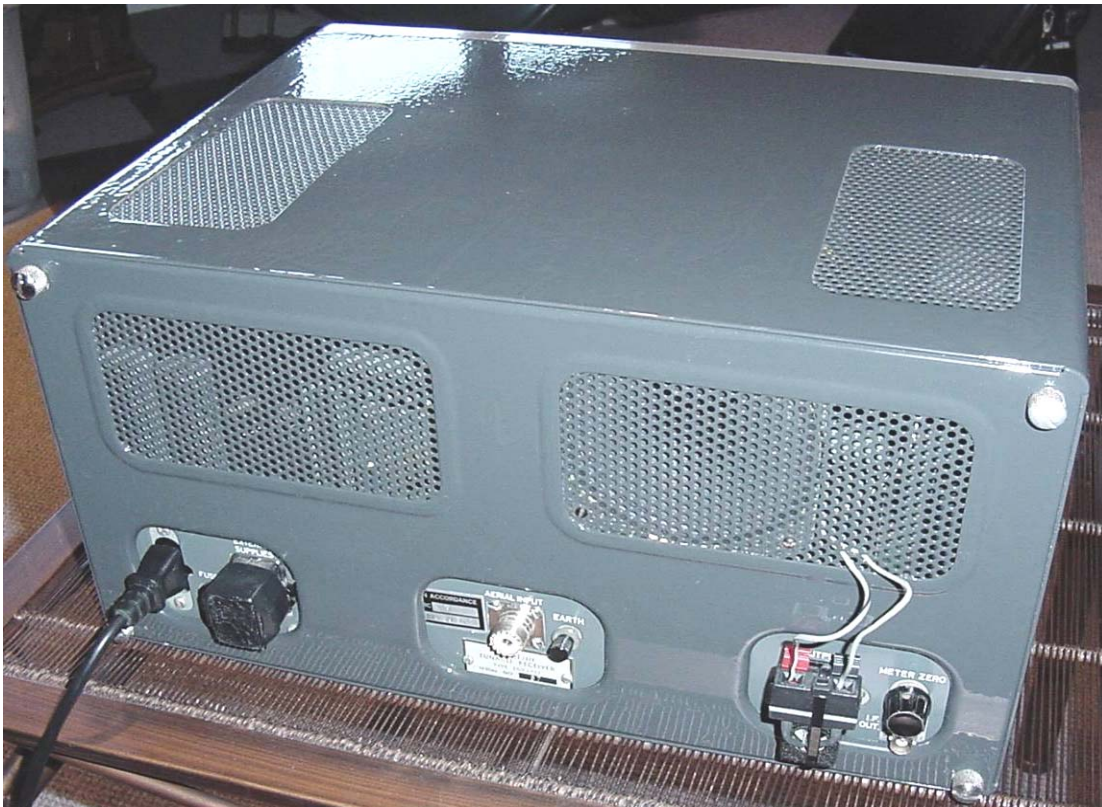
...and better! - note the internal speaker fitted above (easily removed) and the new powder coated case. Spot the rack-mount cut outs in the photo below, also the neat little gadget (I believe original fitment for the 830/4) for locking the main tuning knob.

- Removed the rack mount flanges and stored these away. This leaves machined 'slots' exposed on either side of the set once it is 'boxed up', however, this looks acceptable (see photos of the boxed-up set later) and is better than the sharp edges of the rack mounts when the set is bench mounted.

- The case was quite badly scratched and scuffed, so I decided that a fresh powder coat was the only real solution – cost \$30 cash as a 'moonlight' at a local powder coat
