## A Potted History of my 'Radio Life' and the Restoration of an Eddystone S.740 – by Gerry O'Hara, G8GUH

So, I thought the story of restoring this fine radio to its former glory might be of some interest to EUG folks.

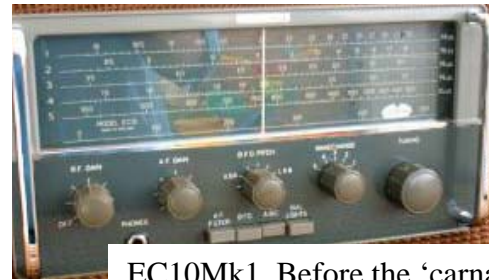
EC10Mk1 Before the ‘carnage’ ...

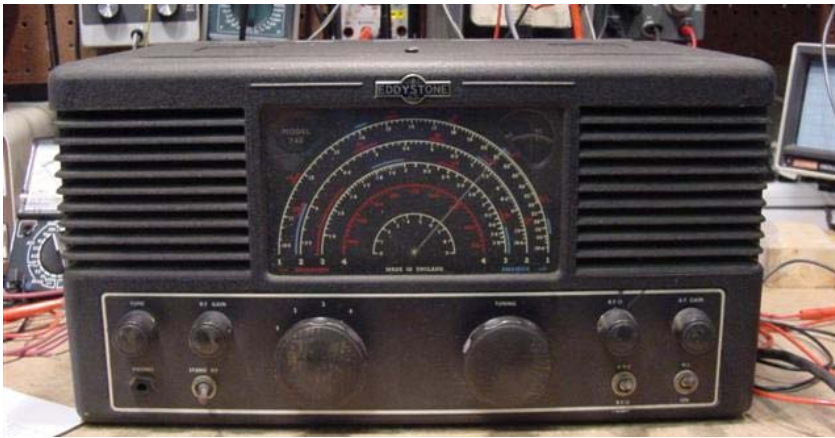
Cedric's S.740 on arrival, outside...

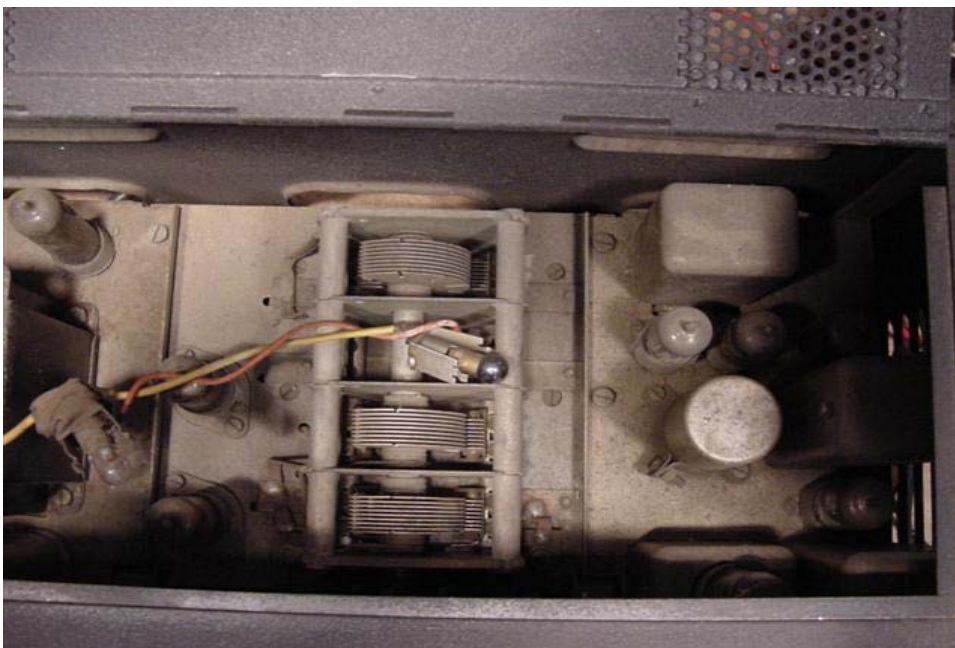
...and inside, through the 'lid'.

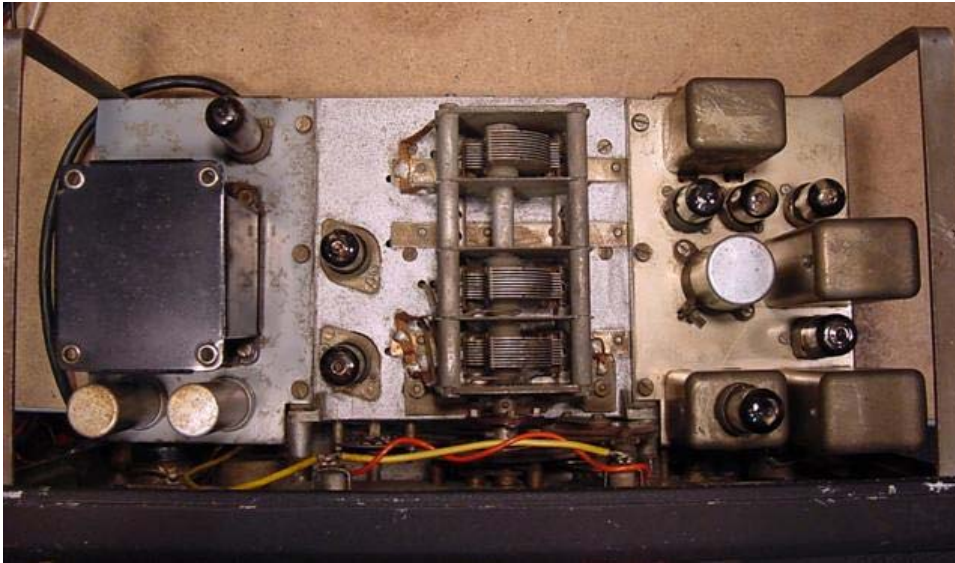
Case removed. Chassis top after initial clean – I know its feeling much better already...

- Vacuum-cleaned the chassis and case, using a small paintbrush to penetrate nooks and crannies. I wiped case and front panel with cotton wool wipes and warm soapy water and wiped the chassis with alcohol (using Q-tips and cloths) to remove grime. I used lighter

fluid to dissolve stubborn areas of melted wax. The dial was then cleaned with lens-cleaner (I have not yet cleaned the inside, marked side of the dial - it is fairly clean anyway).

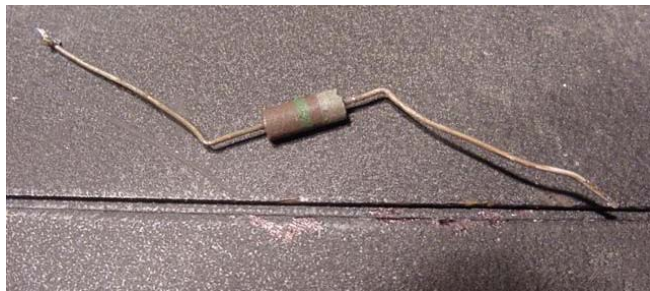
- I undertook a simple (“poor man’s”) signal trace: the 2<sup>nd</sup> audio stage was working ok (finger on output valve grid gave loud ‘buzz’), however, the 1<sup>st</sup> audio stage was very weak (finger on pentode grid gave very low output) – therefore I suspected this stage as a culprit. I checked the voltages around the 1<sup>st</sup> audio stage: the screen voltage was very low and the cathode voltage almost zero. The screen dropper resistor (2.0M ohms) was checked and found to be open-circuit (the by-pass cap was re-checked and found to be ok). I replaced the resistor. The stage now worked well and the audio was loud (almost deafening) with no distortion, however, the AF gain had no effect on the volume! I checked the AGC line with a VTVM – it was working well.

The innocent-looking culprit exposed!  
– not even a scorch mark...

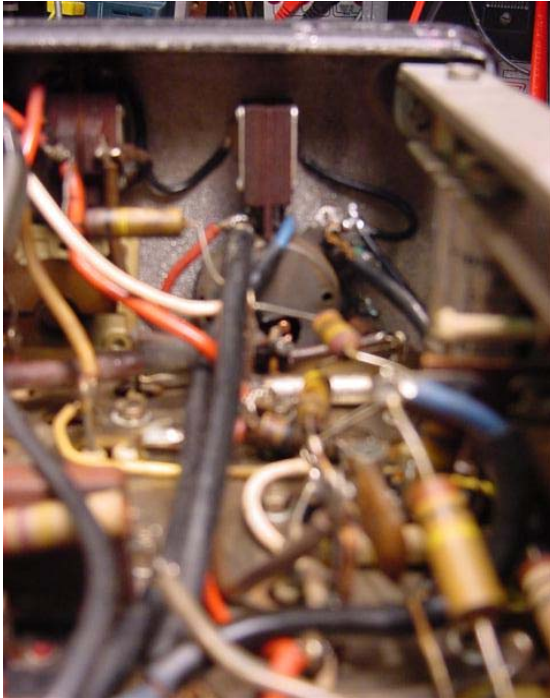
- Careful inspection under front panel indicated that the earth lead to the AF gain pot had corroded and broken off (the control was a little loose on the panel which had flexed the wire). This was repaired with a new lead, and the control tightened. The AF gain control now functioned but was very noisy - fixed by spraying with 'De-Oxit'.

New ground lead (black) to BFO switch, and AF gain pot

- I found that there was no voltage on the BFO unit HT tag when the BFO was switched on. I checked the BFO on/off switch. It was found to be not working (always off). Also, the other half of the same switch, which shorts the AGC line to earth when the BFO is on, was found to be open-circuit. I considered replacing the switch, but only non-authentic-looking ones were to hand. Instead, or at least until I can locate a similar good switch, I applied 'De-Oxit' several times into the switch toggle (with the switch facing upwards) and worked the switch toggle several times. It now functioned.

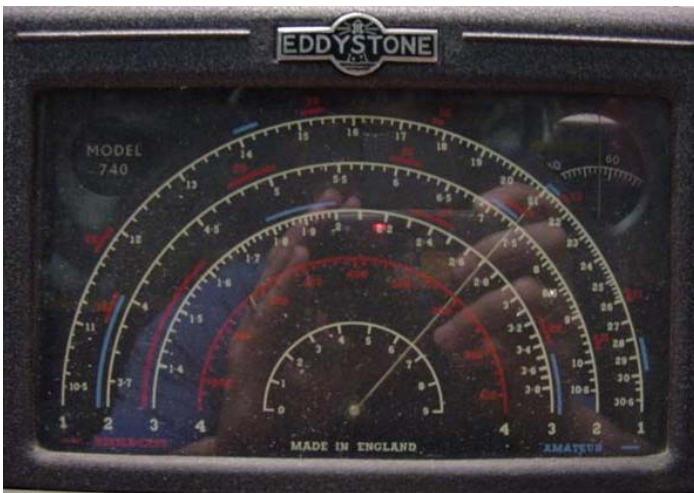
Lovely 'half-moon' dial (before cleaning)

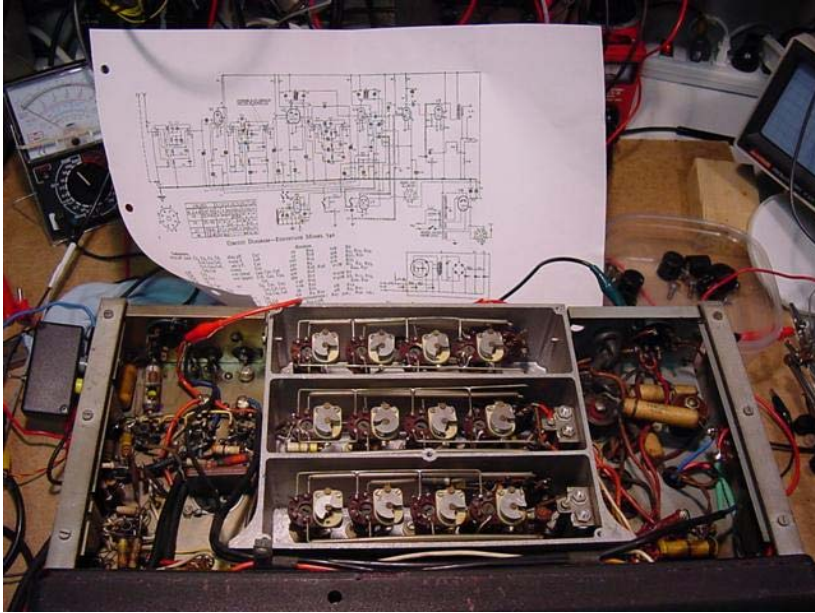
Checking the coil box

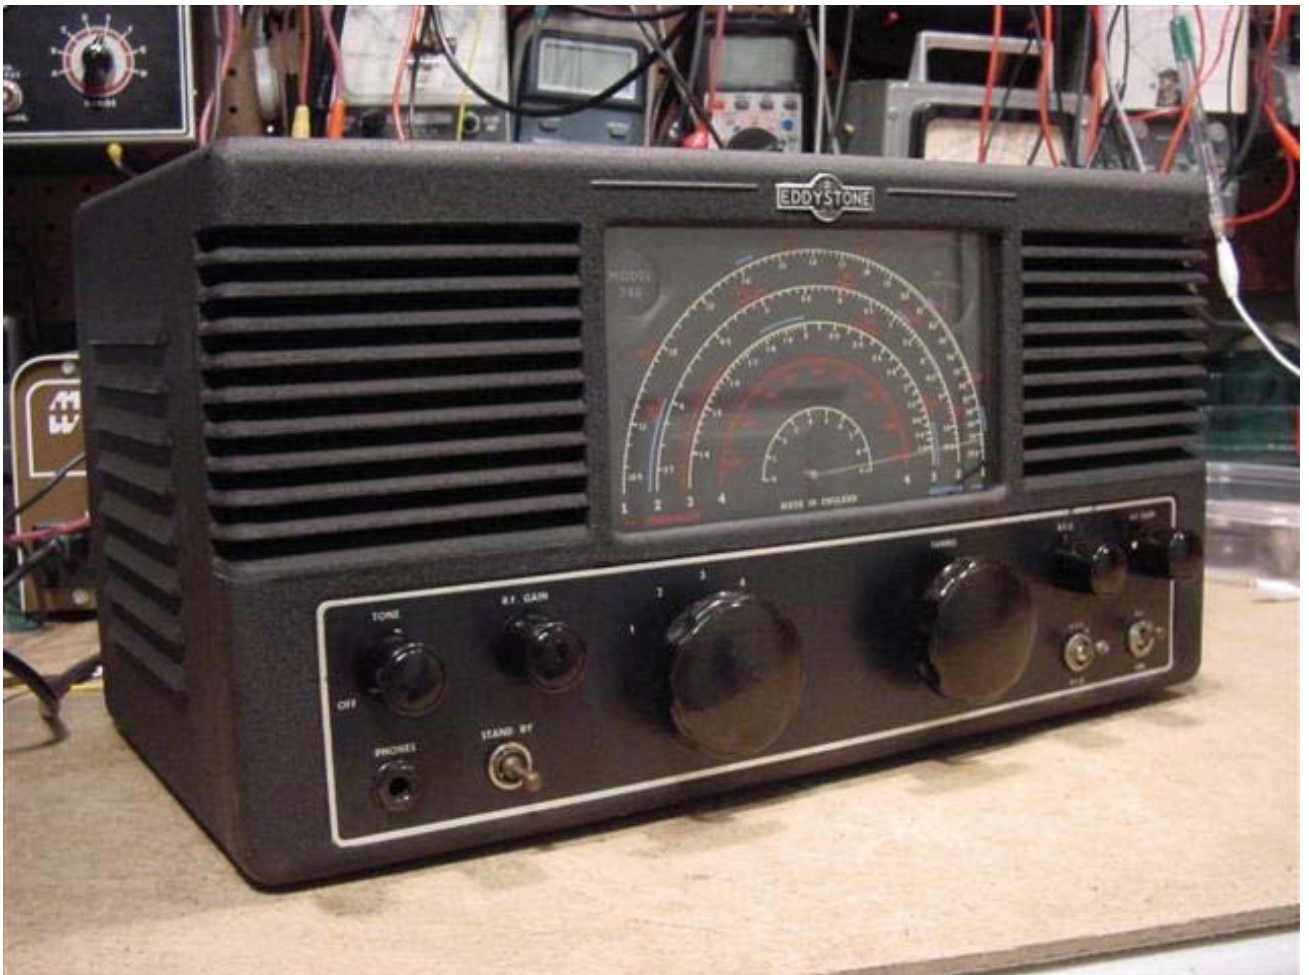
Looking good and working a treat!
