Restoration of an Eddystone EC10 MkI Solid-State Receiver (Part 1) - by Gerry O'Hara, G8GUH/VE7GUH

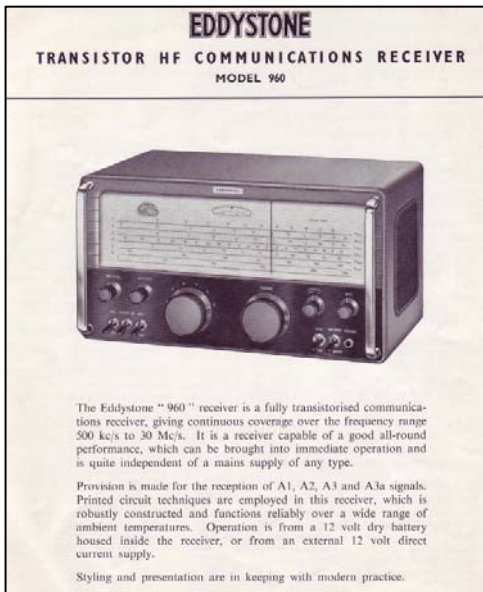
Building on this knowledge, and staying within their more traditional and familiar territory of communications receivers, Eddystone launched their first all-solid-state general coverage communications receiver in 1962. This set looked identical externally to an S.940, though with transistor circuitry replacing the traditional valves. The S.960 sported 12 germanium transistors and seven diodes, had six ranges covering 500kHz to 30MHz and was powered by an internal 12 volt battery pack. The circuit had one RF stage, three 465kHz IF stages, including a bandpass crystal filter. Its

performance was apparently (and very believably) not on a par with the S.940 however, and the S.960 was dropped from the Eddystone range after the Bath Tub manufactured only 150 of the sets over 2 years. It is worth noting that the transistors used in the first experimental Eddystone solid-state sets cost the equivalent of around £50 (\$100) each.

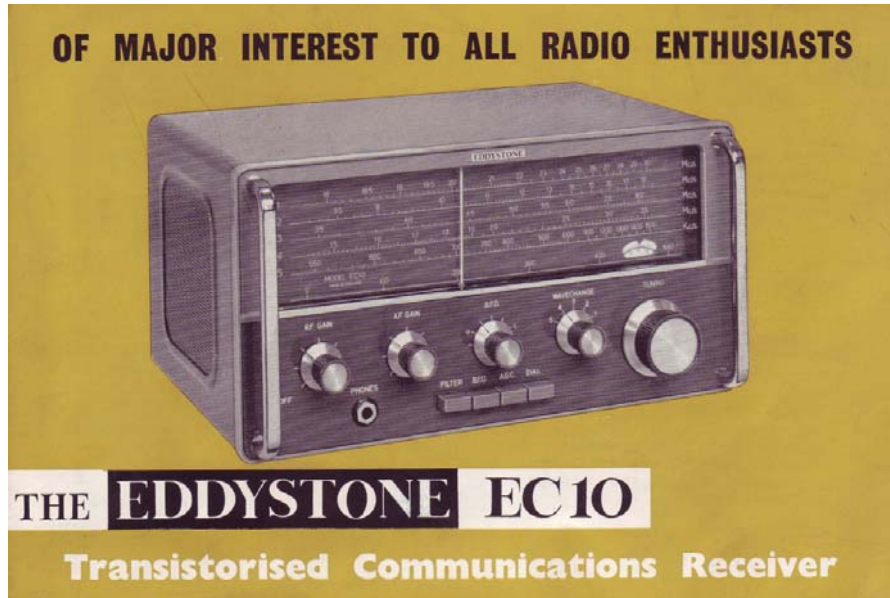
The next solid-state set out the Bath Tub was the famous EC10 – one of the companies biggest successes in terms of total sales (over 16,000 MkI and MkII series sets combined). This set was an instant success, receiving favourable radio press reviews and satisfying the need for a more

‘modern’ and compact communications receiver at a (fairly) reasonable price point. The EC10 was housed in a much smaller case (12” wide) than the S.960, while still retaining the famous Eddystone slide rule dial that made tuning the set a pleasure, as well as the hallmark Eddystone mechanical construction that made it *feel* like a quality piece of kit. The EC10 used an all-germanium PNP transistor line-up that shared many circuit design elements with the S.960 (its main features are described below), but was constructed on two ‘Paxolin’ printed circuit boards, with a zener-stabilized nominal 6.5 volt supply to the RF amplifier, Mixer, local oscillator (LO) stages and the beat frequency oscillator (BFO). The set could be powered from a removable battery pack using 6 ‘D’ sized dry-cells to provide a 9.1 volts, positive earth supply (positive earth was the norm when using all-PNP transistor circuitry). A mains power supply (Type 924) could be substituted for the battery pack.

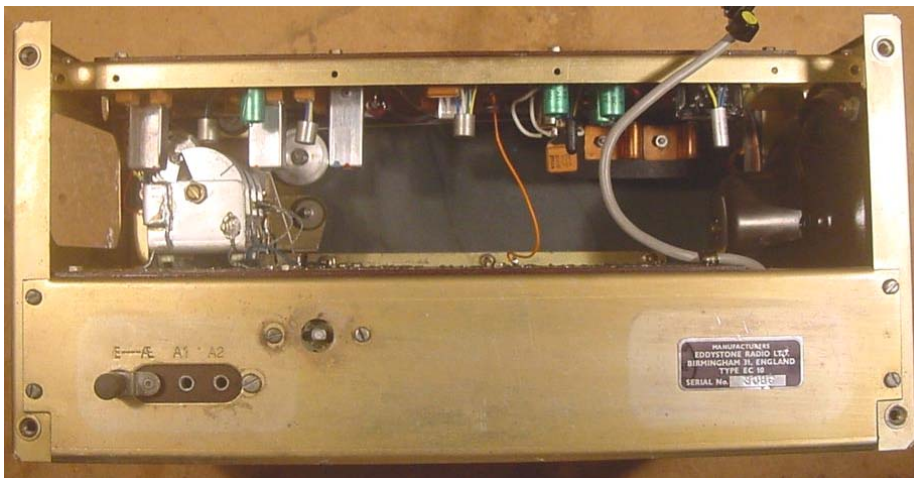
outs are present in the rear of the case for the battery box (or the mains battery psu as a substitute), the usual Eddystone- style aerial/ground connections and the maker/serial number tag per the photo of the chassis rear, above. Perforated sections set into the sides of the case allow for ventilation and one serves as a speaker grill. Chrome carrying handles are fitted to the case front and the bolts for these also hold the front panel casting and dial mechanism mounting plate onto the steel side chassis members.

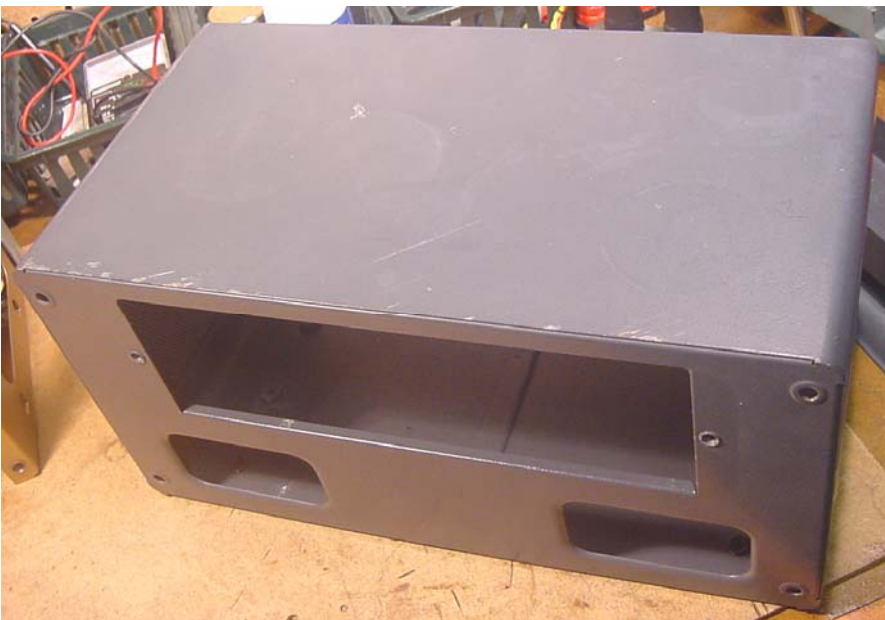
The first thing I noticed on unpacking the set was that the case had a strange discolouration and dullness that could best be described as a 'bloom', along with several darker 'blotches' and many coffee mug stains that would not wipe off with soapy water or alcohol. It also had several

deep scratches and scuffs – though mainly on the top surface. The paint finish was also not as I recall from my other EC10 or as present on MkII Eddystone valve sets – it was much less shiny and had a slight 'orange peel' finish. For now I decided to buff-up the paint finish with Brasso in an attempt to remove the coffee cup rings and blotches and to just touch up the scratches, though eventually I think I may have the case powder coated. The Brasso did indeed remove the coffee mug stains, darker blotches, some of the scuffs and imparted a shinier finish more in keeping of what I think it should be. I used a concoction of three different Humbrol enamel paint colours to touch-up the scratches and deeper scuff marks. When the paint had cured for several days, I buffed the case with more Brasso to better blend-in the touched-up areas – not a perfect finish, but good enough for now.

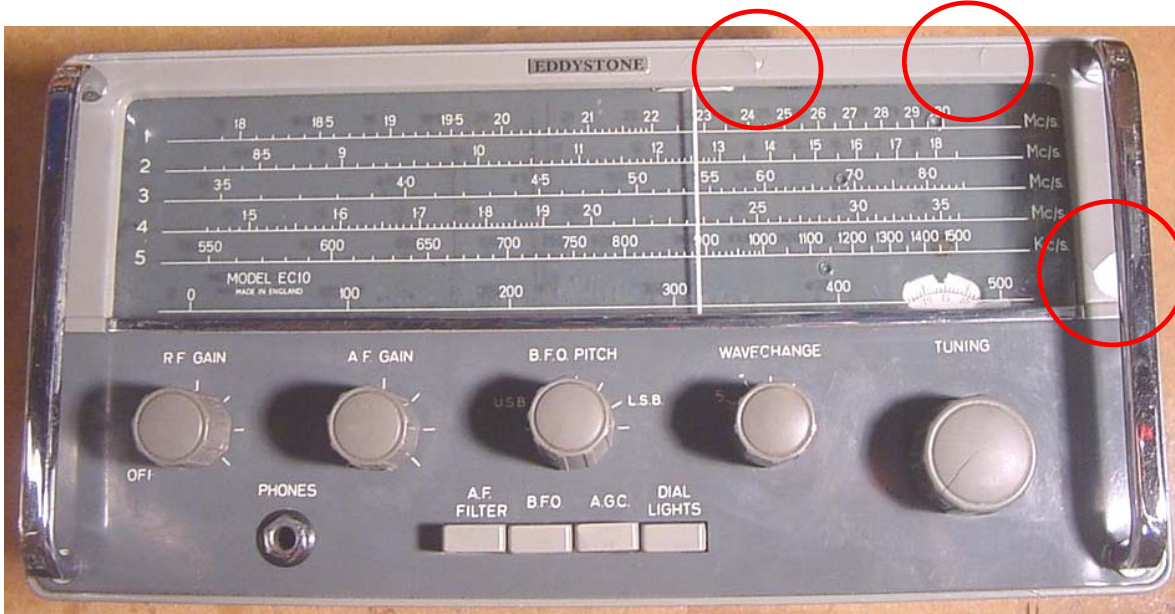
The front panel casting was going to be a tougher job though – looks like it will definitely need either a powder coat or spray job to get it looking as it should. It has several areas where the enamel paint has badly cracked and/or detached from the aluminium casting completely (circled red in the photo above) – as though the finish had not adhered to it correctly from new, or surface cracking had introduced moisture that had encouraged the enamel to part company with the aluminium, however, no corrosion was noted on the casting surface. Again, as a temporary fix, larger loose flakes were glued down and a concoction of Humbrol enamels was applied in several coats to build up the thickness of the original enamel finish on the bare areas before buffing-out with Brasso after curing.

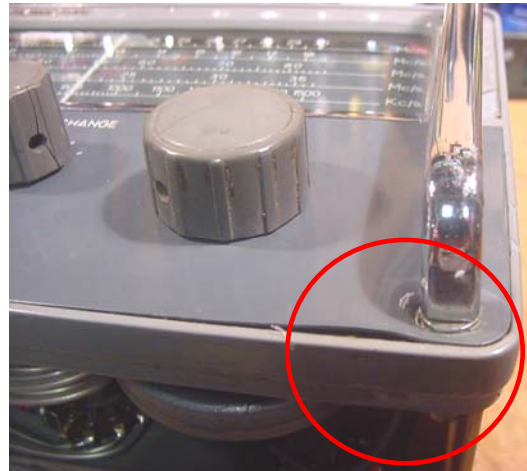
The finger plate was bent in one corner (circled red in the photo, right) where I suspect that the set had been dropped onto one of its handles (aargh! – what is it with Eddystone sets I acquire? – this is the third set I have that has suffered from one of its previous owners testing its ruggedness by dropping from a great height) – at least the front panel casting seemed intact. The white lettering on the finger plate was worn off in parts – particularly around the bands change knob, but was otherwise it was ok.

After some thought on the overall cosmetics, I contacted Ian Nutt and ordered a complete set of knobs and a new fingerplate. At the time of writing I am awaiting their delivery.

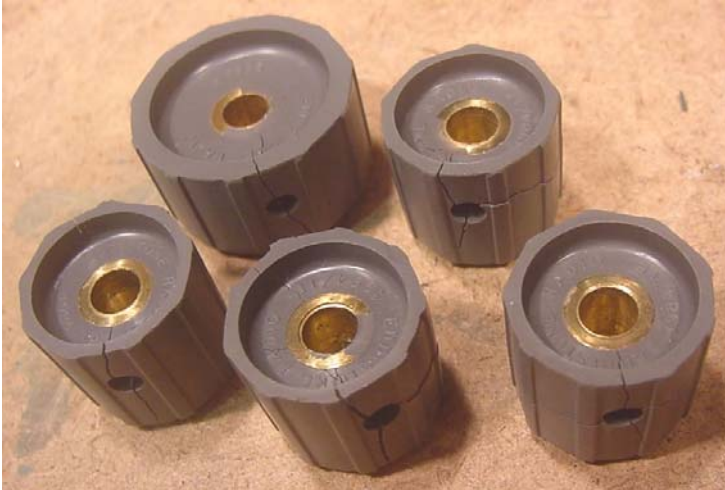
When cleaning the knobs, I noticed that they were in extremely poor condition – they were all suffering from the dreaded cracking syndrome that I had first observed on my S.830/4 and as reported by others in 'Lighthouse'. It seems that the plastic surrounding the central brass insert in this knob design either shrinks with age and/or the different thermal characteristics of the brass and the plastic sets up stresses in the plastic that results in the cracks forming. The larger (tuning) knob only had one crack, but the

smaller ones had multiple cracks – to the point that they looked like 3-D jigsaw puzzles (see photo, left).

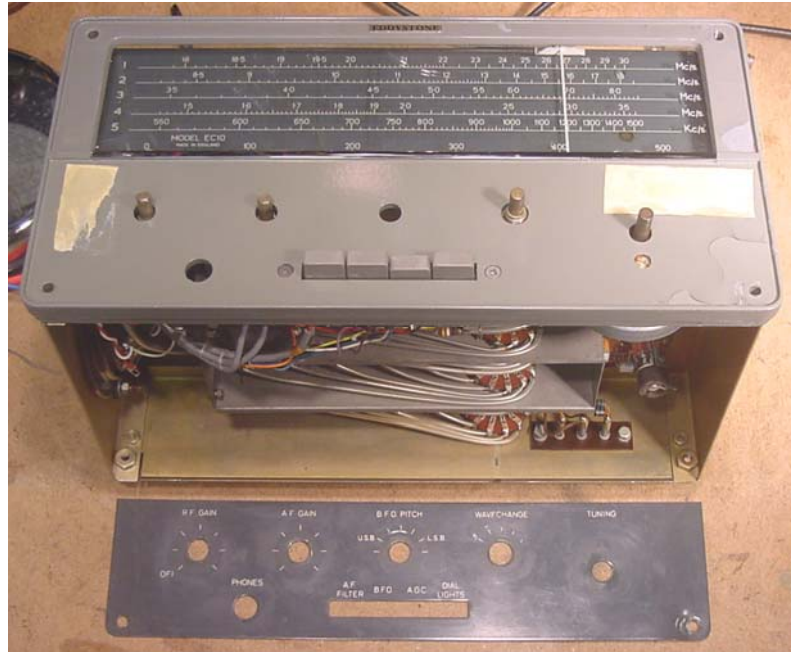
As noted above, the EC10 utilizes a modified Type 898 dial mechanism as found in the small valved Eddystone sets (eg, S.820, S.870 etc). For a fuller description of this mechanism please refer to my article on its use in an HBR13C homebrew receiver downloadable from the EUG website. In this adaptation, the tuning shaft, vernier scale and gearbox are all offset well over to one side rather than being located centrally. Also, the spool pulleys in the EC10 (this set at least) are turned from aluminium rather than brass as in the Type 898) and are slightly larger. Speaking of the Type 898 dial, I was recently given an unused one (thanks Ralph! much appreciated) – photos of the EC10 dial mechanism and the Type 898 are included at the end of this article for comparison.

The metal pointer slider runs along the top edge of the sturdy grey-painted metal mounting plate that forms the support for the idler pulley wheels, gearbox (with cut-out for the circular vernier scale), grommets for the dial lights and an angle bracket that

- Gently pull the front panel casting away from the chassis, with the tuning drive assembly attached;
- To separate the casting from the tuning drive mechanism, remove the single 4BA bolt that passes through the mounting plate just beneath the tuning shaft. This will have some locking compound applied to its nut, so may be difficult to loosen.

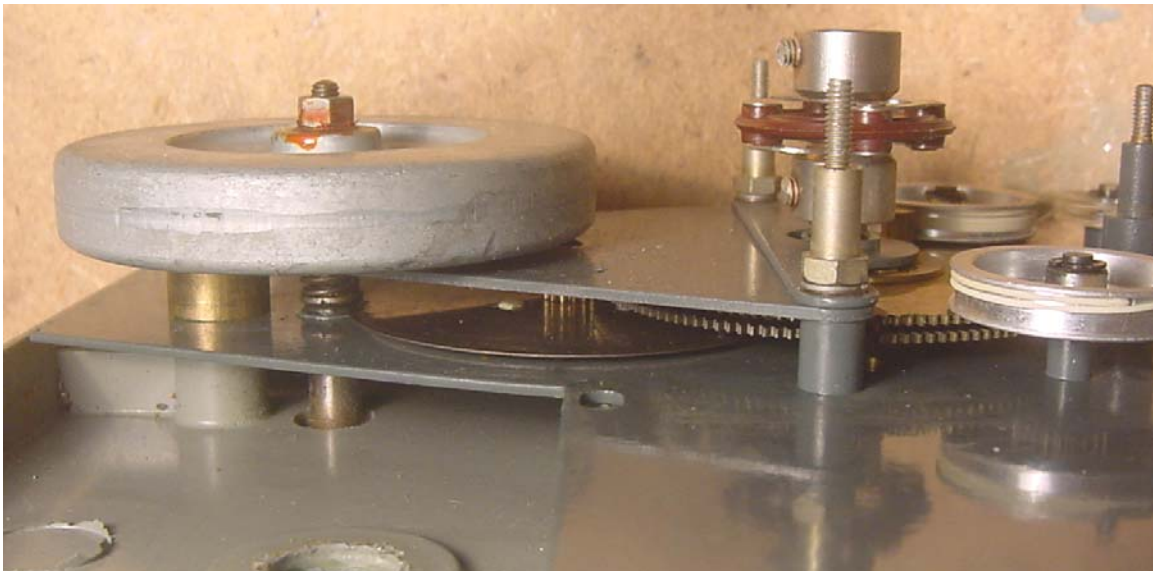
along its upper edge. This is also a good time to clean any hardened oil/grease from the gearbox bearings and gears, the friction drive spring (photo above) and to re-lubricate the gears and tuning shaft bearing with suitable grease (I used a very sparing amount of Moly-grease). Clean the friction clutch mechanism and ensure the outer edge of the drive plate and mating surface on the tuning shaft are grease-free.

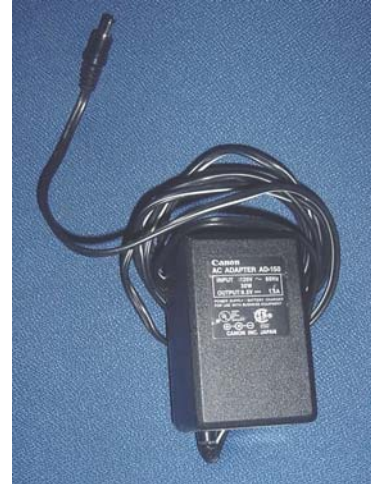
Not having a Type 924 mains power supply handy, I decided to improvise. I had several mains power 'blocks' from consumer electronic products that I had picked up over the years at thrift stores and fleamarkets (these power supplies are also known as 'wall warts')

– photo, right). This type of unit usually supplies an unregulated DC supply of whatever nominal voltage and current is indicated on the back of the 'wart'. However, when unloaded, the voltage output from the supply can be significantly in excess of that indicated, so some caution is advised (varies from 'wart' to 'wart'). I decided to use one of these gadgets to feed unregulated DC into the EC10, with a simple transistor/zener regulator fitted into the sets' battery compartment. I had a suitable 600mA unit in my junk box – plenty of 'oomph' for those 'thirsty' dial lights here (so maybe I won't replace their friendly glow with LED's after all...). A simple, cheap and very effective power supply solution with the benefit of no mods needed to the EC10.

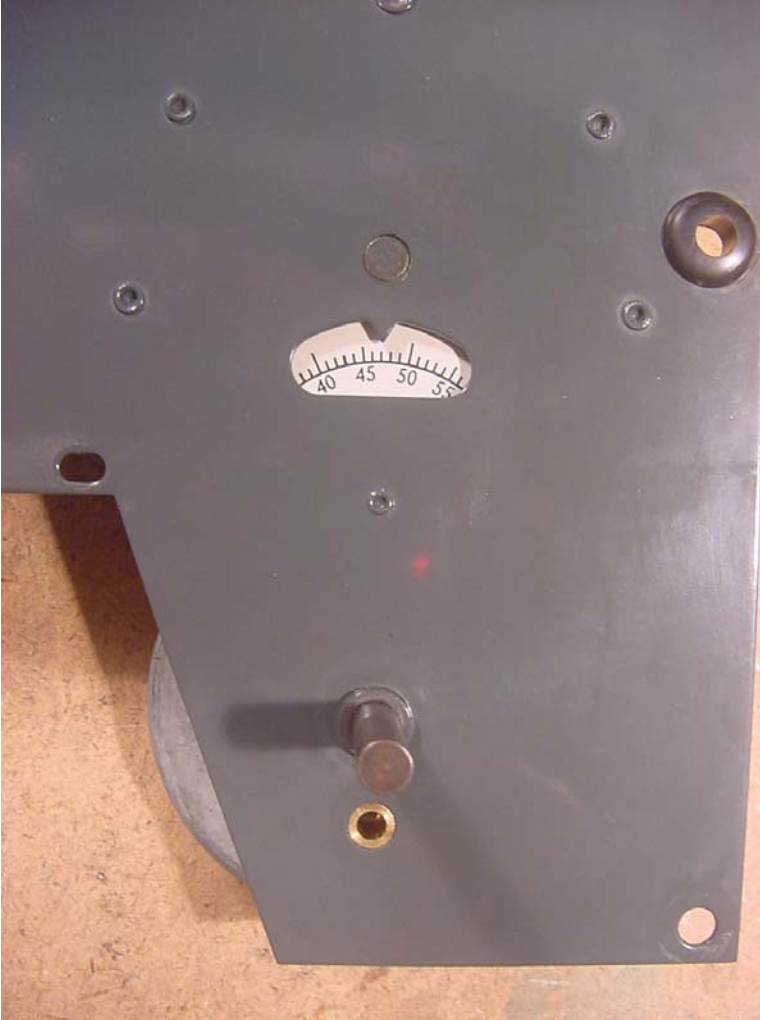
Left: The front panel of the gearbox is formed by the mounting plate for the dial drive. The circular vernier scale is visible through a cut-out in the mounting plate above the tuning shaft

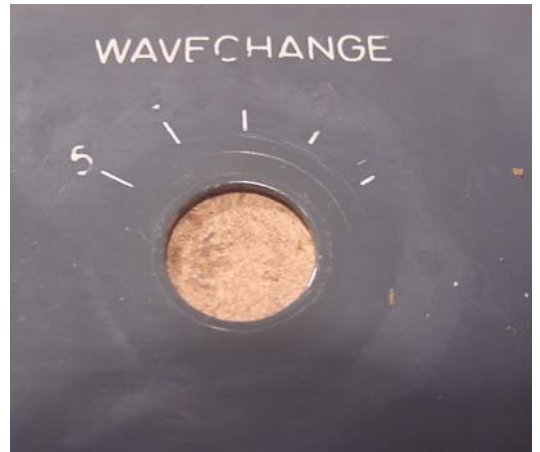
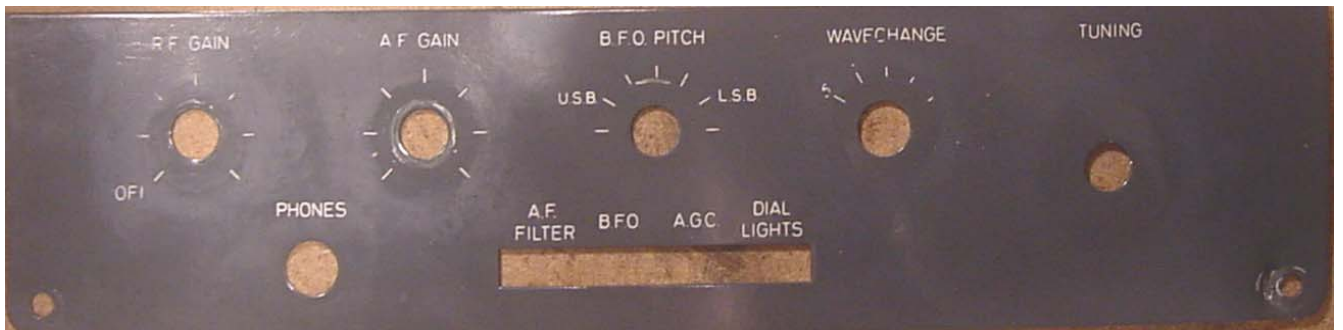
Below: The worn and damaged finger plate - looks like a bullet has passed through one of the holes that secure the handles in place (lower left of the photo of the rear of the finger plate shows this best) – ouch!
