Postscript to the Restoration of an Eddystone's 'One and Only HiFi Separate' – Model S.820 Tuner - by Gerry O'Hara, G8GUH/VE7GUH

Introduction

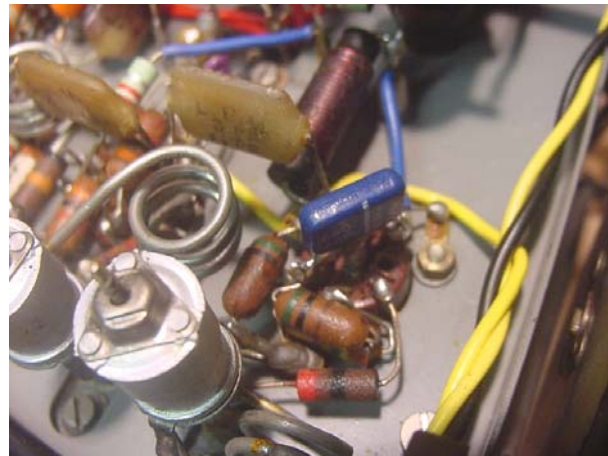
checked the valves on my valve tester. I changed it out for another – no difference. Hmm... I now suspected that the sudden jump in AGC voltage was being caused by some instability in the front-end, ie. a spurious signal generated by self-oscillation of the RF amplifier, V1 (a 6AM6), stimulated by the presence of a very strong signal. The first suspect for such instability was the anode decoupling capacitor on V1 (C3 – schematic, left), a 500pf tubular paper type that also resembles a fat resistor. I bypassed this with a 1000pf Mylar when the strong station was tuned in and the AGC line was reading -10v and it immediately cured the fault condition. I removed C3 and checked it out with my capacitance meter – it was reading only around 17pf (not much use as a by-pass capacitor!). I replaced it with a ‘near-enough’ 680pf Mylar

(blue component on the photo, right) and the fault was fixed – no problem receiving that very strong station now at all (around -7v on the AGC line when tuned on the nose) and not a hint of any instability. Now, back to easy listening... I hope.

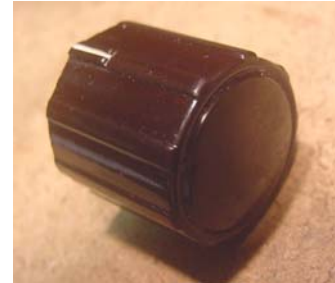
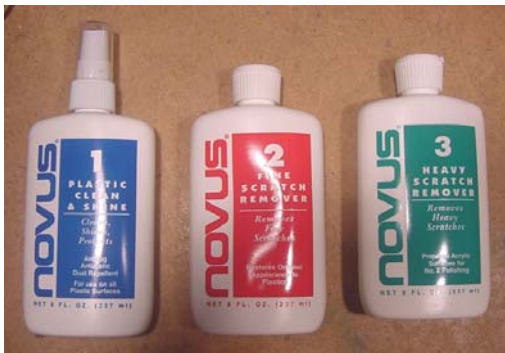
One little cosmetic job not described in the S.820 restoration article was the clean-up of the three knobs. One of these was quite badly scored, the others only had light soiling and minor scratches present. Having just bought a set of three 'Novus' plastic cleaner fluids from Antique Radio Supplies, I was keen to give these products a go (rather than my usual

soapy water/ toothbrush wash, followed by a clean with rubbing alcohol and Brasso to remove any scratches). The set comprises bottles of #1, #2 and #3. #1 'Plastic Clean and Shine' is touted to be suitable for cleaning, shining and protecting plastics, #2 is used to remove fine scratches and #3 is for the removal of heavy scratches. I must say that they work well and the knobs now have a great luster that contrasts well with the reddish-coloured fingerplate (see photos).

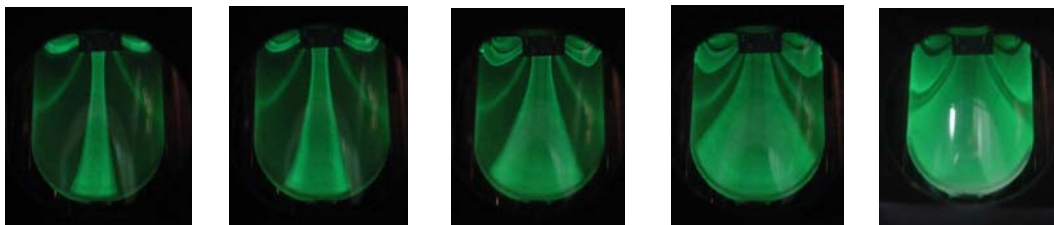
Above: The EM80 'Magic-Eye' at work: weaker signals to the left, stronger to the right

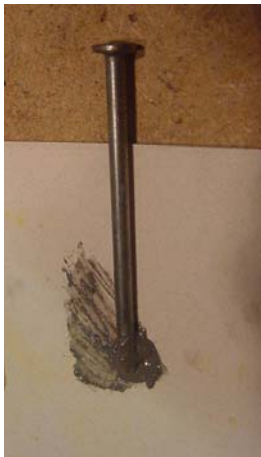
I have been asked how I did the repairs to the valve bases (two of the B7G bases in the S.820 had damage to the shield retaining collar: in one case, on (V1) it had completely detached from the base and on another (V5) only one side was still holding). I mentioned a type of epoxy adhesive 'JB-Weld' that I had been recommended

by someone at the SPARC radio museum over here in Coquitlam, BC. I am not sure if you can buy this goop in the UK, but here is a photo of the packaging so you may be able to find it locally. It is a steel-filled, grey-coloured epoxy that seems to bond metals particularly well. I have also included some photos of how its done (yes, I don't do anything these days without a camera at hand – not even a glue-job!).

(according to the packaging, an outfit in Texas repaired a Cat engine block with this stuff and saved \$4,000...). Anyway, its definitely strong enough to hold a valve shield retaining collar in place! (and certainly beats replacing the valve bases – a rotten job on any receiver).

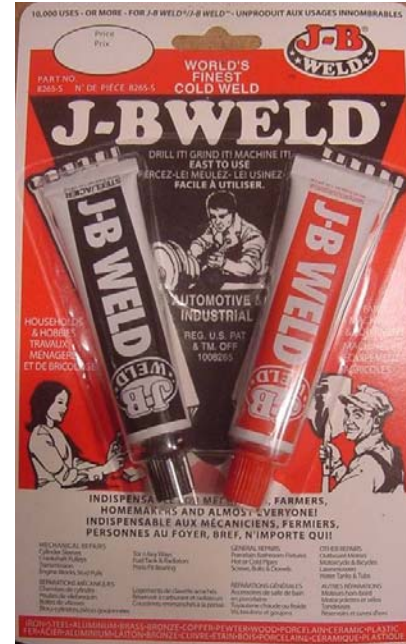
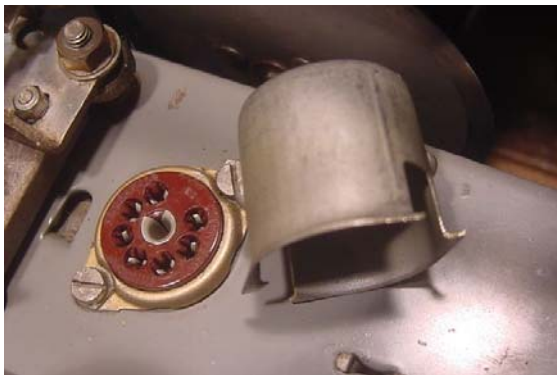
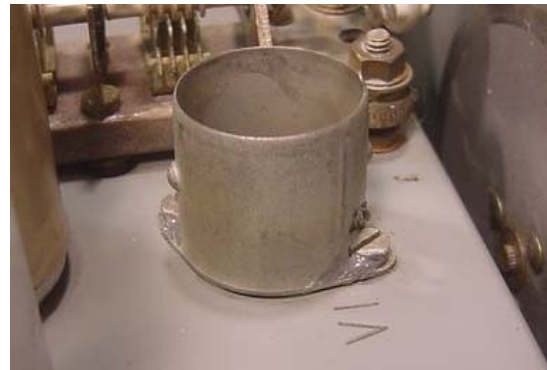
Above: The VHF RF amplifier valve base (V1) before and after 'JB Welding'

Simply clean both surfaces to be ‘welded’ (their term, not mine) – I used a small, stiff wire brush that I use for cleaning-up soldered joints. Mix the goop up (like mixing Araldite-type epoxy) and apply with a small tool (screwdriver). It takes about 6 hours to harden to a point where it can be handled, 15 hours for ‘full’ curing, ie. when the part can be put into service

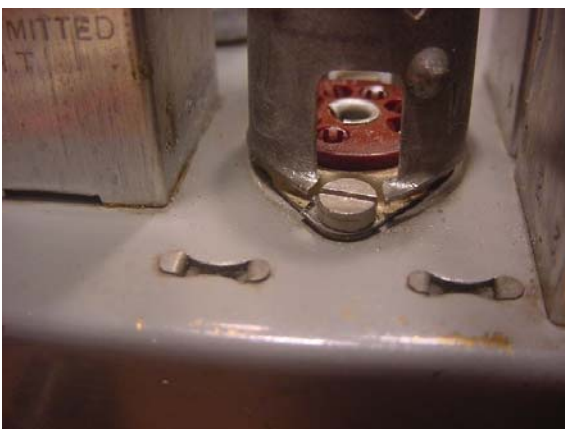
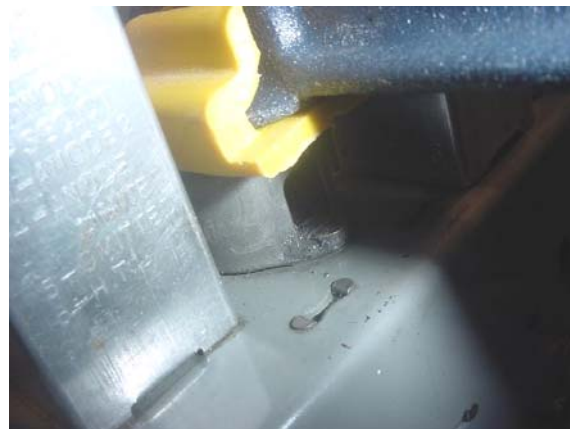
Above: The limiter stage valve base (V5) before and during 'JB Welding' (clamped)

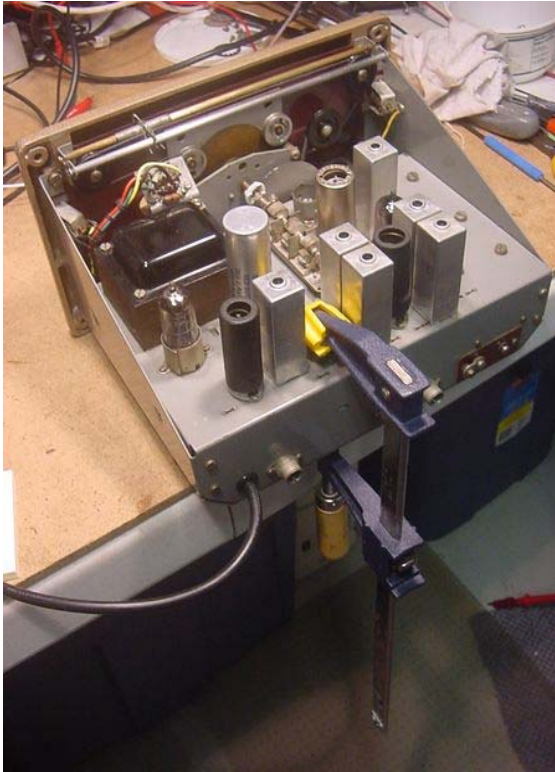
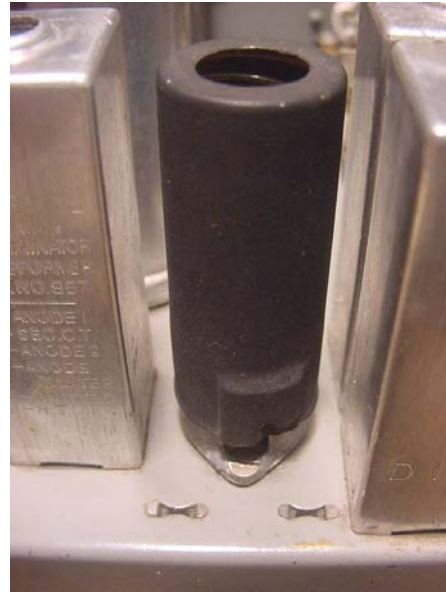
Above left: Clamping during JB ‘welding. Above right: The limiter stage valve (V5) with the valve shield back in place after JB ‘welding’ – the repair is almost ‘invisible’

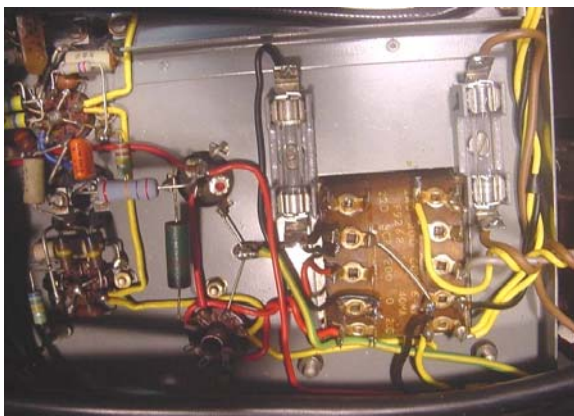
Left: After reading through some of the above Lighthouse articles, I decided to fit a second fuse – this time a 100mA in the transformer HT center-tap to ground (the fuseholder for this is the one located on the left)

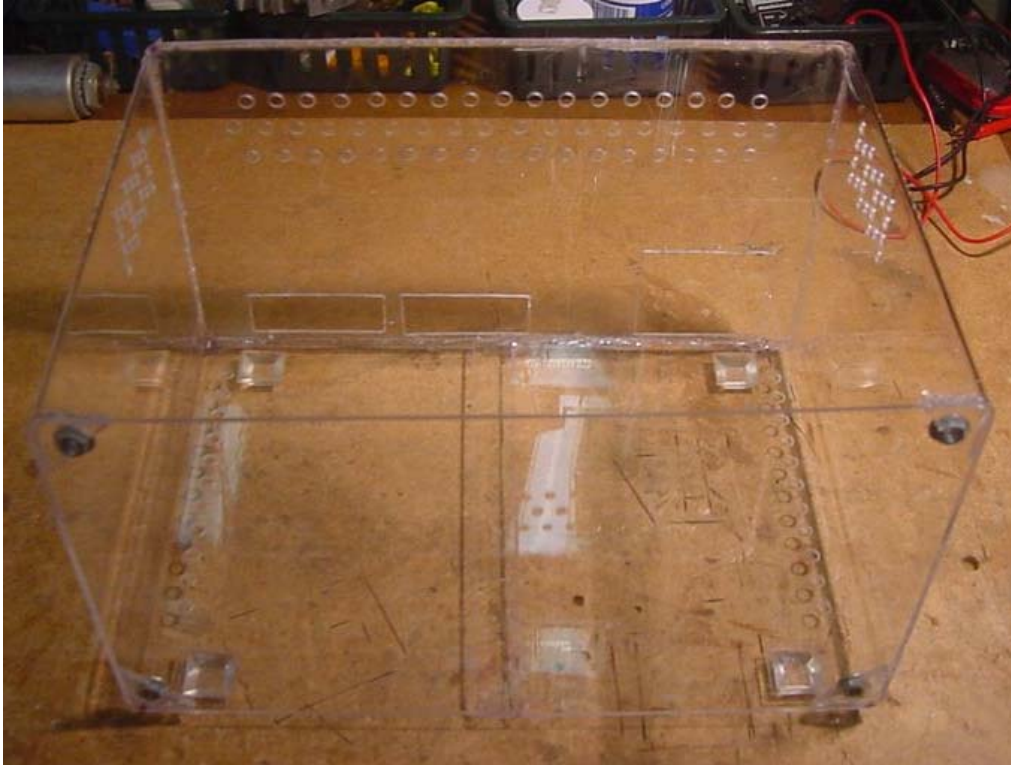
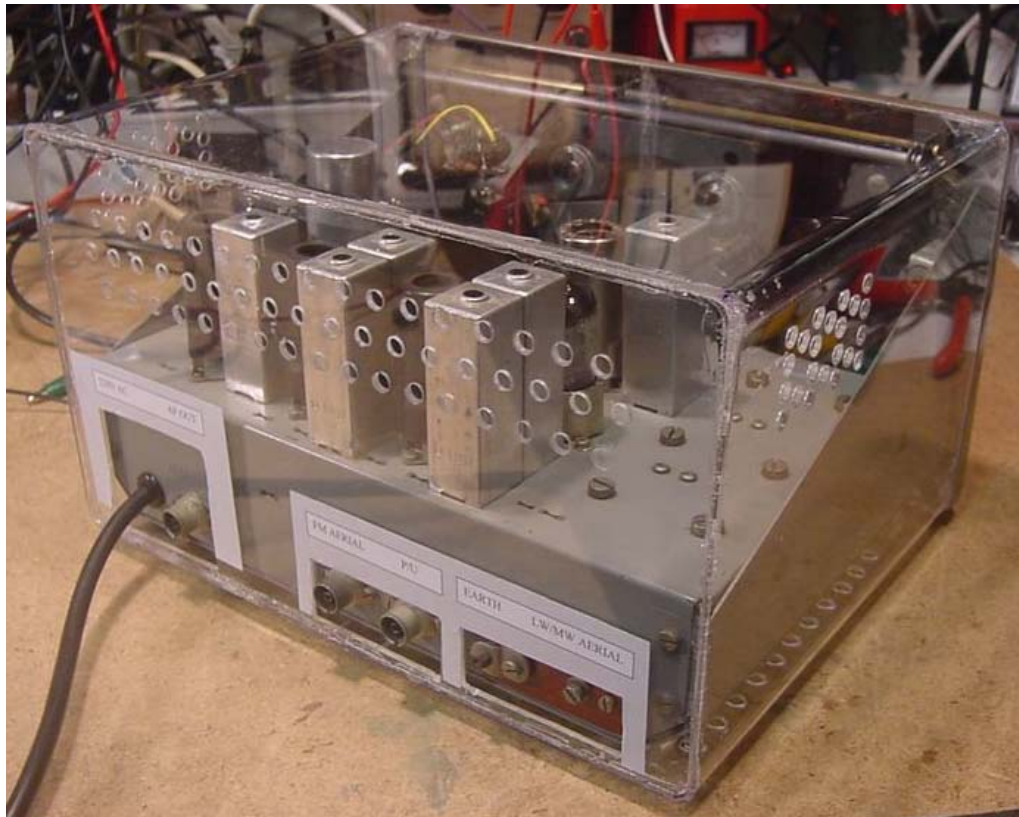
Above: The Perspex case under construction – plenty of ventilation holes and cut-outs for the rear panel sockets and power cable. Below: The finished case fitted to the S.820. I made some labels for the connectors as the chassis stampings are hard to read when looking over the top trying to make the connections

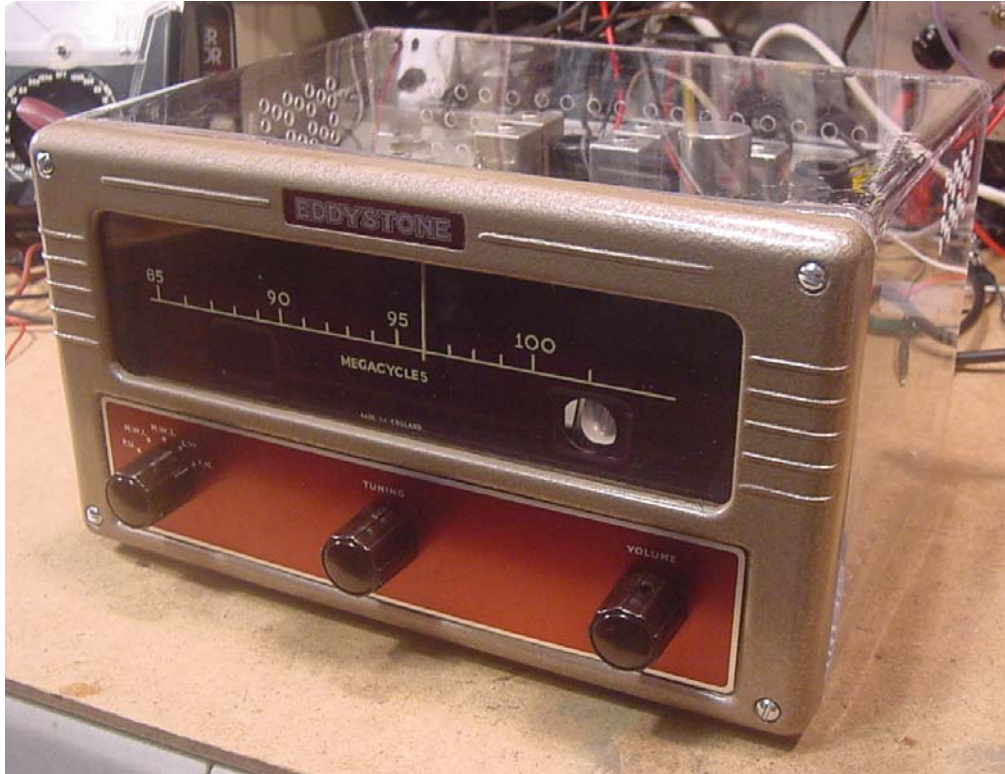
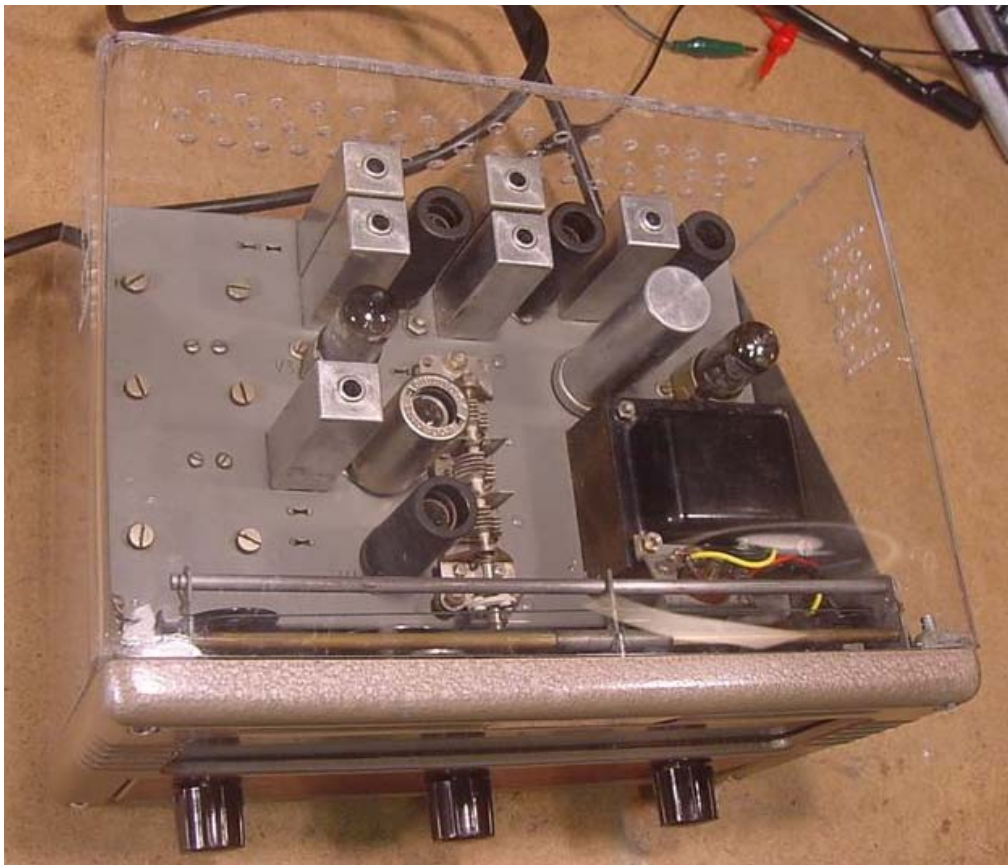
Above: A case at last – looking smart and ready for a move into my home office. Below: Top of chassis viewed through the newly-fitted Perspex case

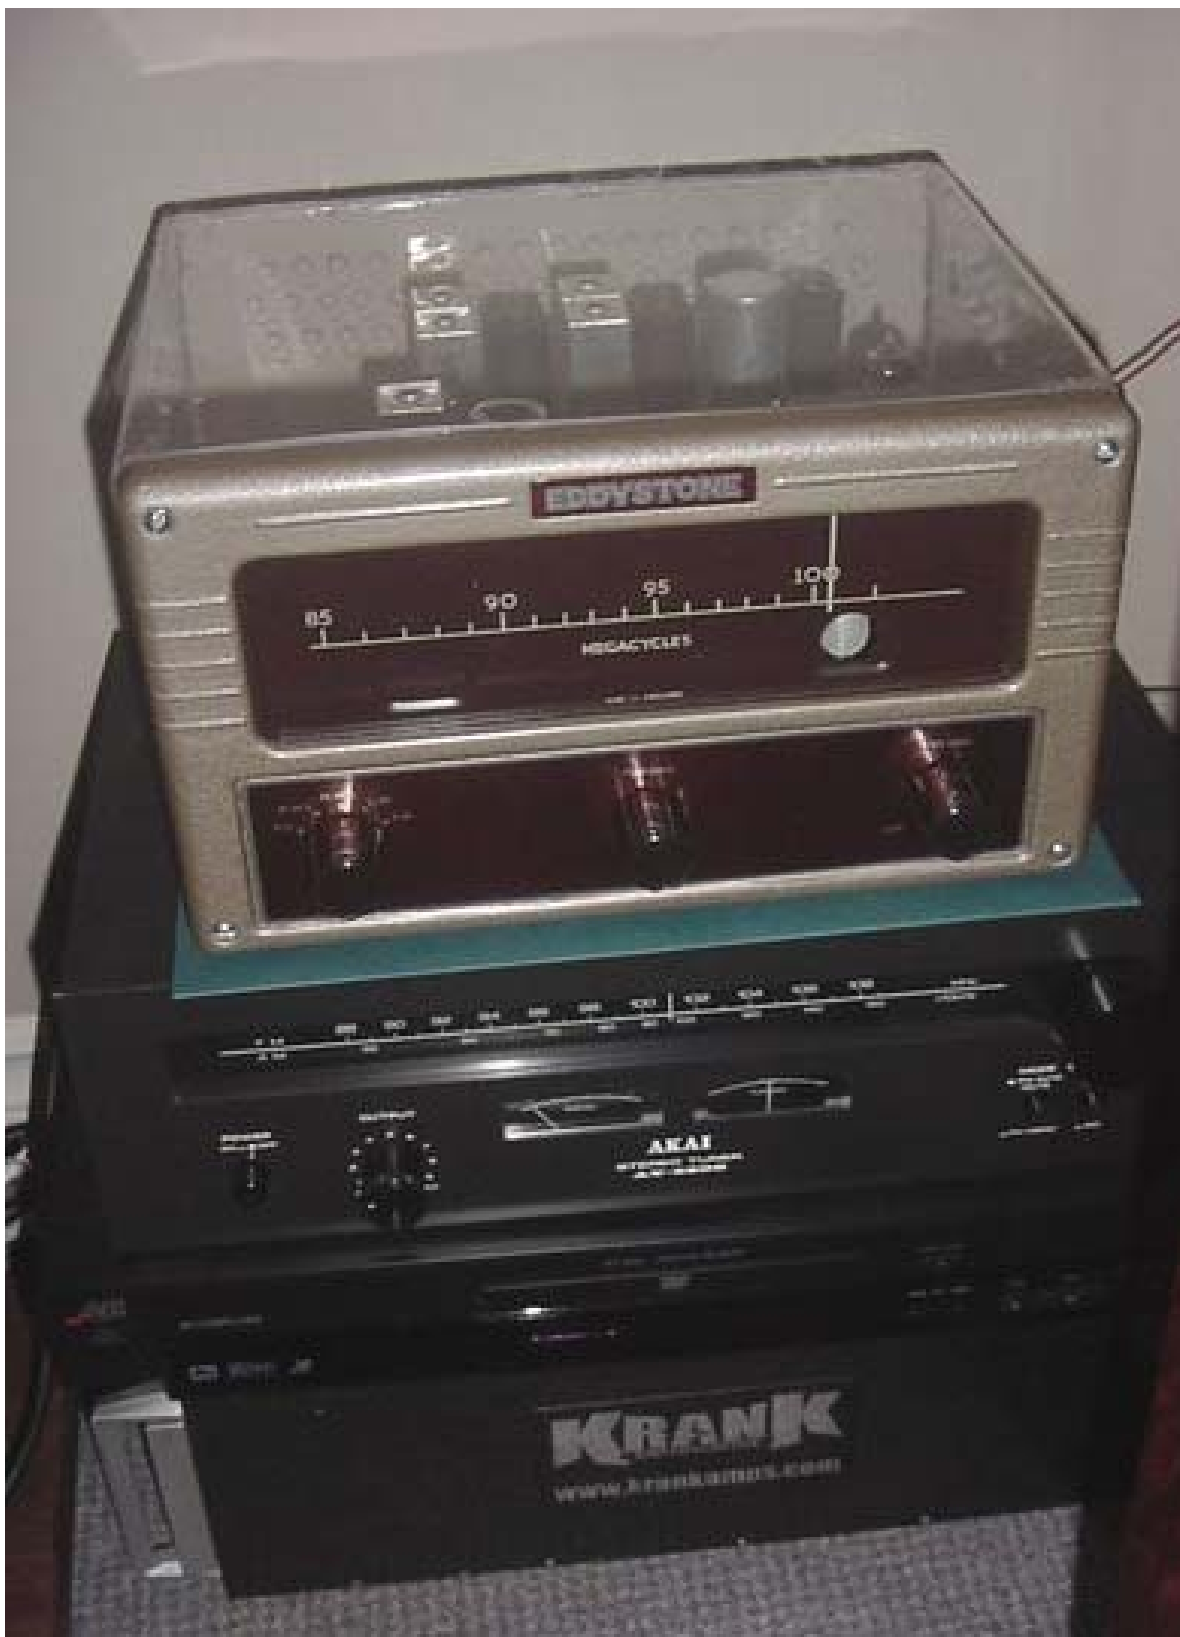
Above: Playing away quite merrily and running nice and cool too (the tuner only takes 40mA HT current, so the EZ41 runs cool, as does the power transformer)

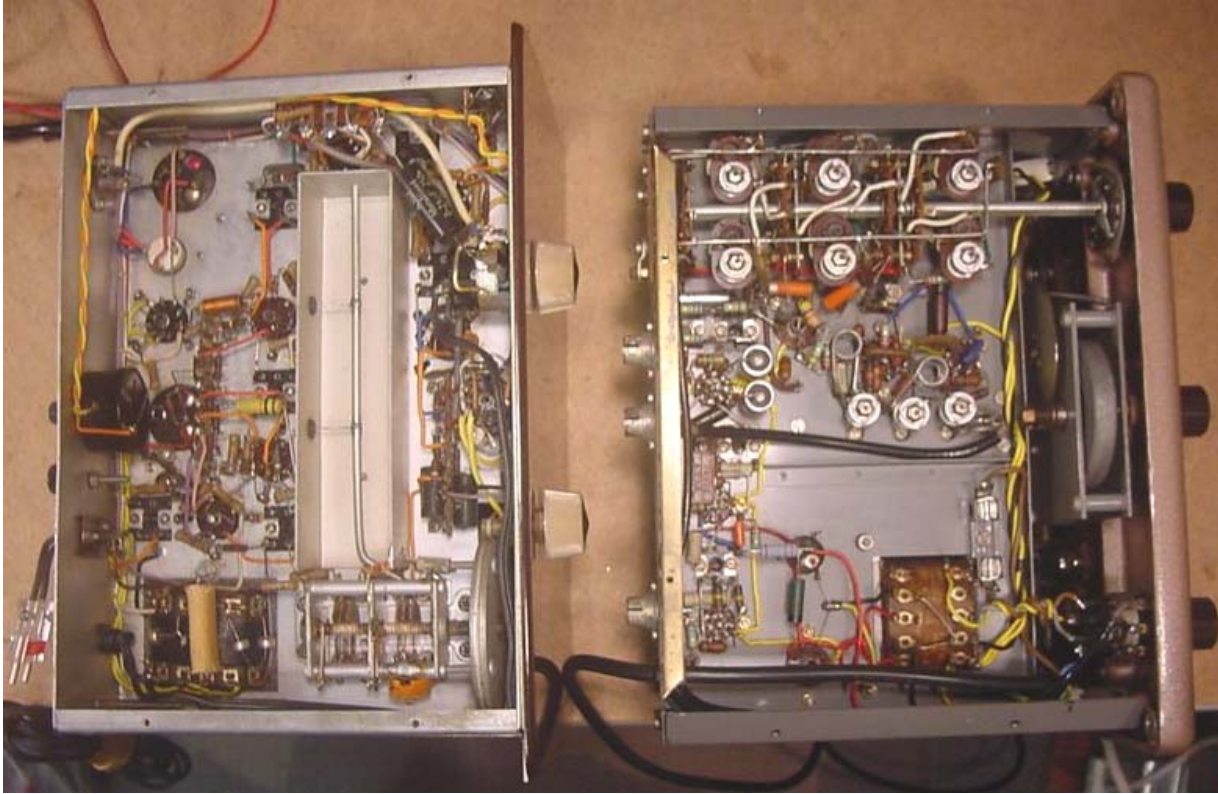
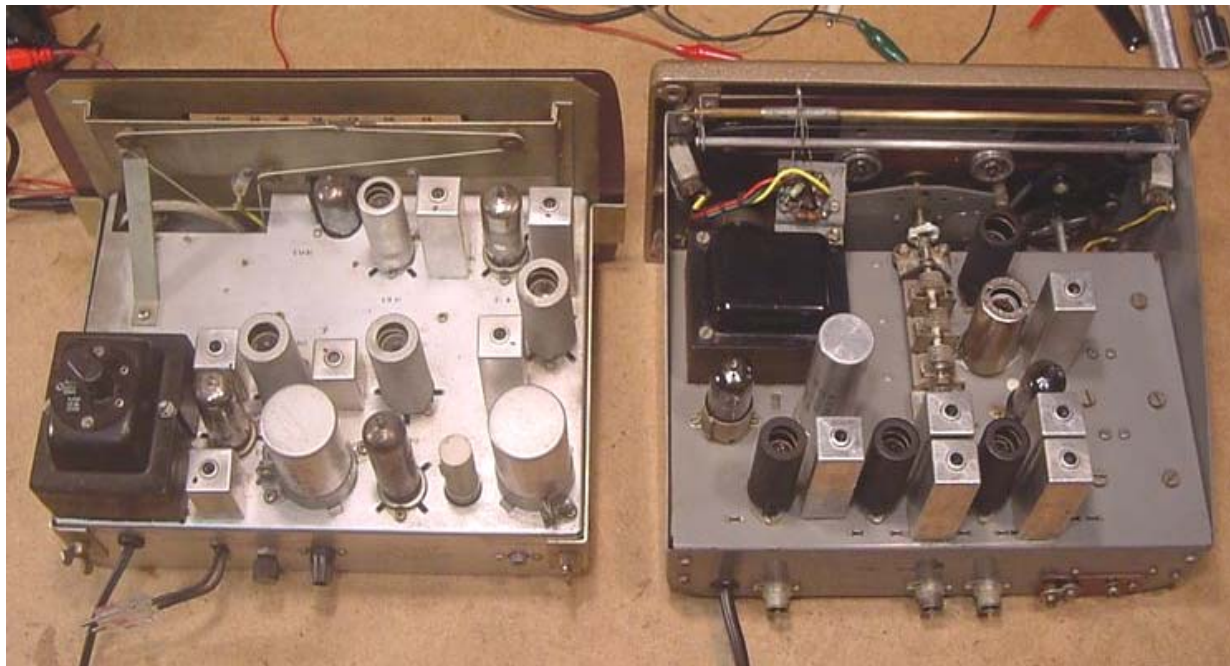
Above: The 'terrible twins' from below (Leak Trough-Line Mk I on the left, the S.820 on the right). Below: Same, but top of chassis views

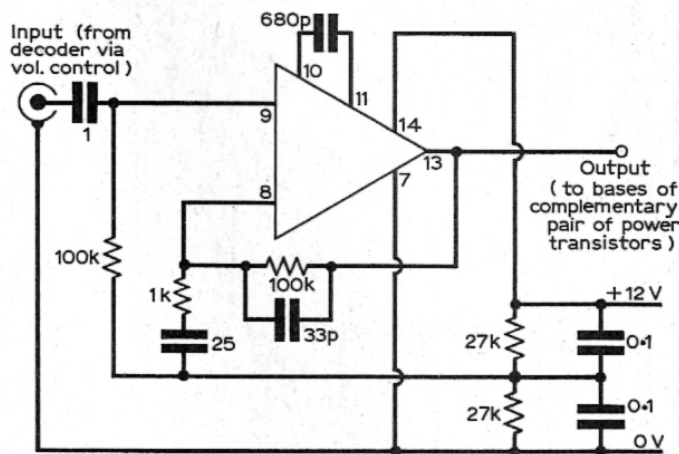
Typical circuit of one channel of a stereo preamplifier built around the MC1303.
