Infrared Applications for Post Construction Radiant Heating Systems

*Eric G. Amhaus, Professional Investigative Engineers
Edward L. Fronapfel, Professional Investigative Engineers*

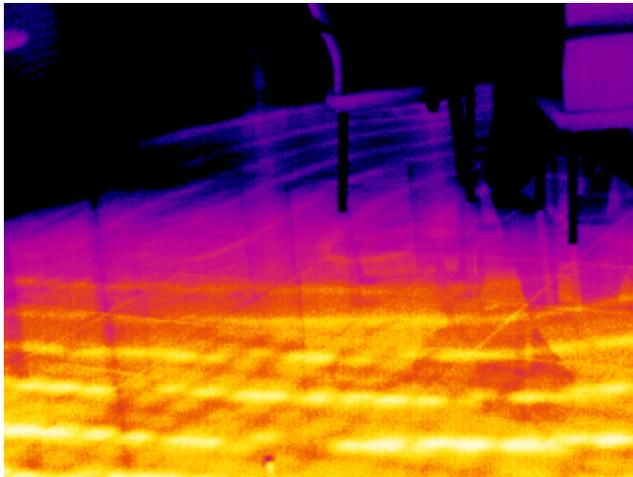
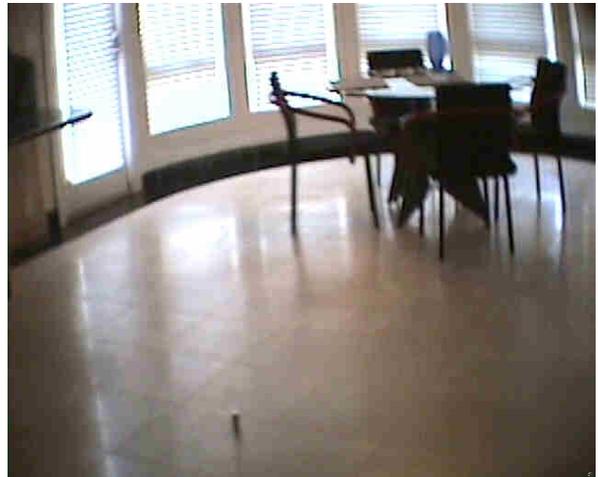
Figure 1. Crimp in radiant tubing at rim joist resulting in low flow of heated glycol/water mix under dining area shortly after initiating system.

With radiant heat systems, building owner complaints very often include reports of cold sections of the floor. One of the possible conditions that can create this condition is a crimp or blockage in the flow of fluid through the radiant line. For example, in Figure 1 the homeowner had reported the floor under the kitchen table never seemed to warm or heat to the temperature of the adjacent flooring. Note the heated radiant lines adjacent to the dining area. The dining area and adjacent living area (where the radiant system is shown warming) were wired on the same zone; however, the thermostat that controlled both of these areas was on the other side of the room. Therefore, when the other side of the room had warmed to the desired temperature, the system was shut down or regulated at the desired temperature. A crimp in the radiant tubing was discovered through intrusive examination at the rim joist within the basement, where the tubing came through the floor. This crimp restricted the flow of glycol/water mix in the radiant tubing in this location only, resulting in a section of floor that would not have time to heat up, due to the fact that the system would shut down once the thermostat had reached its desired level on the opposite side of the room. After a few hours of having the thermostat set at approximately 90°F, the radiant tubing in the dining area floor slowly began to heat (Figure 2). However, notice the differential in heat distribution or “bleed-out” between the radiant lines under the dining area and those immediately adjacent to it.

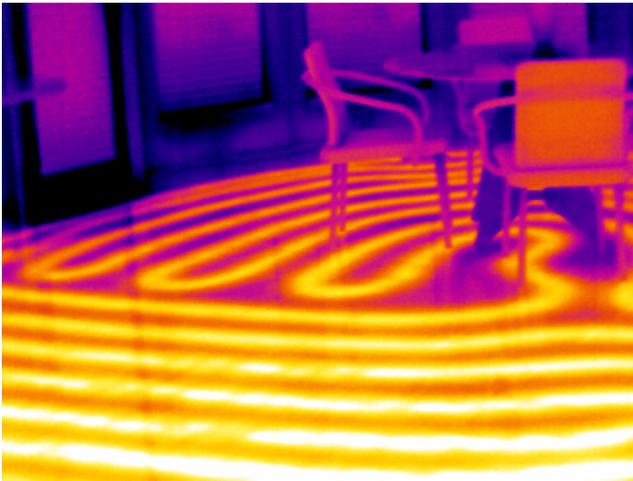
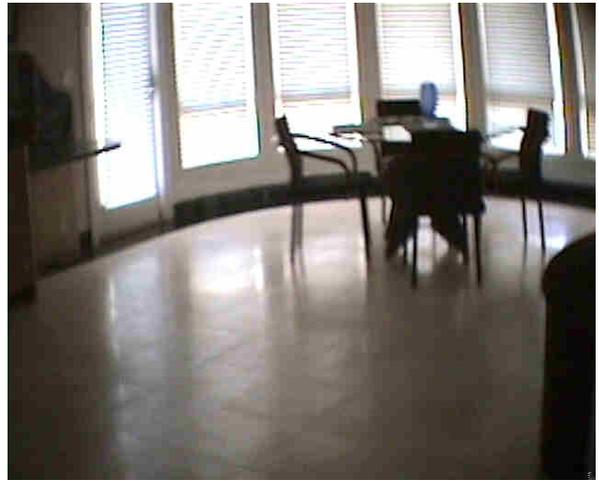
Figure 2. Dining area shown in Figure 1 begins to heat after several hours, however not to the rate of the adjacent floor section. Note that the infrared camera is also able to detect the radiant lines under marble flooring, as is the case with this image and Figure 1.

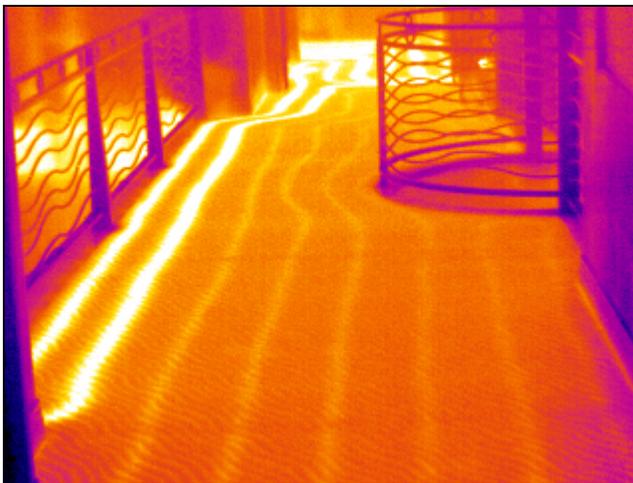
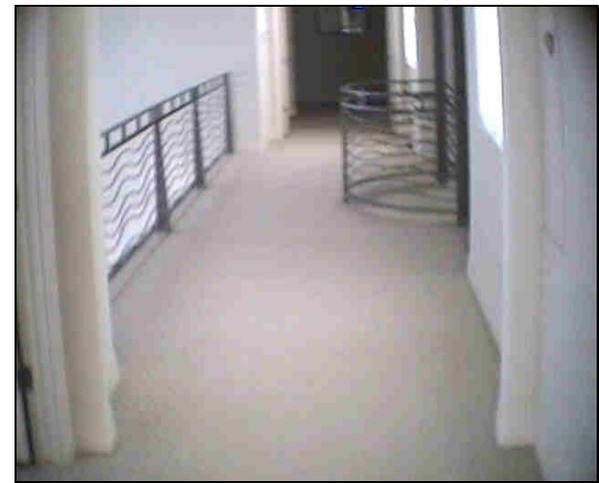
Figure 3. Two different zones and radiant tube positioning, with respect to those zones, are identified through the infrared camera under an elevated walkway.

Another common problem with heating elements (radiant or forced air) can be improper system zoning. In an average size home, there are probably 1 or maybe even 2 thermostats that control the temperatures for all of the interior living or occupancy space. However, in larger homes or buildings, it is not unrealistic to see as many as 3 or more zones that provide comfortable interior temperature control. The proper zoning of a heating element, such as in-floor radiant heat, must take into consideration such things as size of zones, positioning of zones inside the home, positioning or location of the thermostats for each individual zone, direction of the building or individual elevations in relation to solar loading, and windows or expansive glass sections, etc., to ensure that the system will maintain comfortable and uniform temperatures throughout. If these design and installation criteria are not addressed, certain areas of the interior may be cold, while others are warm or vice versa. By isolating zones during the testing, the infrared thermal imaging camera is able to determine exactly which sections of floor or radiant tubing is connected to which thermostat or zone (Figure 3).

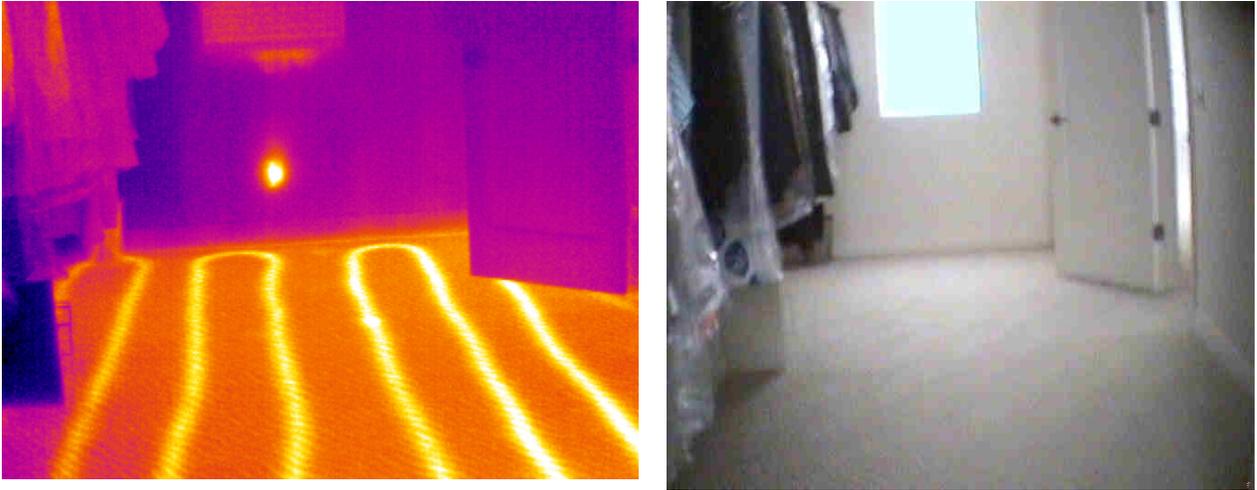
Figure 4. Radiant line spacing under carpet in closet was found to be below designer's specified installation criteria. Note infrared is successful in achieving data through the carpet flooring, as shown in this figure and in Figure 3.

technology allows for easy post-construction confirmation of the spacing of radiant heat tubing to confirm if it meets or falls below the requirements of the system manufacturer or designer (Figure 4).

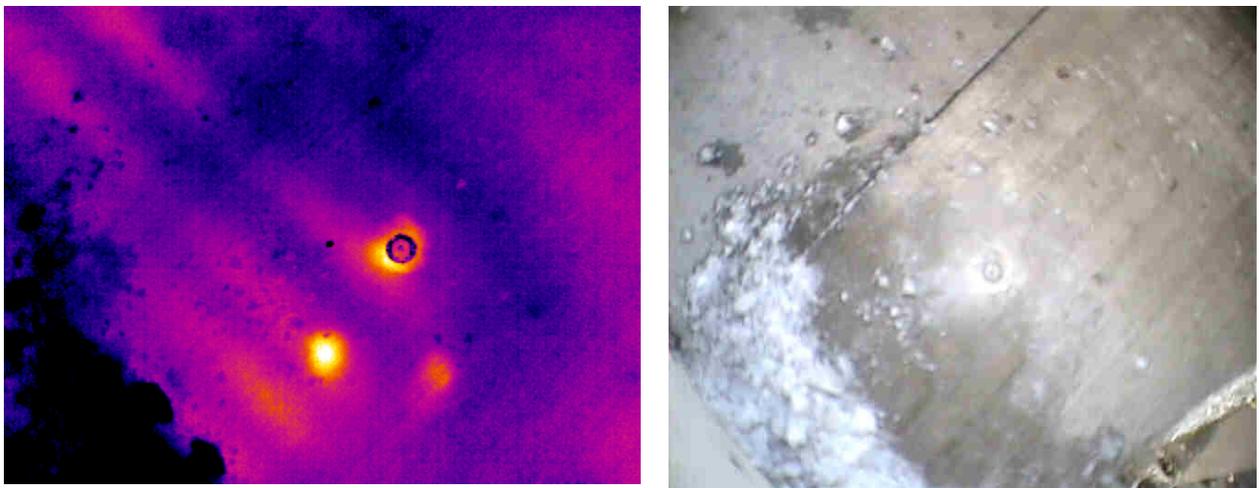
Figure 5. Concrete-covered radiant heat system sensor position identified.

Figure 5 illustrates the utilization of infrared thermography to locate a temperature/moisture control sensor that had been inadvertently buried beneath the surface of the concrete. The infrared thermal imaging camera was able to pinpoint the exact location of the sensor without guesswork or the cost associated with substantial concrete removal and replacement that would have been necessary, had infrared technology not been available.

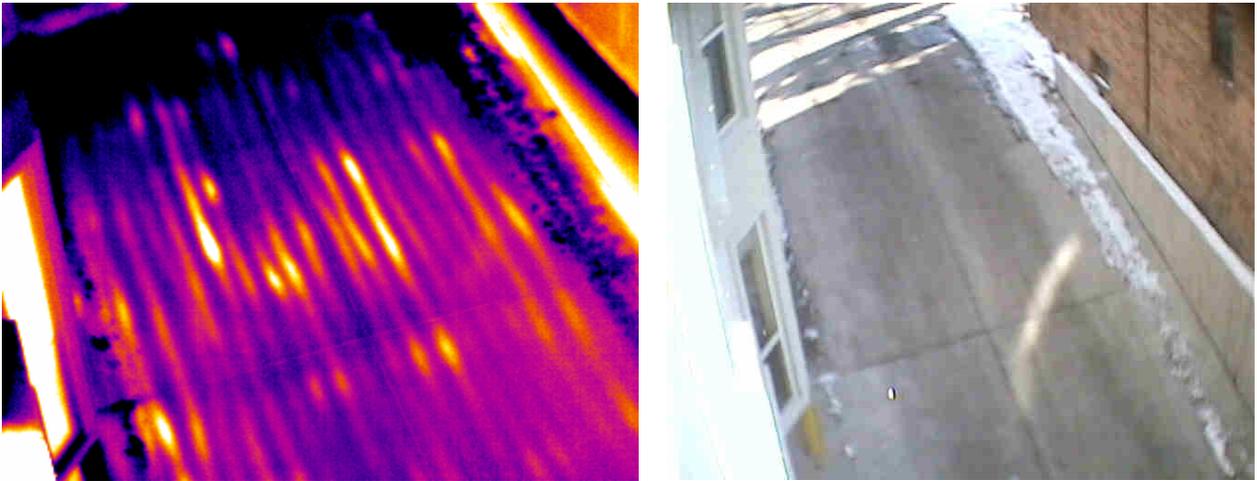
Figure 6. Note differential heating of lines indicating multiple variances in radiant heat line depth below the surface of the concrete.

Another design/installation characteristic of radiant heat systems within exterior concrete slabs is the proper positioning of the radiant tube lines in relation to the thickness of the concrete. If radiant lines are not well supported prior to the pouring of the concrete or are “sagging” between supports, then the thickness of concrete above the lines will vary and result in a non-uniform heat distribution to the wearing surface, as shown in Figure 6.

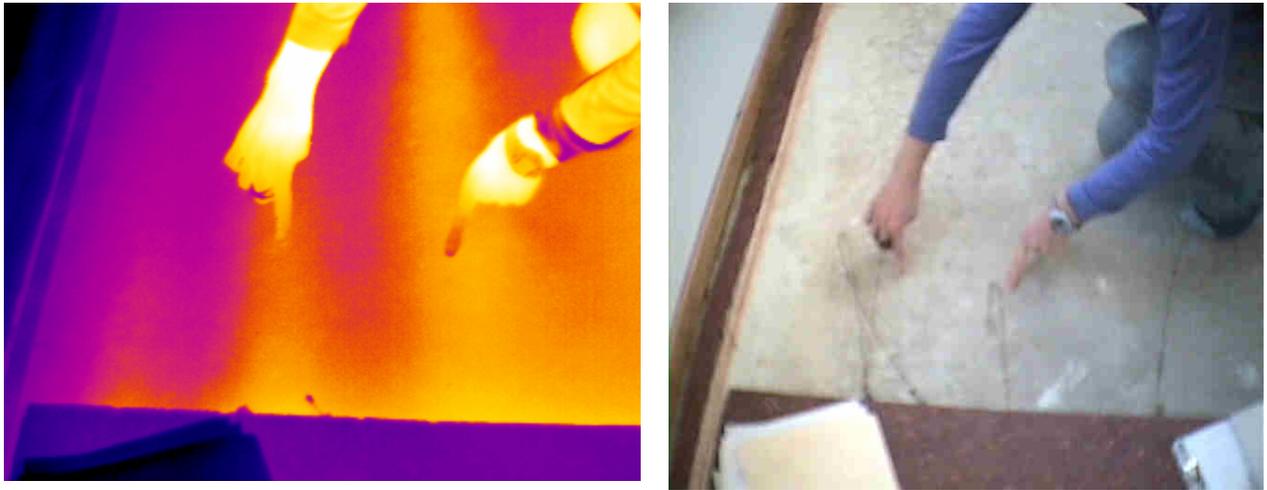
Figure 7. Radiant tubing locations identified in basement slab for purposes of slab coring and soil testing.

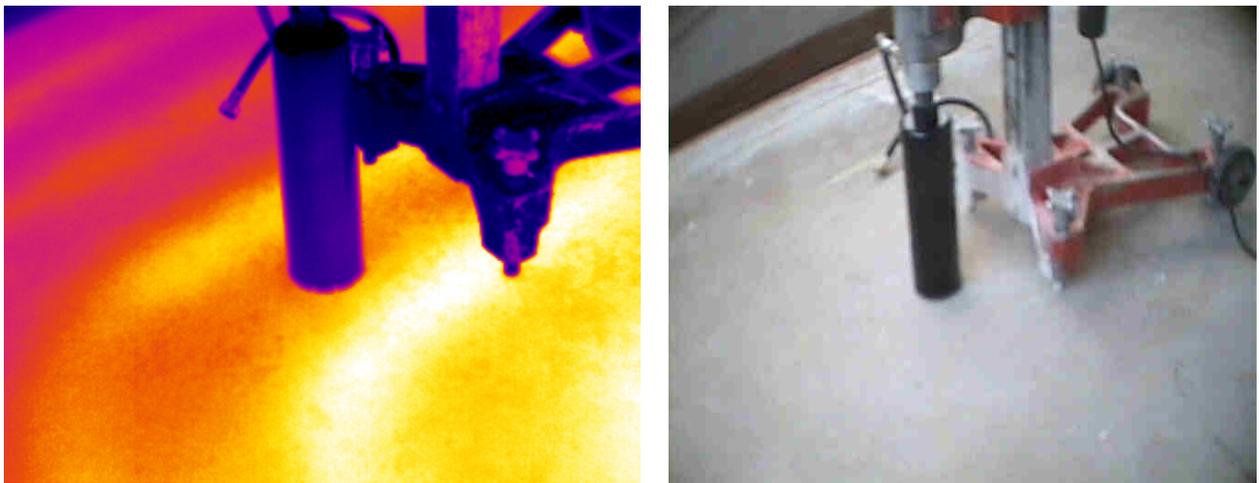
Figure 8. Concrete coring saw positioned between radiant heat lines to prevent damage to the system and subsequent leakage.

Once the lines have been identified and marked, the placement of the drill bit can be positioned in such a way that there should be no concern for damaging the system, as shown in Figure 8.
