81	66A	-01
S	Е	R	V	Ι	С	Е	Ν	0	Т	Е
						S	SUPERSEDES	S: NON	E	
816	6A Lig	htwave	Measu	remer	nt Syste	em				
Seri	al Numb	ers: DE3	39600101	/ DE39	9600322					
Rec	omme	nded M	IOV ren	noval	in 8166	A power	supply			
Dup	licate Se	ervice No	otes: 8166	6A-01						
To F	Be Perfor	rmed By	: Agilen	t-Qualif	ied Perso	nnel				
Part	s Requi	red: Non	e							
Situ	ation:									
acco haza prob	mpanied rd involv lem, Agi	by a loud ed. Beca lent/OCM	d noise, s use custo MD decid	moke an omers m ed to of	nd possib ight perco fer a full	le spray of eive such f modificati	wer supply can small particals failures as serior on on all related ithin 18 months	. There is us quality d product	no safety	
									Continue	ed
						C	DATE: Decer	nber 200	00

This document contains the procedure to remove the redundant metal oxide varistor (MOV) on the 8166A power supply. Assembling the instrument is the reverse of this procedure.

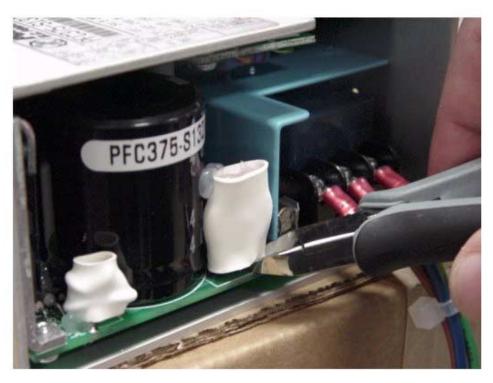
Figure 7. MOV shown while being removed by use of wire cutting pliers.

The MOV is a component located on the rear of the power supply right between a big black capacitor (with a label "PFC375-S132" on it) and the input power line cables. It's covered by a - mostly white - shrink tube. Use wire cutting pliers to cut it off. See figure 7 and figure 8.

The MOV shall be removed without replacement (component is redundant)
