66101A-08

S E R V I C E N O T E

66101A DC Power Supply

The instrument will not communicate or will not complete self test.

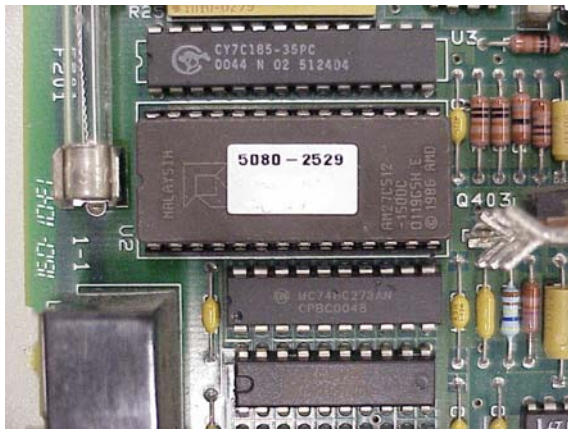
FIGURE 1 Tested PCA P/N 66101-61022 (Location of Circuit Reference “U2”)

The ROM “U2” should be removed from the socket. (See [Figure 1](#)). The socket and the ROM should be inspected for contamination or other defects. The ROM is a ceramic part and can be damaged or broken if too much force is applied when reinstalled. [Diagram “B”](#) shows the ROM “U2” inserted correctly.
