# 66102A-07

## S E R V I C E N O T E

### 66102A DC Power Supply

**The instrument will not communicate or will not complete self test.**

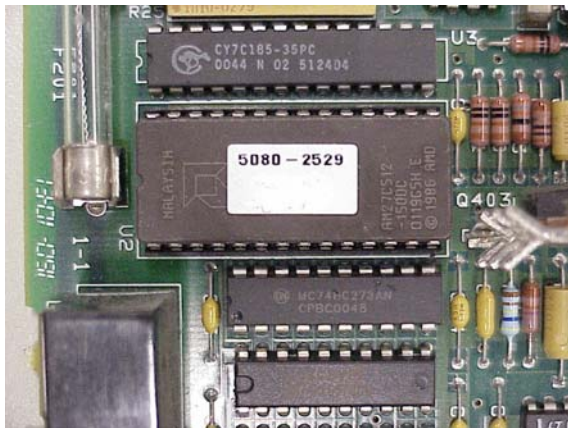
**FIGURE 1** Tested PCA P/N 66102-61022 (Location of Circuit Reference “U2”)

The ROM “U2” should be removed from the socket. (See [Figure 1](#)). The socket and the ROM should be inspected for contamination or other defects. The ROM is a ceramic part and can be damaged or broken if too much force is applied when reinstalled. [Diagram “B”](#) shows the ROM “U2” inserted correctly.
