# 66104A-08

## S E R V I C E N O T E

### 66104A DC Power Supply

**The instrument will not communicate or will not complete self test.**

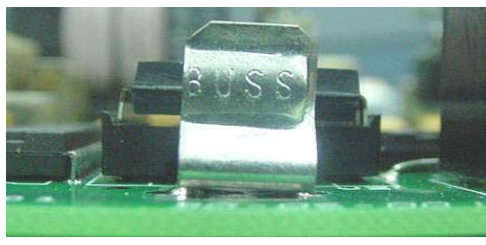
**Diagram A:** ROM not fully inserted

The Programmed ROM P/N 5080-2529 (Circuit Reference “U2”) See [Figure 1](#).below for the location of “U2”. When the ROM “U2” is not inserted correctly See [Diagram “A”](#) for details, the instrument may exhibit the following faults:

These faults could also occur if the ROM or the socket is intermittent due to dirty or contaminated pins.

1. The instrument will not turn on
2. All of the segments on the Front Panel display are not light.
3. The instrument will fail self test or will not boot-up.
4. The instrument will not communicate & can not be calibrated.

The ROM “U2” should be removed from the socket. (See [Figure 1](#)). The socket and the ROM should be inspected for contamination or other defects. The ROM is a ceramic part and can be damaged or broken if too much force is applied when reinstalled. [Diagram “B”](#) shows the ROM “U2” inserted correctly.
