66105A-09

S E R V I C E N O T E

66105A DC Power Supply

The instrument will not communicate or will not complete self test.

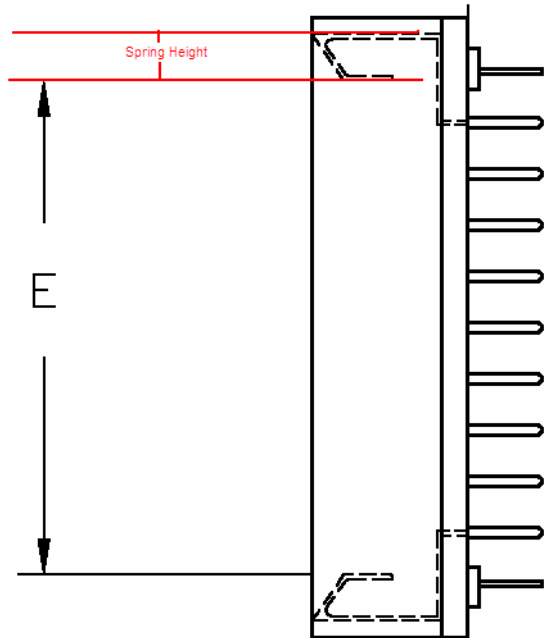
The condition of the recessed beams has been corrected by a design enhancement implemented in production. This design enhancement increased the spring height dimension by 0.04mm and decreased the spring height tolerance by 40%. The spring height dimension is shown in the drawing below.

This design enhancement is intended to position the contact beams closer to the middle of the socket and increase the normal force exerted on the contacts of the chips mated to the socket.

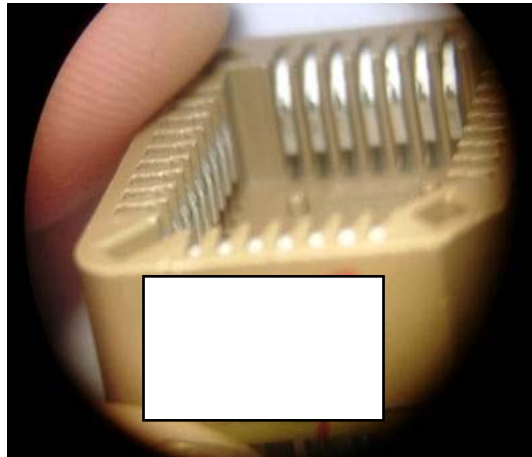
The effectiveness of this design enhancement was tested by comparing the mating and un-mating forces on the older and newer designs. The test results for sockets with the increased spring height (newer design) showed an increase in the mean mating force of 18.9% and an increase in the mean un-mating force of 23.4%. The increase in the un-mating force test results between the old design and the new design indicate that a greater normal force is being exerted on the test chip contacts by the socket contact beams. The two revisions of this contact beam design were visually examined after the mating and un-mating force testing. Photos of the two sockets are shown below. The photo on the left shows the older version socket prior to the enhanced contact beam design. The photo on the right shows a socket with the design enhancement. The contacts with the older design appear to be recessed farther into the housing after un-mating.

Material with this design enhancement will be labeled with a 2007 date code
