**66106A-07**

**S E R V I C E N O T E**

**66106A DC Power Supply**

**The instrument will not communicate or will not complete self test.**

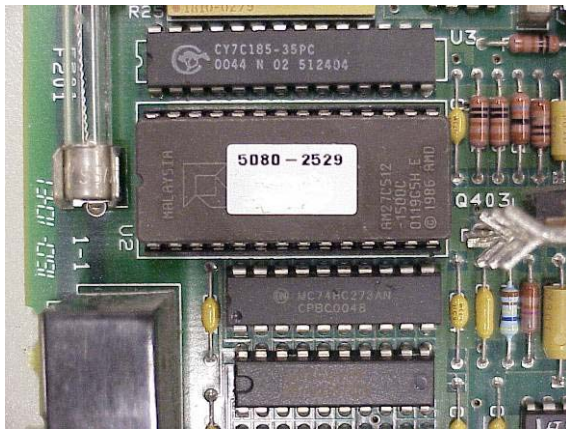
**FIGURE 1** Tested PCA P/N 66106-61022 (Location of Circuit Reference “U2”)

The Programmed ROM P/N 5080-2529 (Circuit Reference “U2”) See [Figure 1](#).below for the location of “U2”. When the ROM “U2” is not inserted correctly See [Diagram “A”](#) for details, the instrument may exhibit the following faults:

The ROM “U2” should be removed from the socket. (See [Figure 1](#)). The socket and the ROM should be inspected for contamination or other defects. The ROM is a ceramic part and can be damaged or broken if too much force is applied when reinstalled. [Diagram “B”](#) shows the ROM “U2” inserted correctly.
