HP 3456A digital voltmeter restoration

Repair work log and restoration project for Hewlett-Packard (later **Agilent Technologies**, now **Keysight Technologies**) Model 3456A 6½-decade system multimeter is covered in this article. Difficulty of this repair was in inability to run self-diagnostics and lack of reference working meter to trace issues. After repair there are some extra modifications described and tested, to gain performance improvement on this multimeter.

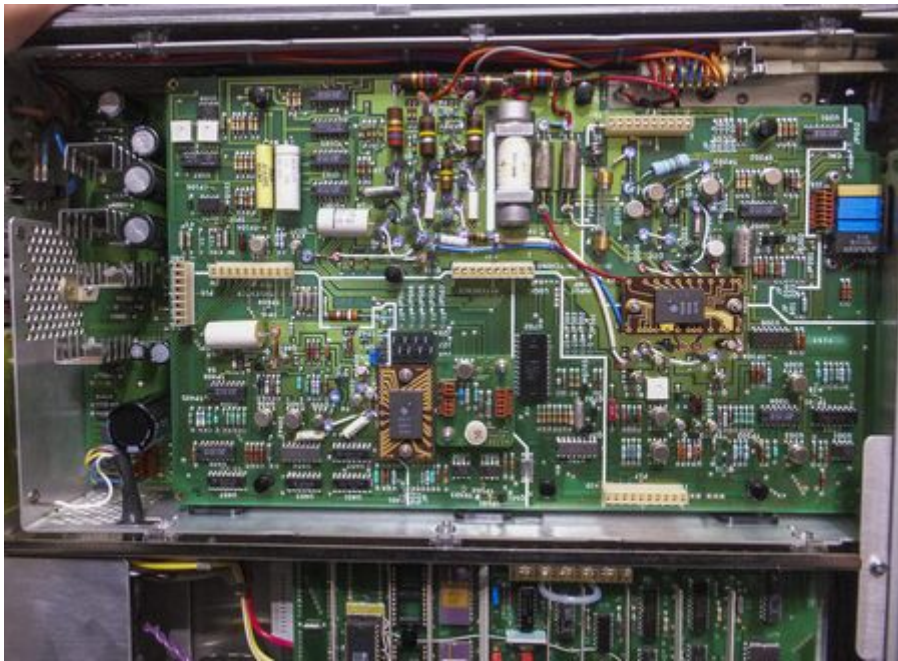
Depending on operation mode, input terminals are connected either to resistance measurement circuitry, or DC voltage attenuation/protection circuits or **RMS** AC voltage converter, which is located on module A40. Later have own divider and amplifier and have separate measurement path for ADC. DC voltage circuitry also handles direct measurement or ratio measurement switching, amplification of low voltage ranges, such as 1 VDC and 0,1 VDC to 10 and 100 times accordingly, as well as using 100:1 divider for high-voltage measurements on 100 VDC and 1000 VDC ranges. There is also optional filtering circuits, which can be disabled. Resulting voltage, properly scaled for 10V range is later fed to integrating Multislope A/D convertor for further conversion of analog signal into digital code. Reference voltage around 6.9VDC for A/D convertor is generated by dedicated module with ovenized buried zener reference LM399.

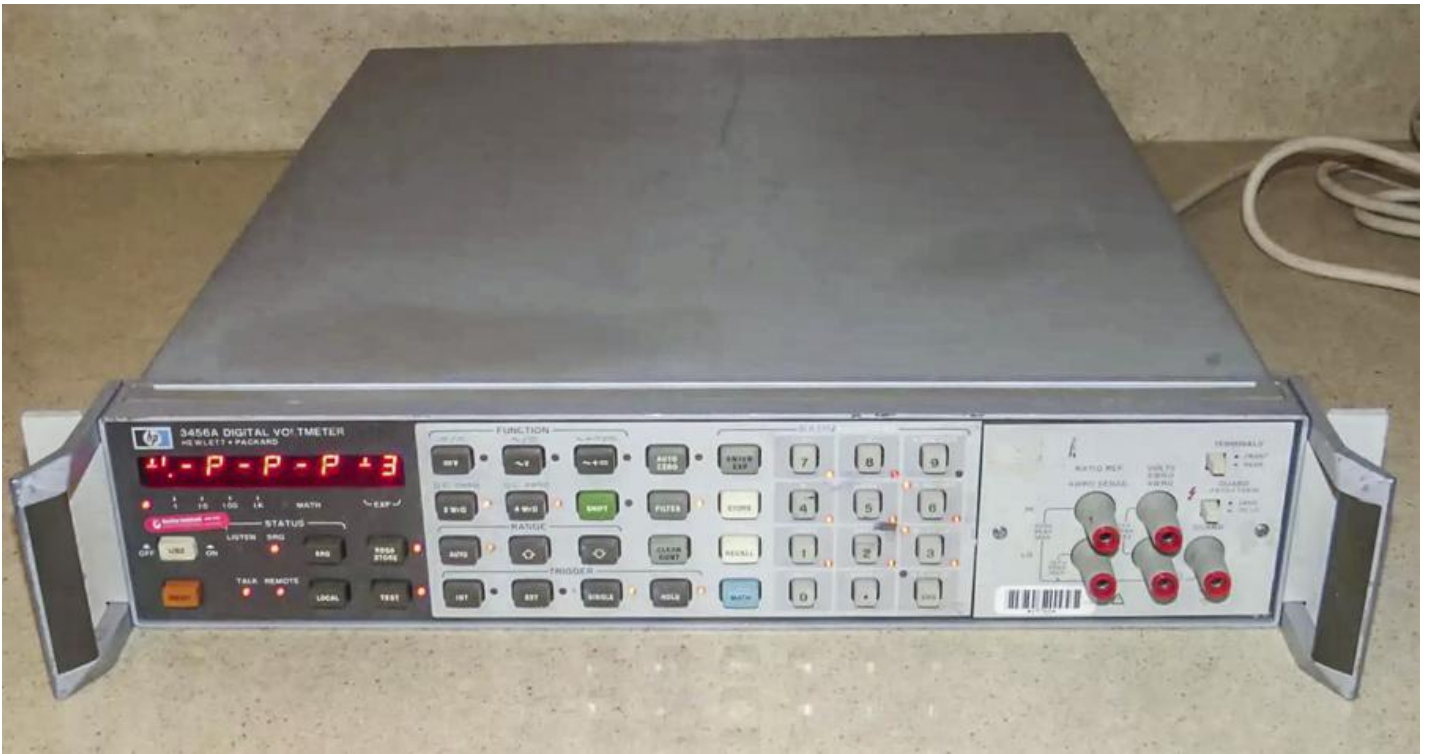
Just as honest description from seller, unit was missing one of outer covers and inguard internal shielding covers, and showing garbage on display and front panel LEDs:

After arrival unit was switched for proper mains voltage (220VAC here), prior to connecting power. First attempt to boot meter revealed random front panel operation, without any system or pattern. Most of keypresses do not change any behavior, and some cause random indication changes.

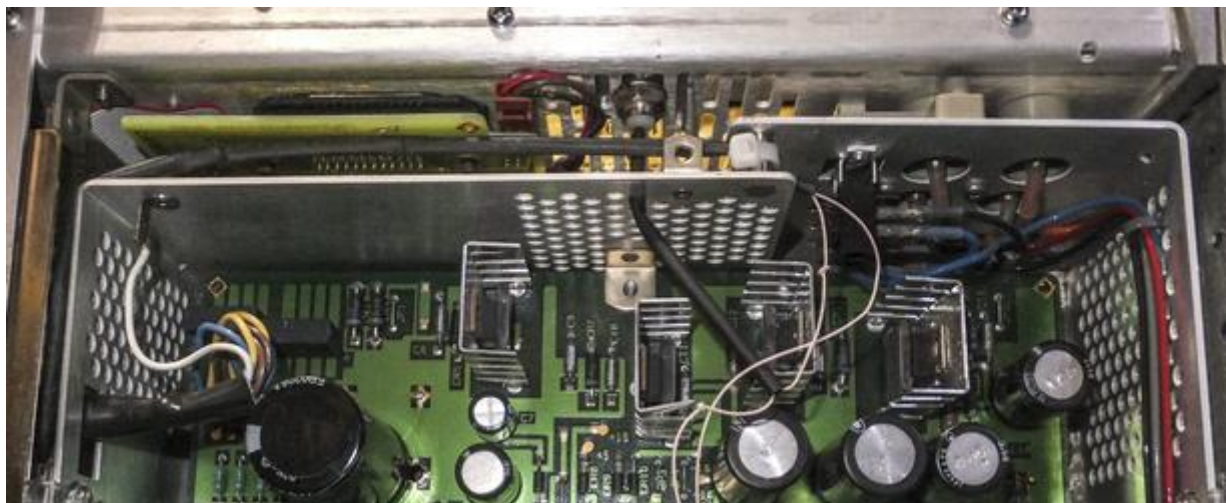
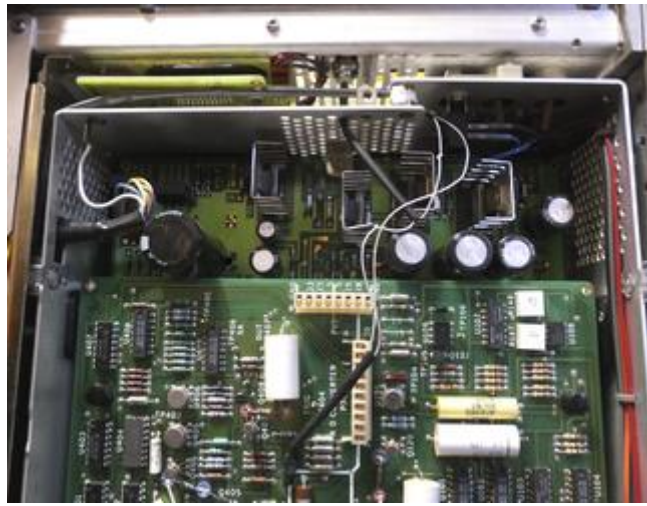
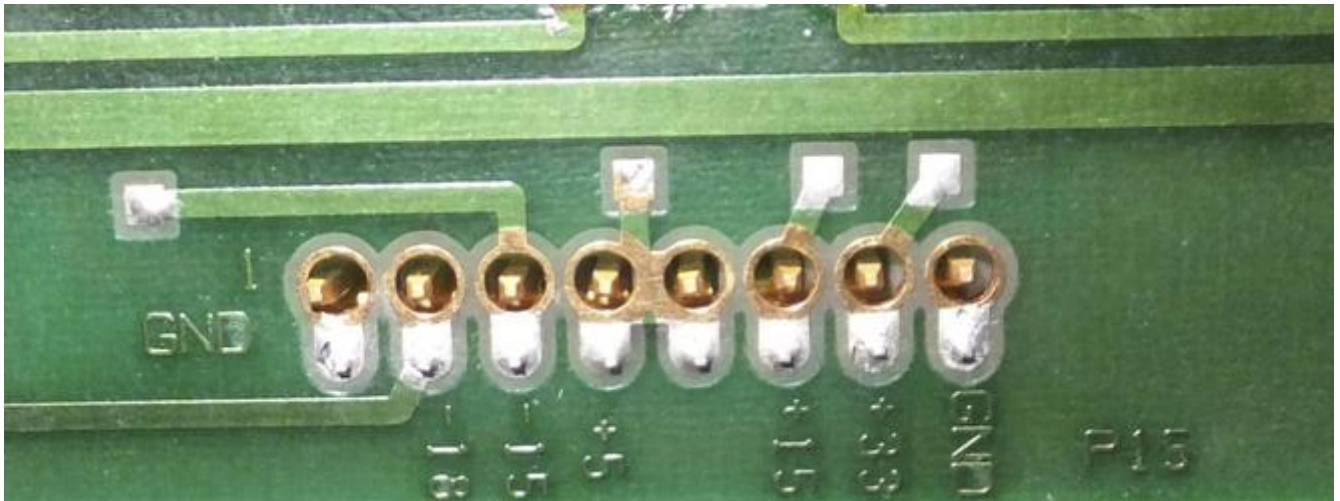
Power supply test revealed serious reduction of +33V rail output. Root cause of this was dried out old electrolytic capacitor C7, but all other electrolytic capacitors with capacity over 1 μ F were replaced as well. Usually not bad idea to install higher capacitance and voltage ones, if area and size permits.

- C13 and C15 – 2200 μF 50...63 V instead of original 1000 μF ;
- C16 and C19 – each 1000 μF 50 V instead of 330 μF and 470 μF ;
- C5 – 4700 μF 63 VDC instead of 4000 μF ;
- C7 – non-polar type 100 μF 50 VDC instead of polar 47 μF ;
- C8 – 220 μF 63 VDC instead of 100 μF .

After this simple operation all power voltages become normal, but this did not solve issues with our HP 3456A. There is more to fix.

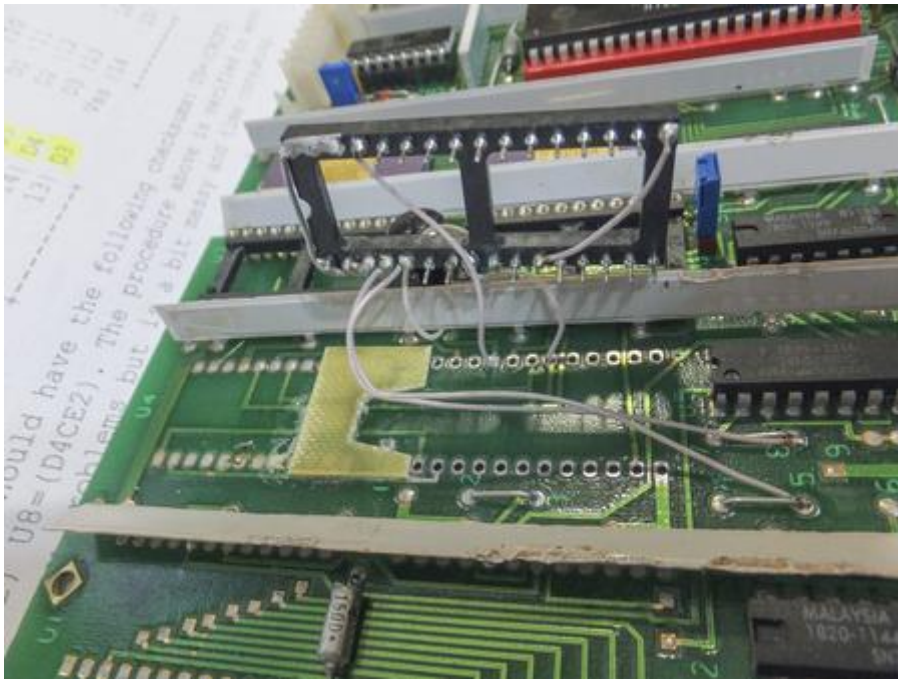
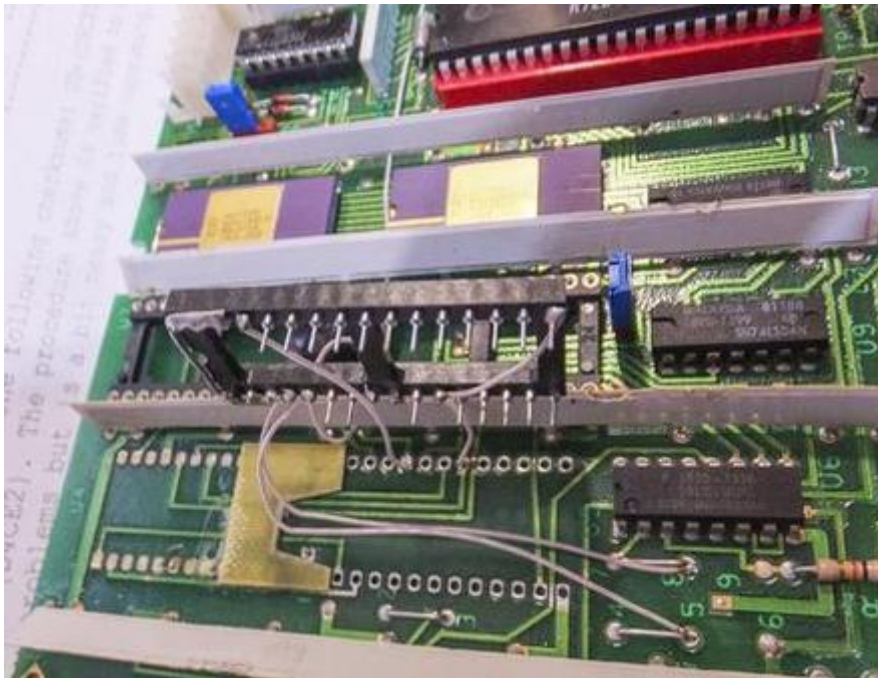
Since new ROM has 32 pins, instead of 24 on original circuitry, direct replacement would not work. So IC socket was installed, but due to larger size and to avoid possible short-circuits I made an insulator from thin PCB layer, glued to nearest ROM footprint.

Also due to different pinout definition, some pins from socket were isolated from board, so we can solder wire and reroute signals to proper locations. Isolated pins are: **1, 2, 3, 4, 22, 24, 25, 28, 29, 30, 31, 32.**

IC socket was soldered on PCB in a way, so pin 16 fits pin 12 of original ROM, so we get data bus and some address signals match original layout.

- Pins 1, 2, 3, 30, 31, 32 were powered from digital +5 VDC;
- Pin 22 grounded (just a short to pin 16 on socket);
- Pin 25 routed to pin 18 of original ROM location;
- Pin 4 routed to signal A12 from original ROM's pin 21;
- Pin 28 routed A13 from jumper pin 4-5(JMPRB);
- Pin 29 routed A14 from jumper pin 7-8(JMPRC);
- Pin 24 routed to chip select CS from U23 pin 6 (A4).

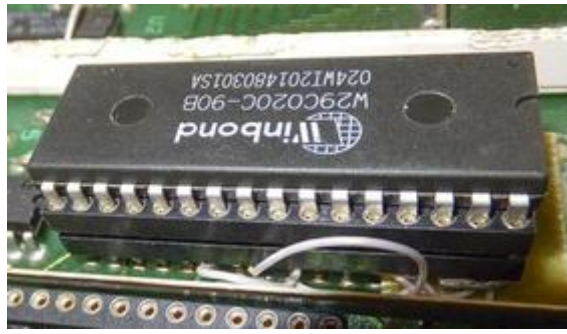
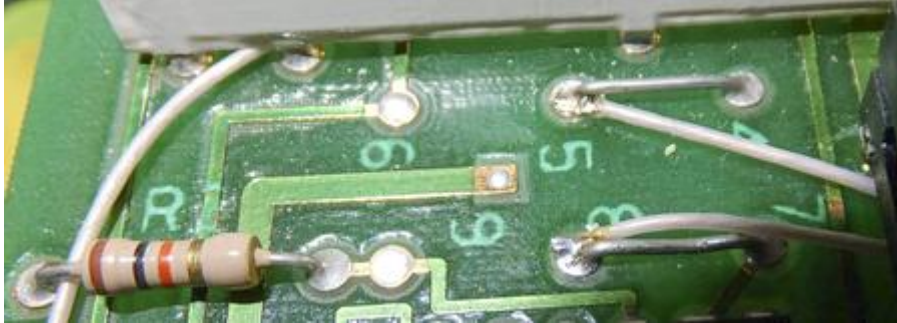
Rest of isolated pins were connected in next fashion (marked blue in A4 schematics):

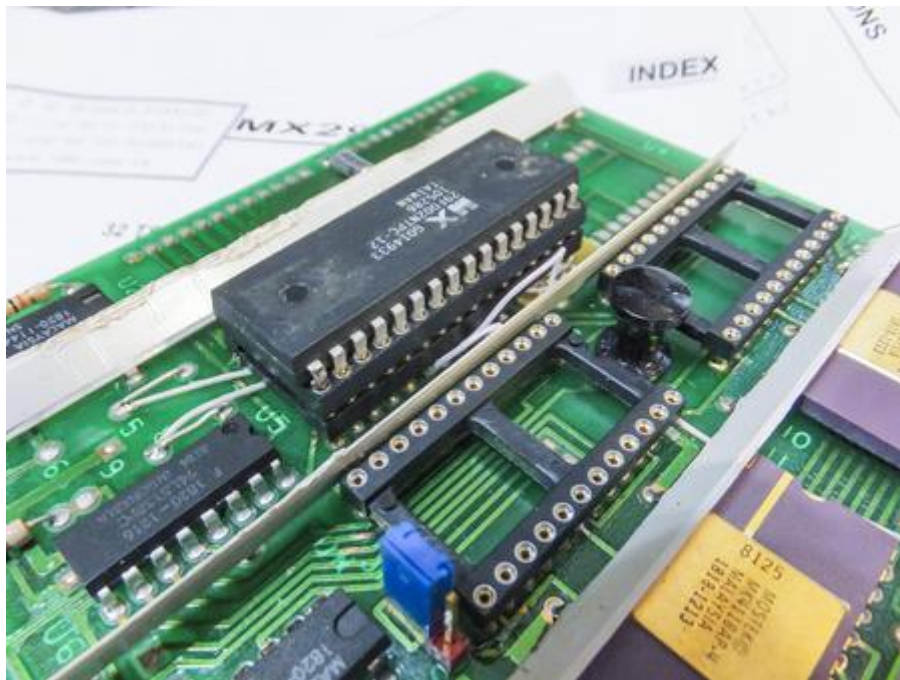
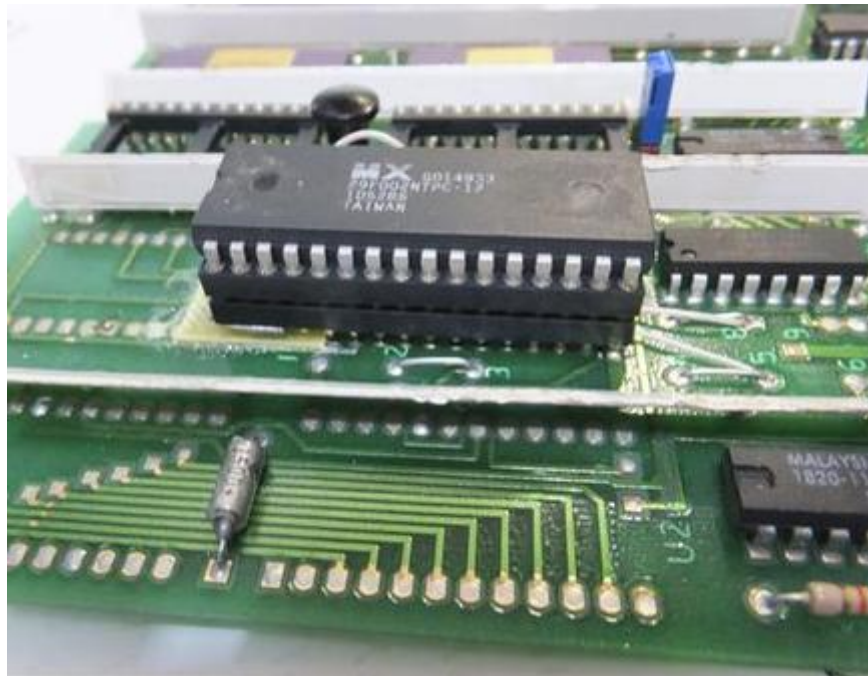
You can also spot second IC socket on photo. This is due simple reason, as my MX29F002 had missing data pin, so had to fix with extra bit. To avoid damage of socket mounted on PCB, this intermediate socket was used to hold fixed ROM chip.

This firmware dump can be flashed once to ROM area 0x38000h – 0x3FFFFh, or can be simply written 8 times, so with any upper address combination, which are actually not used in meter's normal operation, we still can get firmware. Somewhat a backup feature for future-proof operation.

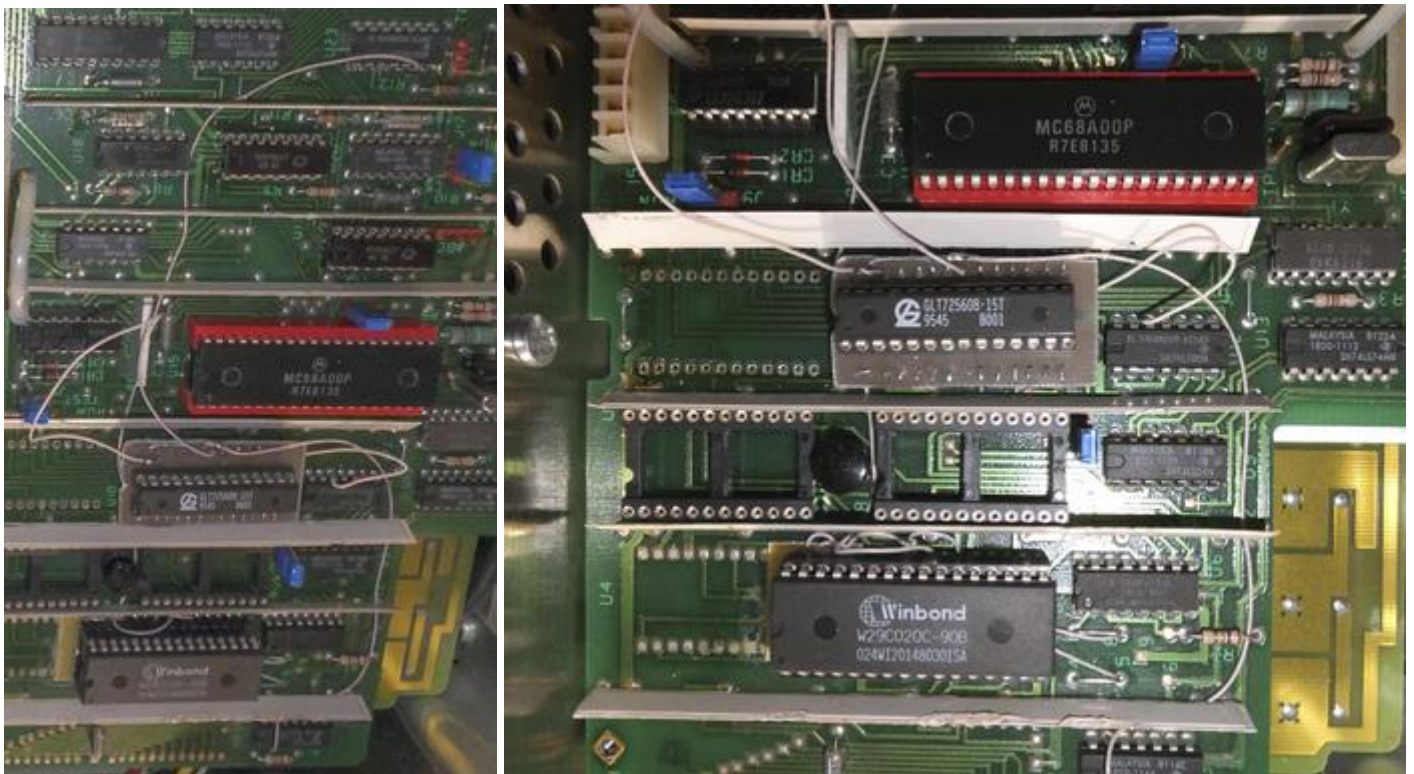
I did not have anything similar to 6116 series RAM, and only suitable RAM was **GLT725608**, which was used as cache-SRAM used on ancient i486 motherboard. It had narrow package, so 28-pin socket (fixed up from two 14-pin IC sockets) was installed into intermediate adapter.

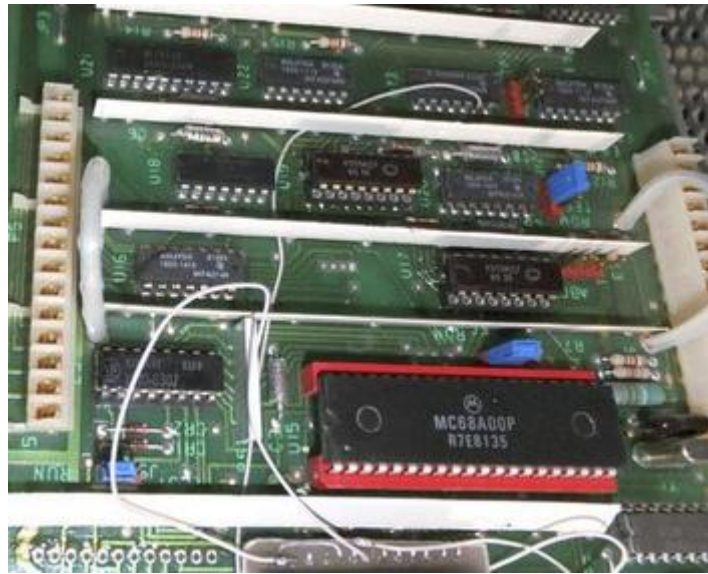
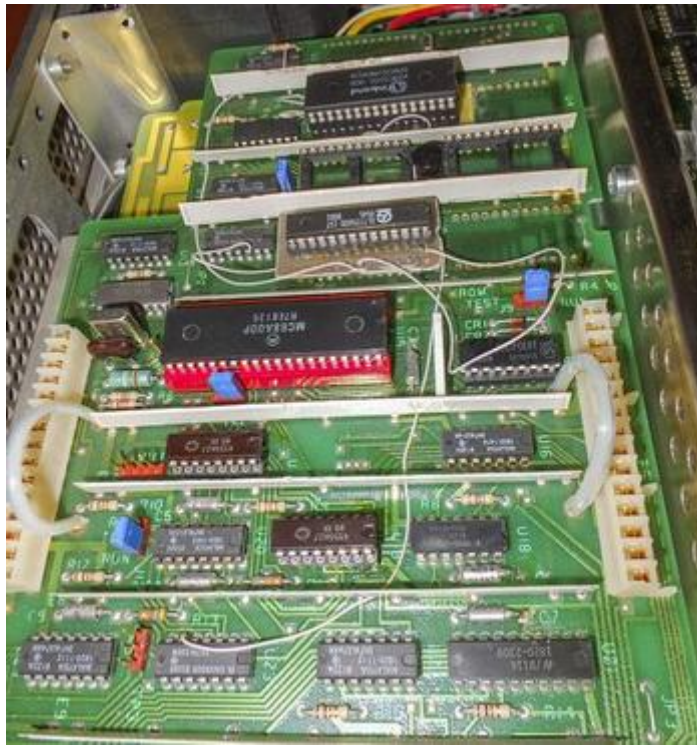
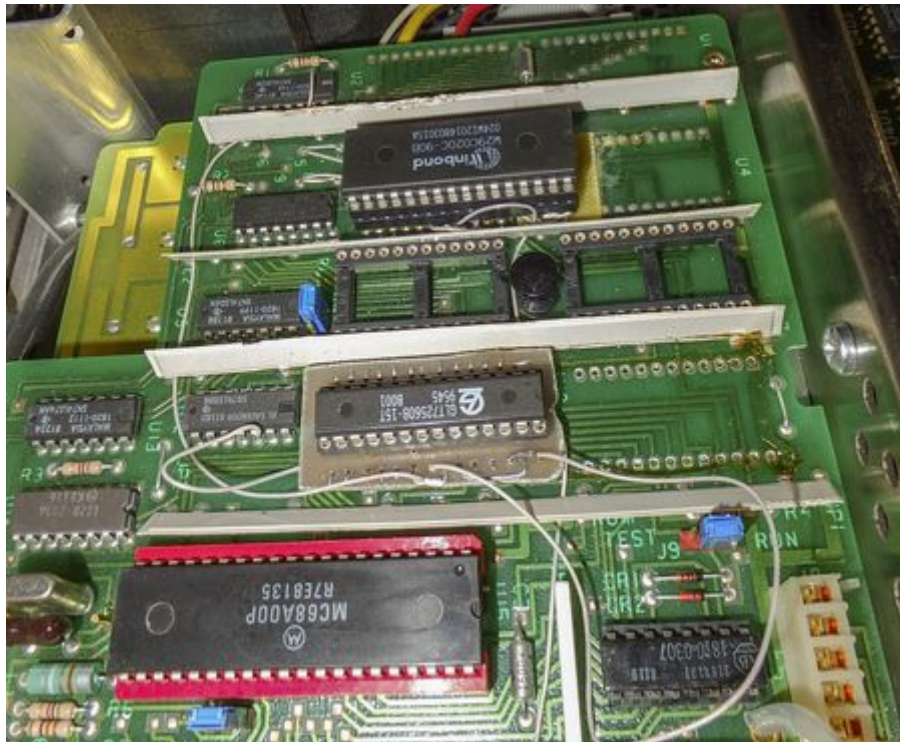
Everything else is similar to ROM repair workflow – careful removing old RAM chips from A4 PCB, soldering some socket pins with copper studs into PCB, so pin 14 of socket match PCB's pin 12. Ground to ground, data bus signals to data bus.

Isolated pins on adapter socket: 1, 2, 21, 23, 26, 27, 28.

Pins 1, 2, 23, 26, 28 connect to digital power +5 VDC;

Pin 21 – wired to address signal A10 taken from U12 pin 12. In original schematics, signal A10 is used to switch which RAM chip is being accessed, and for reliable operation delay line, consisting of logic in elements U12d, U12c, U9f, U9e was used. Our RAM chip have more density, so we don't have to use this workaround, and just enough to use direct connection to address line A10;

Pin 27 wired to old pad for pin 21 (write enable signal WE).

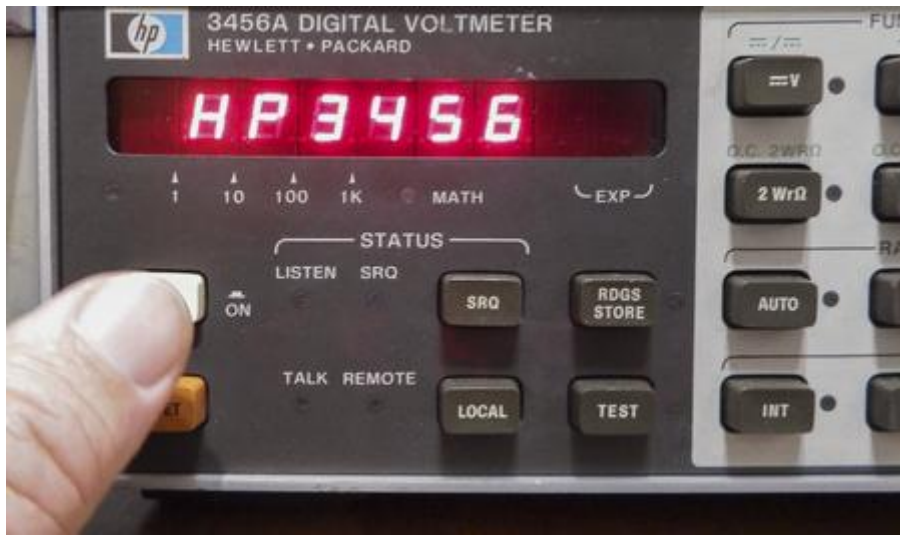
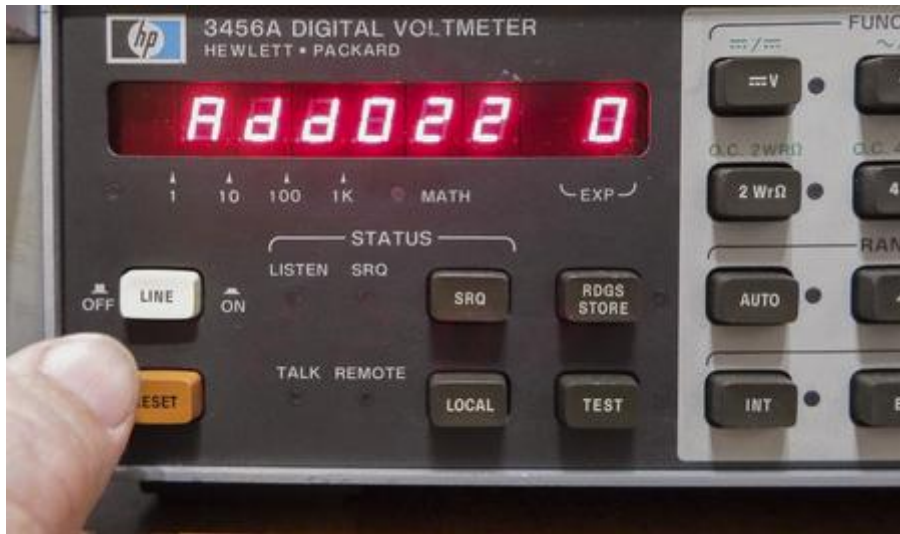
Now, after RAM replacement, instrument finally came back to life. Self-test discovered inguard-controller failure. In my case processor i8048 was installed in socket. Chip temperature was OK, so I just removed chip and installed back in. Immediately instrument went to normal operation and show few counts on display. So I went ahead and replaced old socket with modern high-quality collet-type socket. HP in [3456A-13A Service note](#) recommends to solder chip down to PCB.

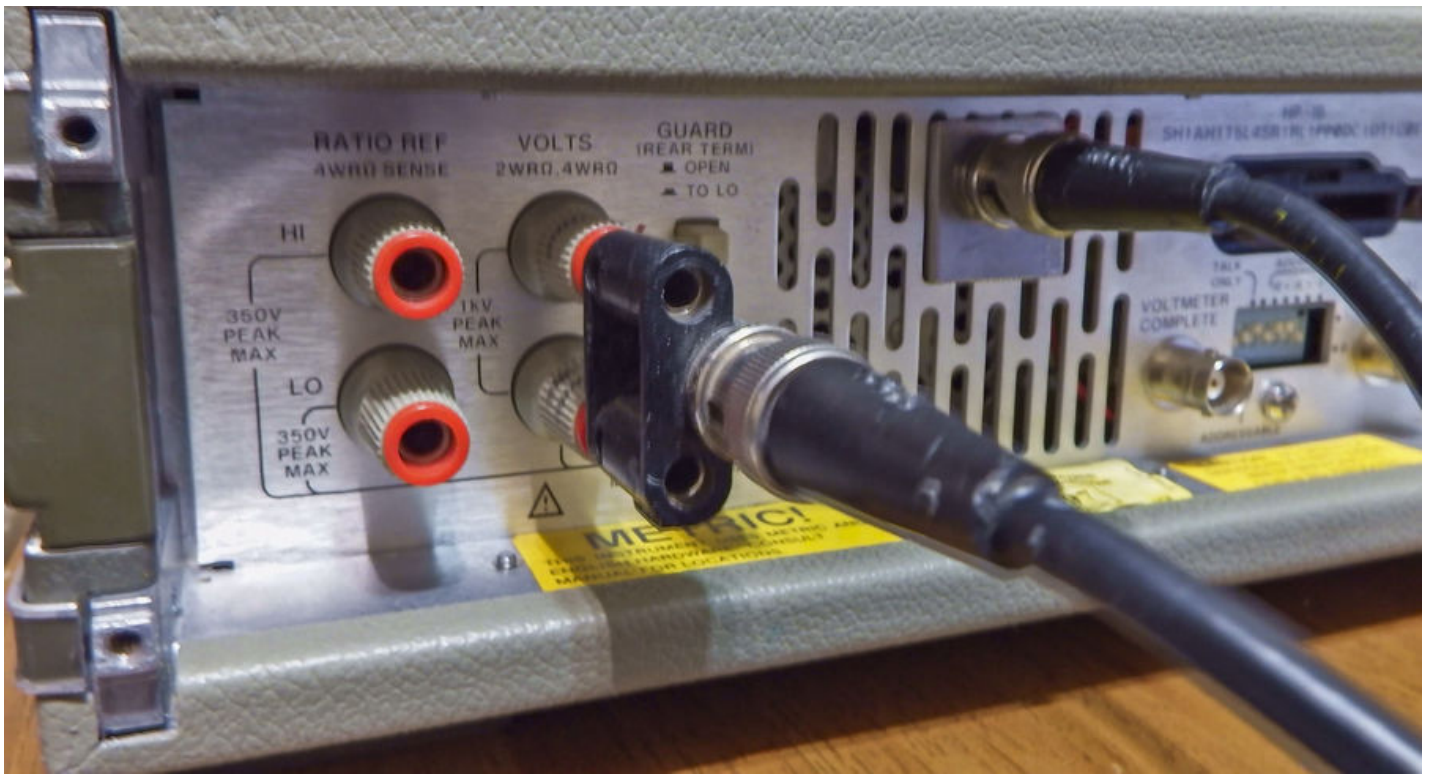
Thermal sensor output can be connected externally to rear multimeter terminals.

Temperature measurement can be performed on both inside meter (left photo) and outside ambient (right photo):

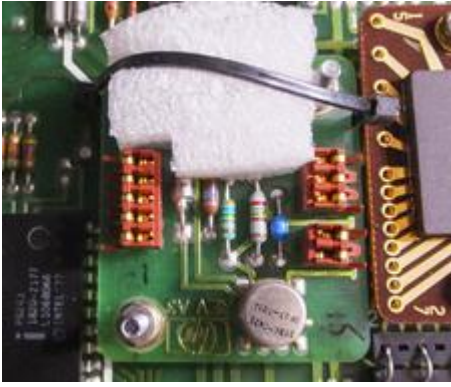
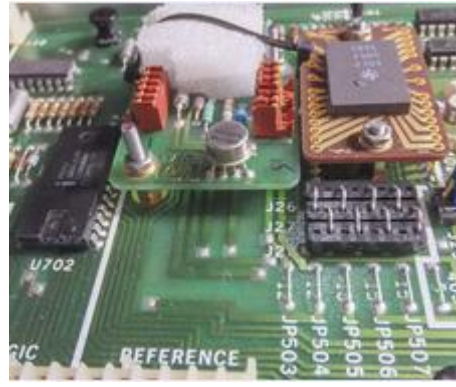
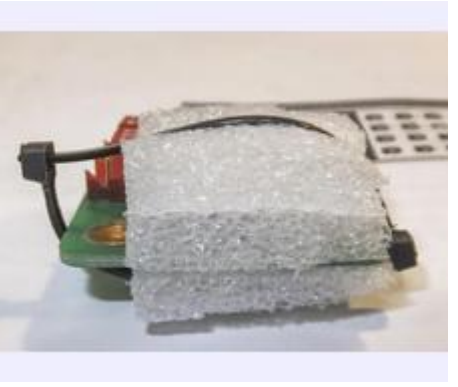
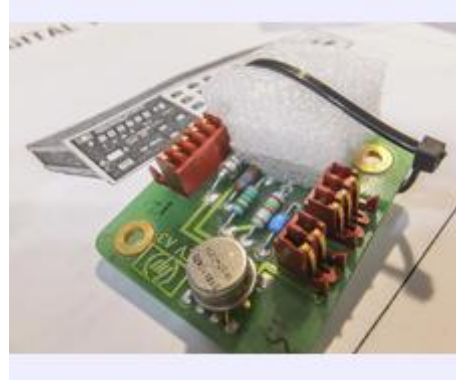
Decision was taken to modify original PCB around LM399 zener chip, leaving only space for PCB tracks. This approach will allow reducing thermal coupling between zener diode and circuit boards around, helping to reduce thermal power required to maintain temperatures.

It's critical to be extremely careful, not to track tiny traces around or damage components. To further isolate reference there were foam caps installed on top and bottom surfaces of reference board, like was shown on photographs. It's best to fix these caps with simple fabric thread, instead of plastic coupler, as excessive pressure and mechanical force will cause extra stress to zener chip and output voltage will observe larger drifts.

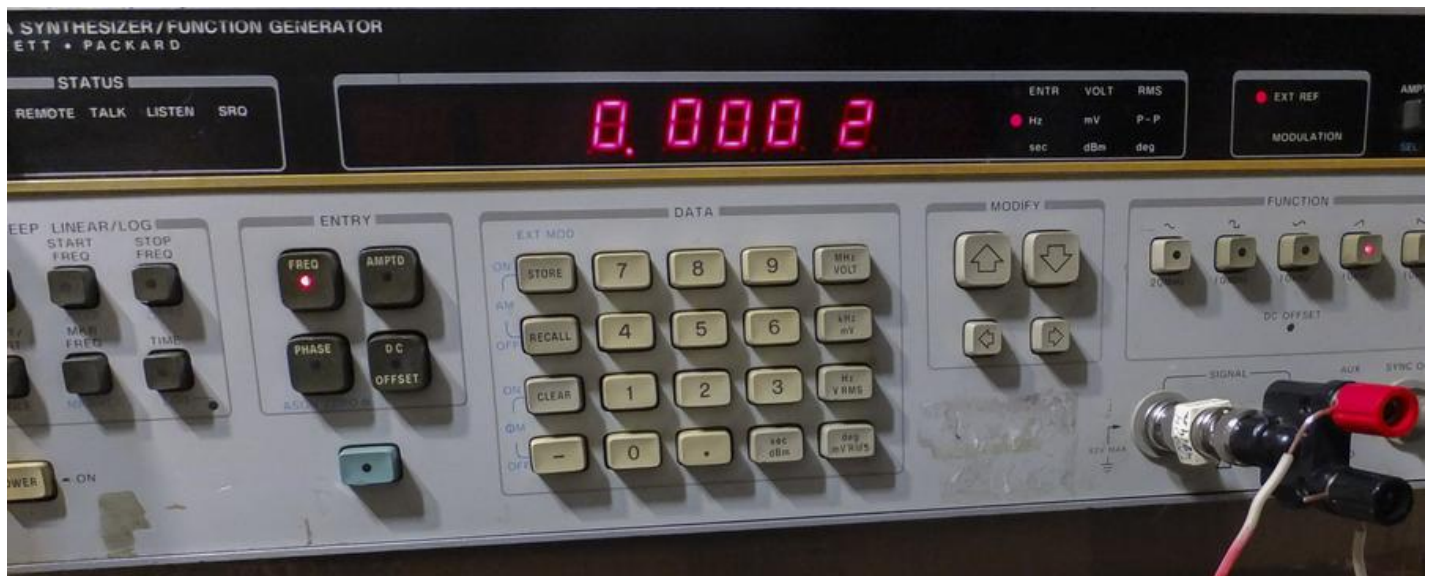
As sawtooth generator I used function source **HP3325A** in RAMP+ mode. Voltage output amplitude was set to highest value of most accurate range, which is 10V for HP3456A and HP34401A, and 3V for HP3457A. Now, recalling our time needed for 100 ppm span , we can calculate required frequency such as $1/5000\text{sec}=0,0002\text{ Hz}$. Offsets are not being used, just set to zero, to avoid any unwanted instability in output. Generator's output loaded with 50 Ω resistor to ensure proper source operation.

Divider 10000:1 was used to get signal with maximum range about 100 ppm. It was built around two resistive SSSR-made dividers, DNM-30 to divide 10:1 and similar R35 divides further 1000 times more. All connections are made by clean single-strand copper wire to reduce effects of thermal EMF.

HP3456A in 6½-digit mode at 10 PLC is able to perform measurements with 2.5Hz speed, so I used 500ms timing in GPIB measurement. If we want to get 100 samples with 1ppm voltage differential this would take 50 seconds. For 100 ppm we will need 5000 seconds. Remember this value.
