This page is devoted to the repair of my **HP-8753C** Network Analyzer. I hope you enjoy it!

HP-8753C NETWORK ANALYZER

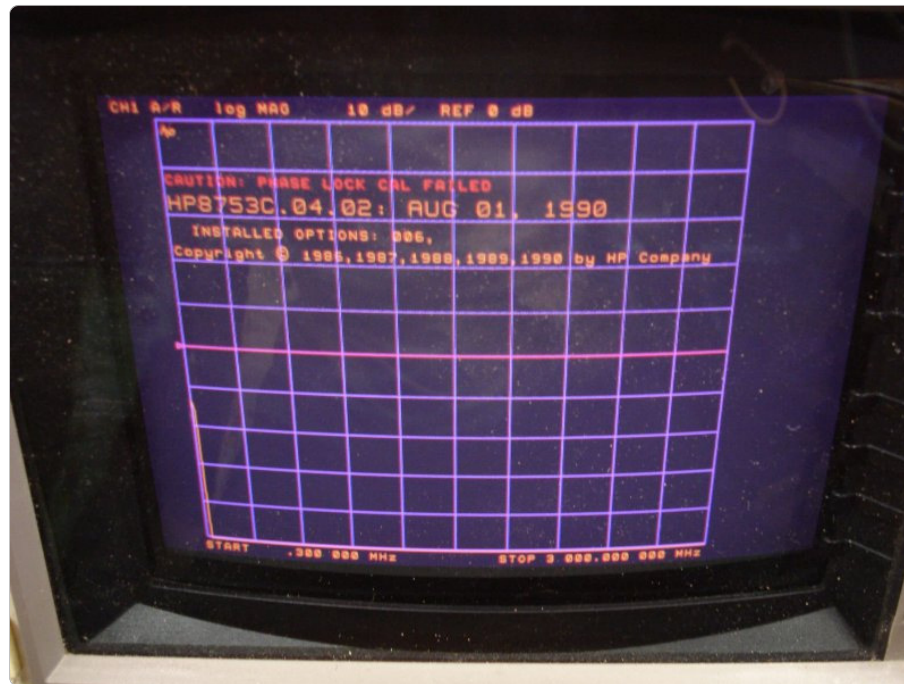
As you can see, it shows a **PHASE LOCK CAL** error. So that was a good starting point!

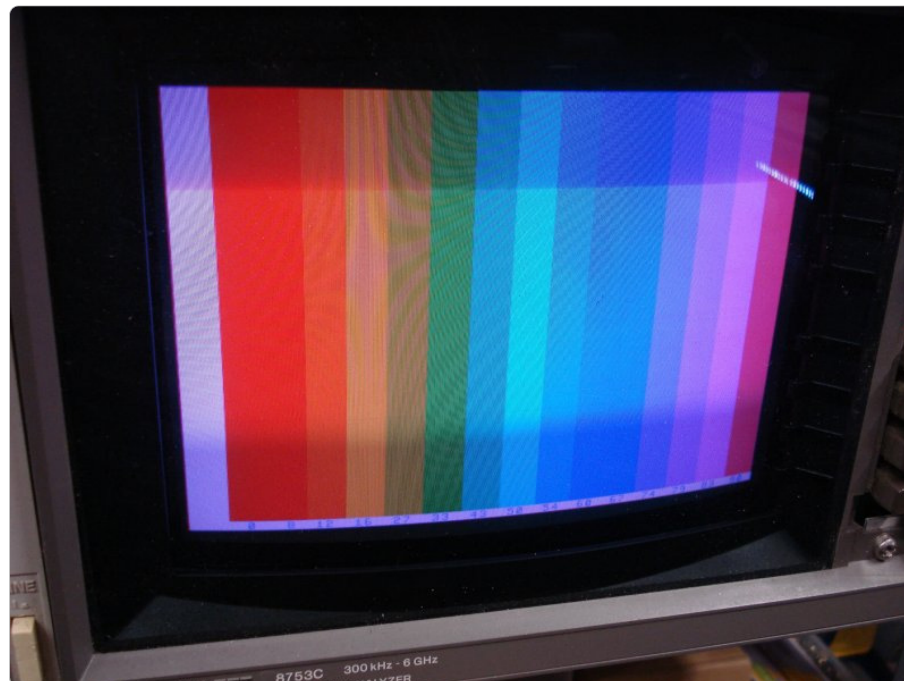
Here you have a test pattern displayed on the Sony monitor subassembly (yes, it is a Sony Trinitron tube!)

The display looks really nice, which is a plus for a 20 year old instrument

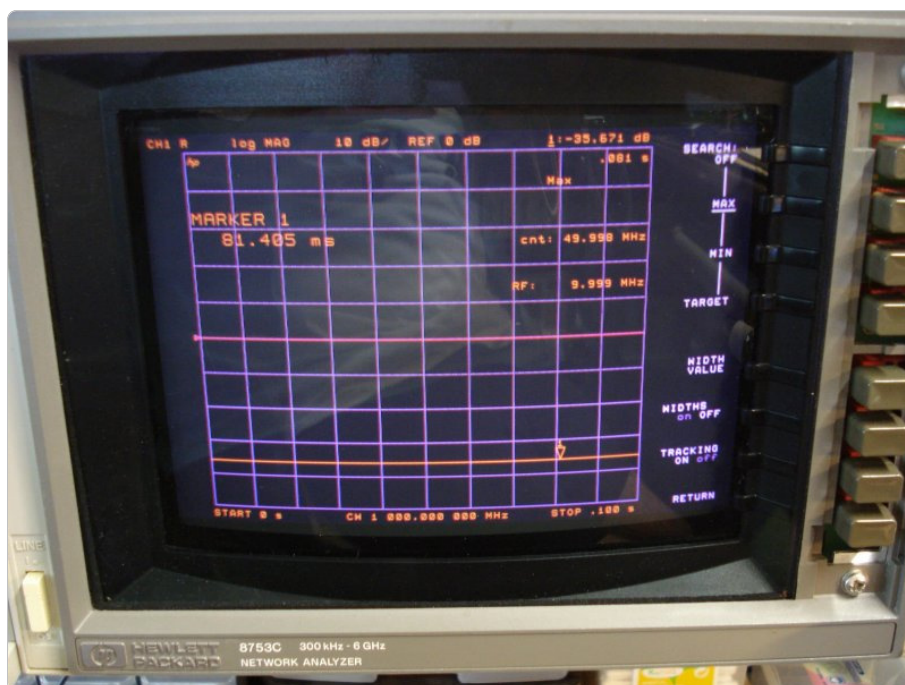
This kind of microprocessor controlled systems, even being 20 years old (in 2011), have usually a large quantity of self checks which save a lot of time measuring here and there. So I took the [Service Manual](#) and found the tests which had to do with the **A3 SOURCE** assembly. But before doing them, I thought that a good way to know if the rest of the system was OK, was to check the unit with an external reference. So I did the **MINIMUM R LEVEL FOR EXTERNAL SOURCE PERFORMANCE TEST** procedure (page 125 of the PDF) and got good results at 10MHz, 20MHz, 100MHz and 1GHz (I didn't check at higher frequencies). Here you have a sample display:

Knowing that the analyzer seemed to run fine with an external reference was a good thing, as it really pinpointed the **A3 SOURCE** as the real culprit. So I run all the tests which were related to it. And the results were, as you can imagine, bad (at least for the first one; the other ones seem to be similar to what the manual says, but with some offsets). You can see from page 361 of the PDF what the different displays should be in a working unit. Here you have what I got:

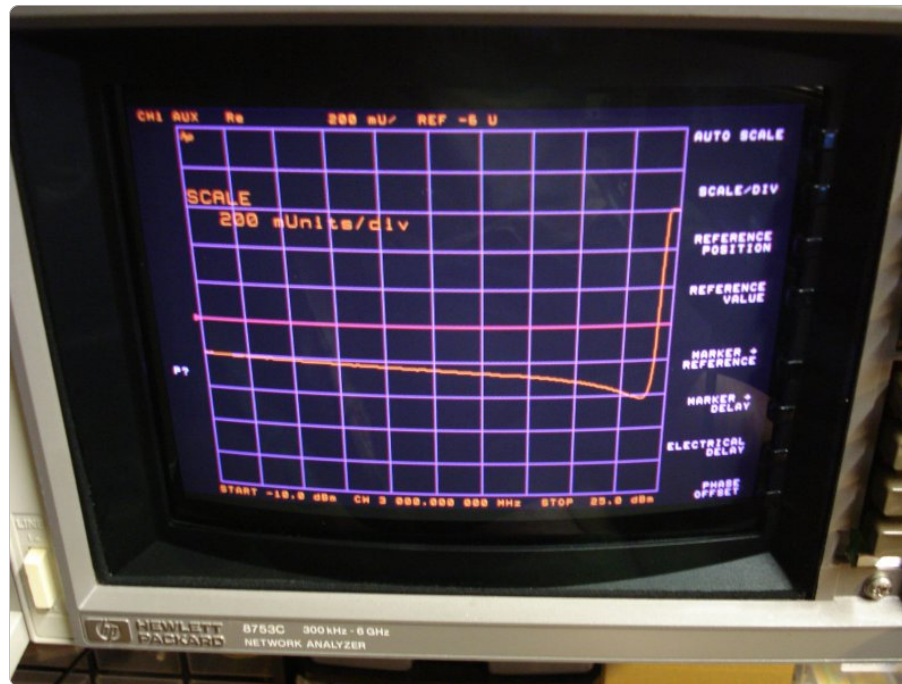
Now the **LmIn TEST** showed something different than a flat line:

I run all the other SOURCE tests and everything seemed OK and the **PHASE LOCK CAL** error was gone for good!!!

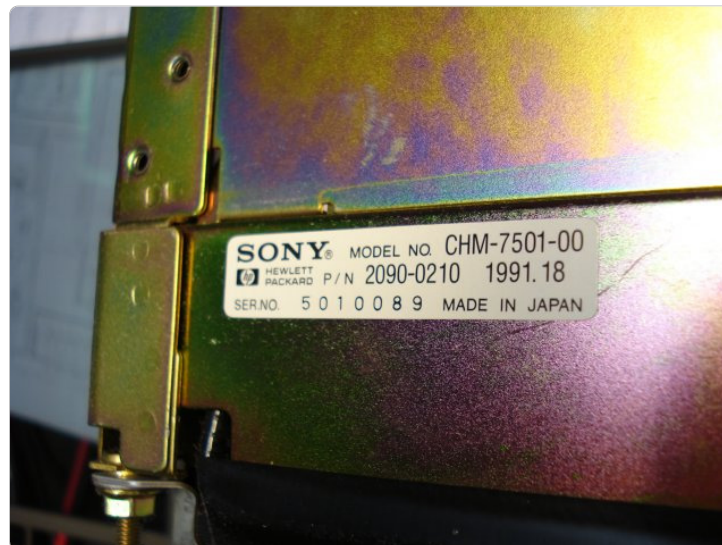
I had some info about the colors not being accurate on this unit. But as I had never used an 8753C before, I was not aware that the **Channel 1** should be **yellow** instead of **orange**... so I decided to fix that. These units use a SONY display module, which is a **Sony CHM-7501-00** or, by HP numbers, a **2090-0210**, as you can see on the label:

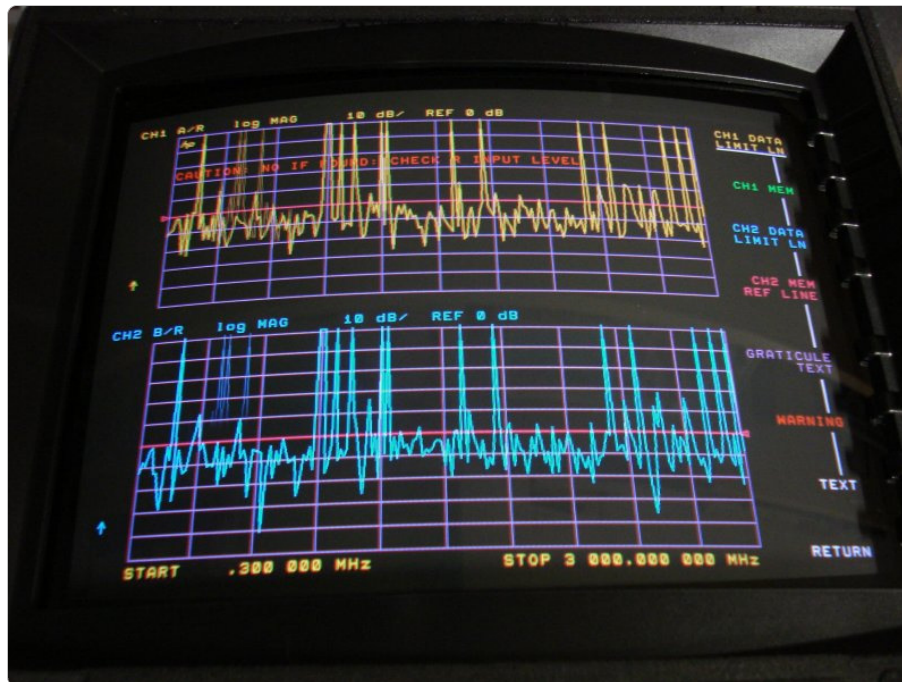
And now Channel 1 was, as intended by HP, **yellow!**
