S E R V I C E N O T E

**EPM-441A Power Meter
(Product Number E4418A)**

In Line Fuse Holder Clips Defect.

DATE: March 1999

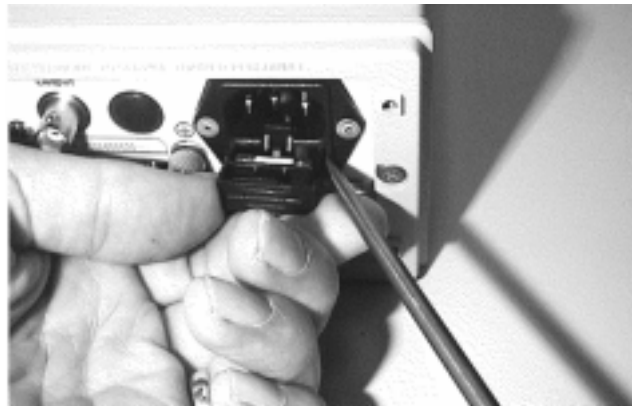
Figure 1

- 1) Remove the Fuse Box using a flat Blade screwdriver (See Figure 1)

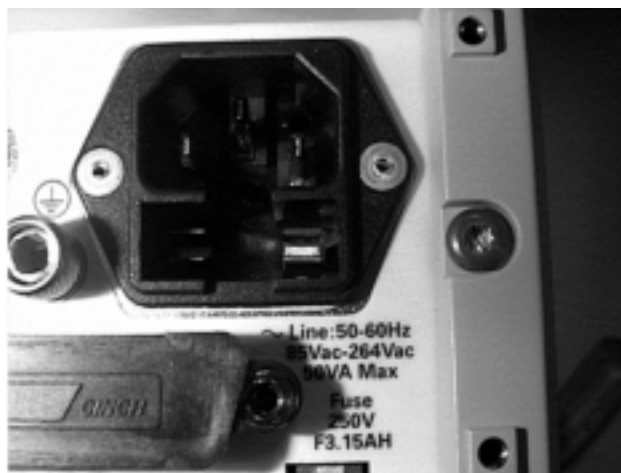
Figure 2

- 2) Inspect the Fuse clips.
- 3) If the Fuse Clips are as per figure 2 then proceed to step 9.

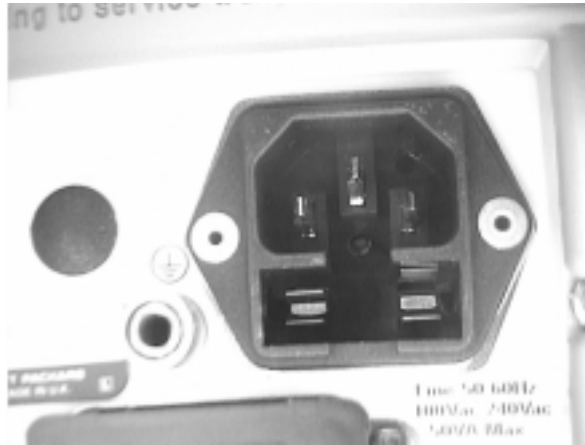
Figure 3

The true fault is that one of the fingers of the fuse holder (the right hand upper fuse clip as viewed from the rear) has been formed incorrectly thus providing an intermittent contact. This has been traced to units within a certain batch code. These fuse clips need to be repaired.

- 4) If the Fuse Clips are as per figure 3 then check for signs of arcing on the clip.

- 5) If there is any evidence of arcing then proceed to step 8.
- 6) If there is no evidence of arcing then bend the fuse clip into the correct position (i.e. level with the left hand clip) using a Flat Blade screw as shown in figure 4. Proceed to step 7.

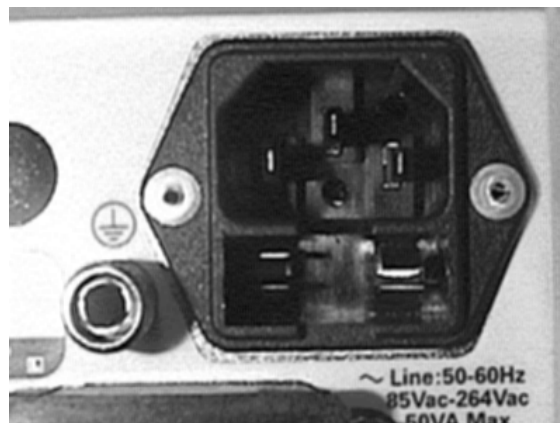
Figure 5

- 7) Ensure the fuse holder clip has not been bent too far (as per Figure 5).

If it is bent too far bend it to the correct position as per step 6 Proceed to step 9.

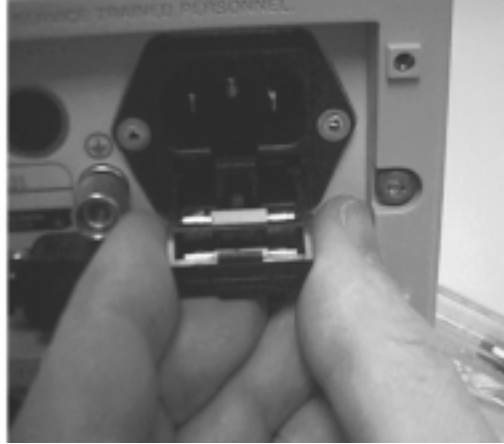
Figure 6

- 8) Supply QMD Product Support with Unit Model Number, Serial number Fitted Options and return the unit to division for replacement. (QMD for prefix GB and MID for Prefix US). Proceed to step 9.
- 9) Replace the Fuse holder as per figure 6. Proceed to step 10.
