S E R V I C E N O T E

Agilent E4419B EPM Power Meter

Additional Regulatory Information For Power Supply Replacement

Duplicate Service Notes: E4418B-08-S

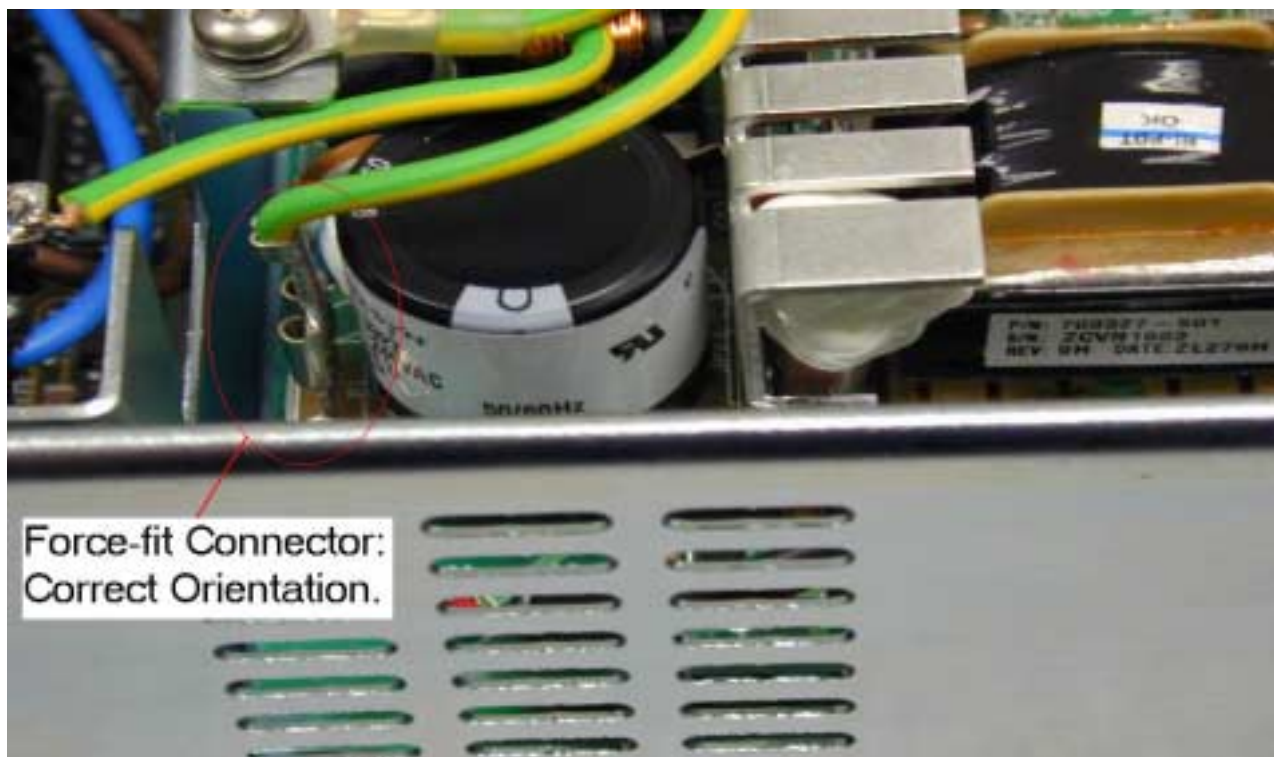
Figure 1: Correct orientation of force-fit connector.

It has been highlighted that the force-fit connector connecting the earth wire to the Power Supply Unit can be fitted in two different ways.

By fitting the connector with the bottom (flat) side facing the large capacitor on the Power Supply Unit, the gap between them is maximised (approximately 2mm).

By fitting the connector with the top (rounded) side facing the large capacitor on the Power Supply Unit, the gap between them is minimised (approximately 1.2mm).

The gap should be maximised at all times to ensure the unit meets the design and regulatory requirements relating to electrical insulation. This requirement is such that the gap should be at least 1.71mm.

During the replacement of the Power Supply Unit, the force-fit connector will be disconnected.

Ensure that this connector is re-fitted such that the bottom (flat) side of it is facing the large capacitor on the Power Supply Unit.
