S E R V I C E N O T E

**8664A Synthesized Signal Generator**

**I/O Assembly Replacement requires modification to Reference Assembly**

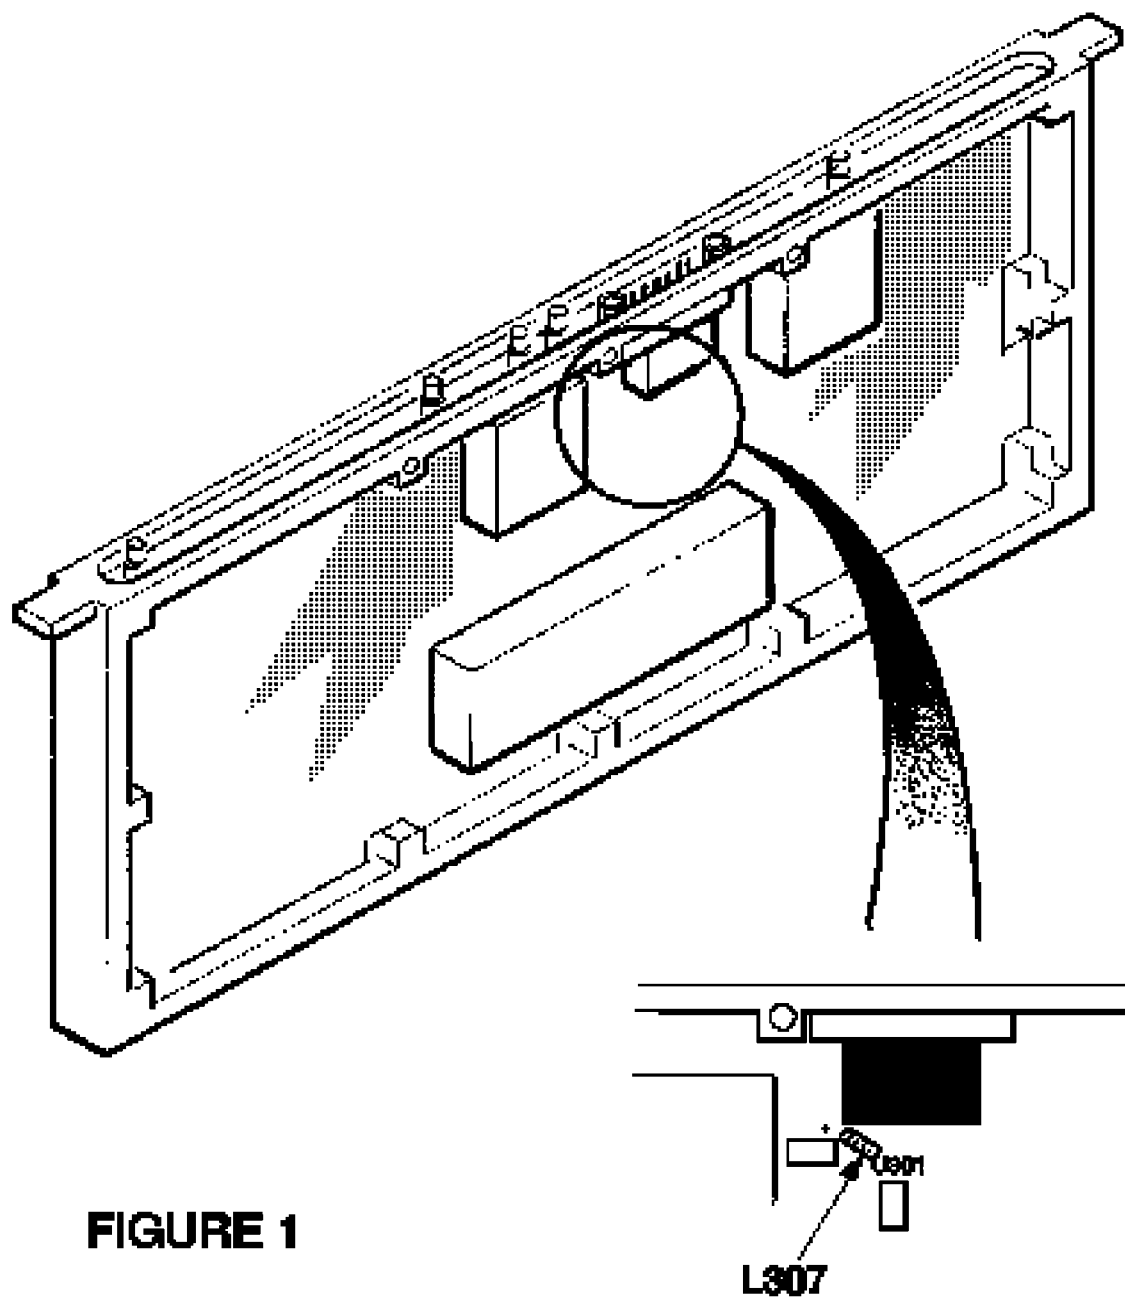
**FIGURE 1**

When an I/O assembly (08665-69104 or 08665-60204) is replaced in instruments (serial numbers noted above) a component on the Reference assembly (P/N 08665-61006) must be removed to insure proper operation of the reference oscillator.

Remove L307 on the Reference assembly. Refer to Figure 1 for component location. Re-calibration is not required.
