# S E R V I C E N O T E

# 8665A Synthesized Signal Generator

## **Potential RPP Assembly Failures**

**Duplicate Service Notes:** 8664A-03

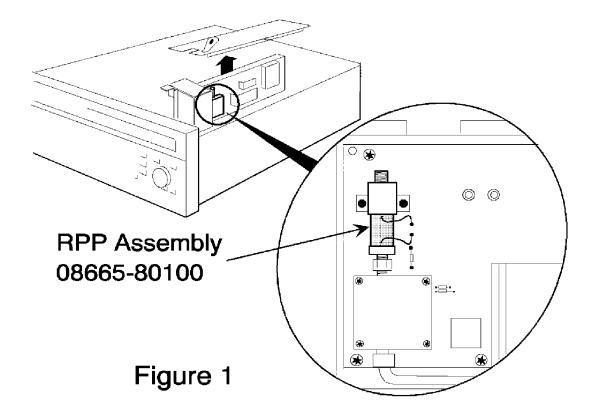
Instruments with specific serial numbers noted below may have defective RPP (Reverse Power Protection) assemblies. The RPP assembly protects the RF output circuitry from damage due to externally applied power. Failure symptoms include no RF output or a low output level (relative to front-panel settings).

The RPP assembly consists of several components, one of which is reed relay encased in a glass tube with teflon plugs at both ends. An elastomer envelope is used to secure coil windings around the glass tube and to provide consistent electrical characteristics.

The RPP fails when the elastomer expands beyond its nominal size and contacts the external connections of the reed relay. This causes a low impedance RF path to ground.

- 1. Remove the original RPP assembly and replace it with the part number listed above. Refer to Figure 1 for assembly and component location.
- 2. Run the internal diagnostics after replacing the RPP assembly.
- 3. Perform RF Level Accuracy Performance Test to insure that the instrument meets specifications.
