11759D-01

S E R V I C E N O T E

HP 11759D RF Channel Simulator

220VAC Line Module Miswire

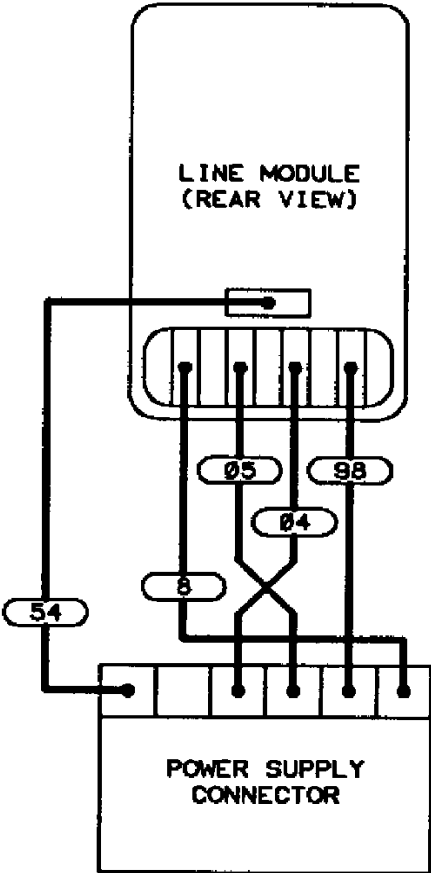
The shrink wrap tubing can be cut from the solder lugs on the line module and the wiring altered to match the diagram below. Please note that the ground wire (green/yellow) and the gray wire need not be touched. Also note that the two capacitors on the line module leads should remain in their positions and should be securely soldered. Shrink tubing should be installed on the line module leads as part of this repair procedure. When the wiring has been altered to match the diagram in this service note, the line module and harness can be installed by reversing the removal procedure described above.

The wiring should be confirmed first. Unplug the line cord from the instrument. The top cover of the instrument should be removed. Make sure that none of the visible RF signal cables on top are moved since calibration may be affected. The shielding plate covering the line module should also be removed by unfastening the six screws holding it in place. One Phillips-type screw attaches the shield to the top of the power supply module, two Torx screws attach it to the frame, and three Torx screws attach the shield to the main deck. Once the shield is removed, compare the wiring with the diagram in this service note. The diagram shows the correct wiring configuration. If the instrument in question does not match (wiring is incorrect), proceed to the next section of this service note for repair details. If the wiring matches (is correct), this service note does not apply.

The miswire should be corrected at the line module. The harness plug can be removed from the power supply module by squeezing the side tabs and pulling on the plug. The ferrite core can be removed by spreading the mounting bracket slightly apart and having the core pulled out from the bracket by grasping the wiring bundle. This may require two persons to accomplish. The line module can next be removed from the rear panel after its two mounting screws (Torx) have been loosened.
