This page is devoted to the repair of my **HP-8566A** spectrum analyzer. I hope you enjoy it!

HP8566A MICROWAVE SPECTRUM ANALYZER

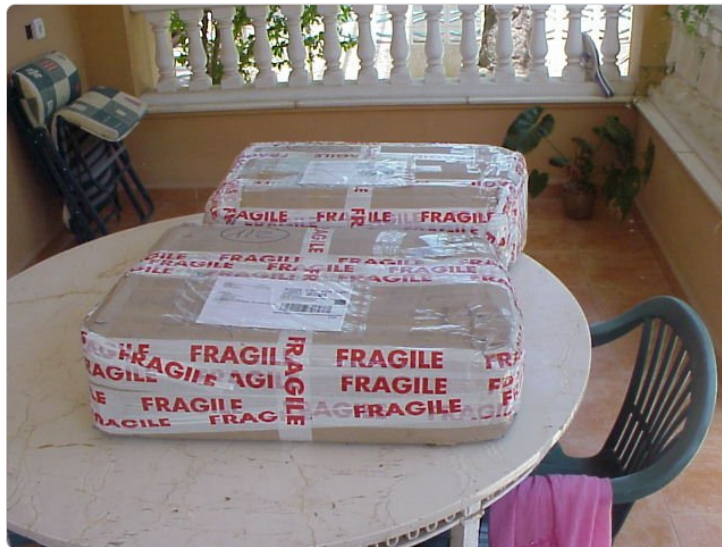
Packaging was extremely POOR as you can see in this picture

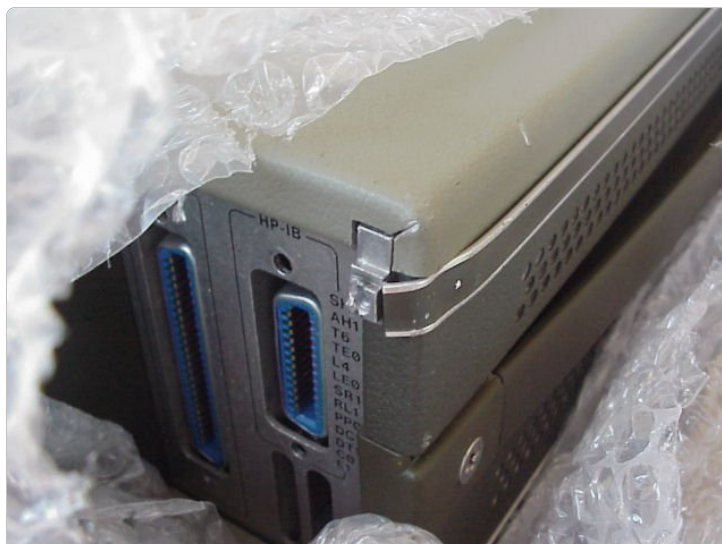
So I was sure there would be some damage... and there was :-)

I did my best to fix the unit

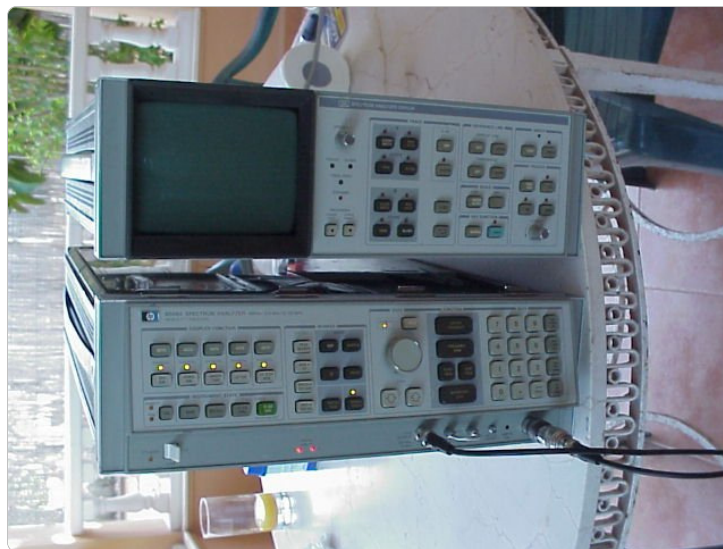
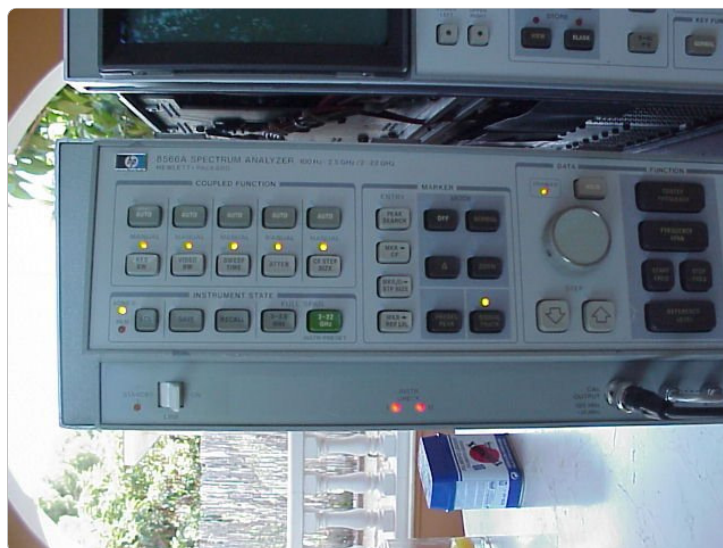
But then, after toggling the POWER, all I got were all LEDs ON and a flashing ADRS'D LED

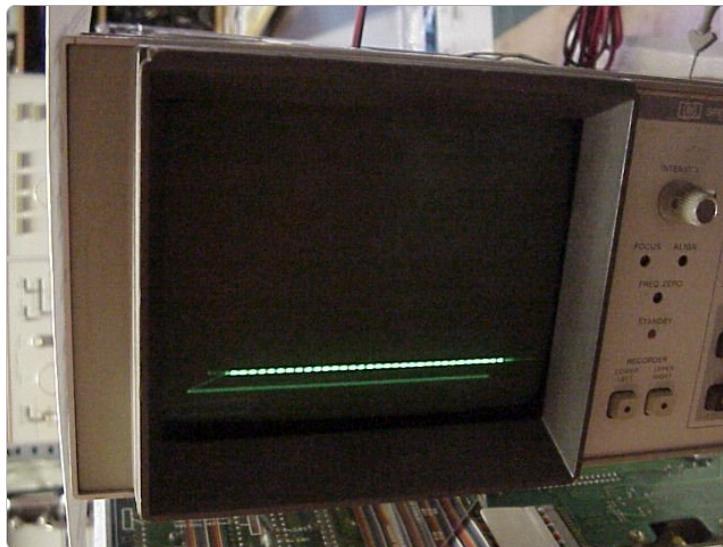
I began with the display section. There is a way to operate it without the RF unit, by placing a couple jumpers, one to start the unit and another one to select TEST mode. Once done, pressing RESET button you should get a test display... this is what I got:

Not too pretty :-)

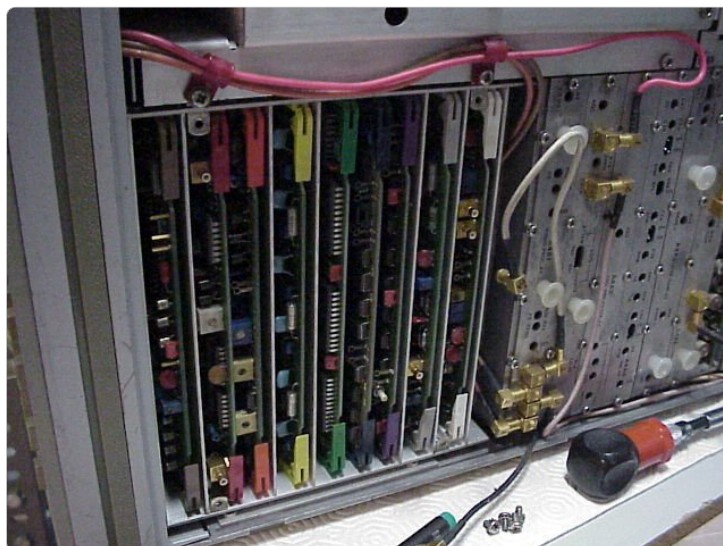
I took some cards out of the display area, which is this:

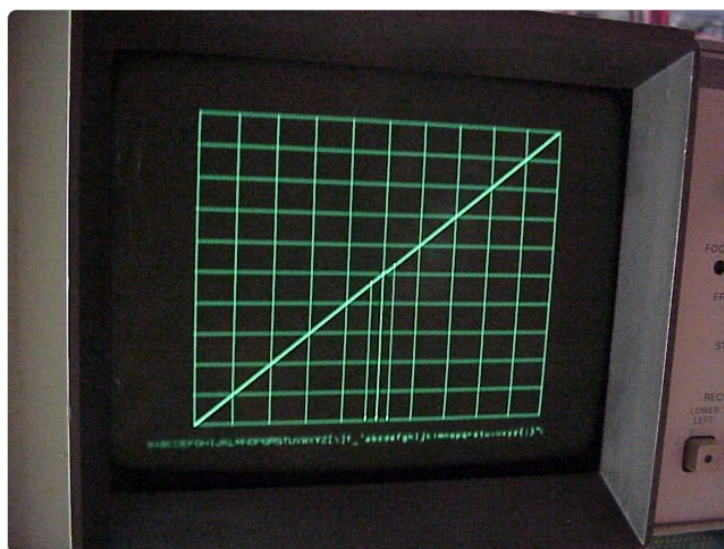
Right image come and went by barely touching the cards, specially the A6 one. So I got it out and found some oxide on its edge connector

Image is not focused and FOCUS control does nothing... but well, that is an analog problem which will take care of later.

Once cleaned, display unit showed a nice test pattern consistently so I decided to connect it again with the RF unit... but not, it didn't work. So I decided to get all cards out and carefully clean them and the card cage

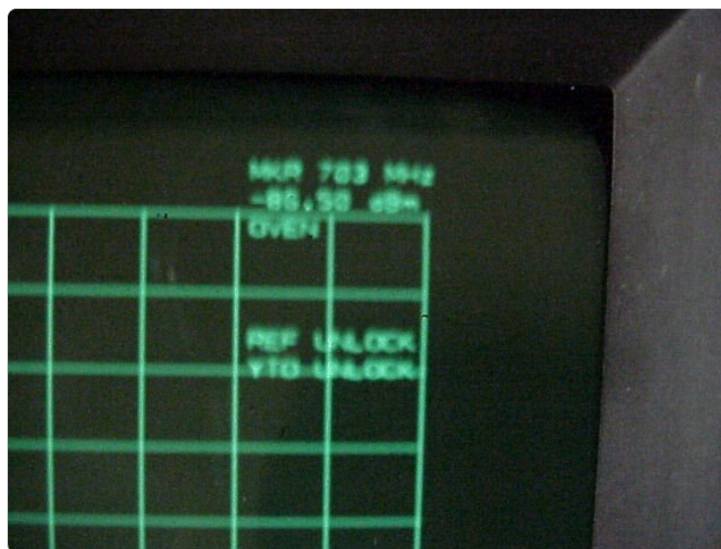
As oven was still heating, there were some errors:

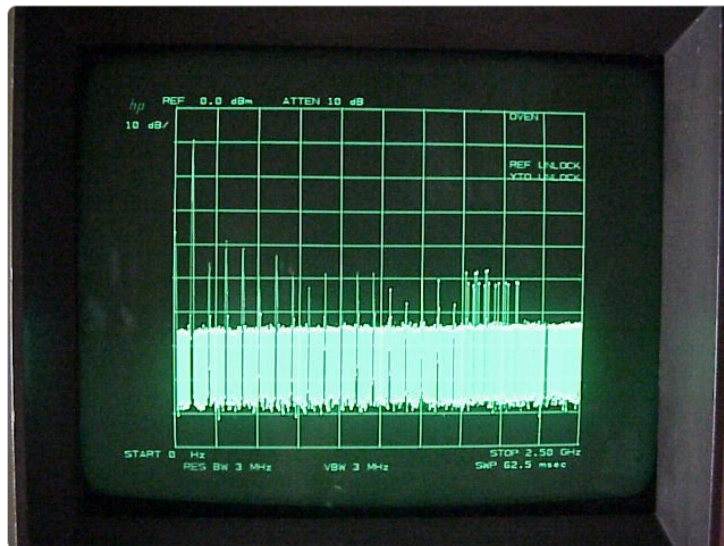
I decided to go for the FOCUS problem. Checking the service manual, I found the circuit which managed it. It is a small PCB, just over the CRT. It is the Z-axis circuit.

I got it out and found a resoldered transistor, just in the FOCUS circuit. Workmanship was not too fine so I redid it and

also cleaned the PCB edge connector. Once I got the unit back to the system, I got this nice display:

And now FOCUS control works as it should :-) !

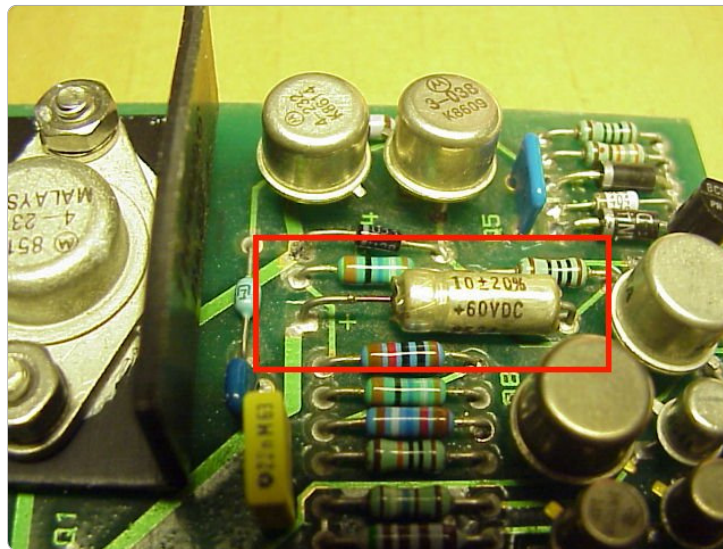
I was looking for bad capacitors, so this one seemed very suspicious (look the discoloration in one side):

And, yes, all were OK except for the suspicious one, which was open :-)!!!. It was a 10uF/60V capacitor. All what I had in stock were 10uF/50V 105C, so I replaced it with one of them

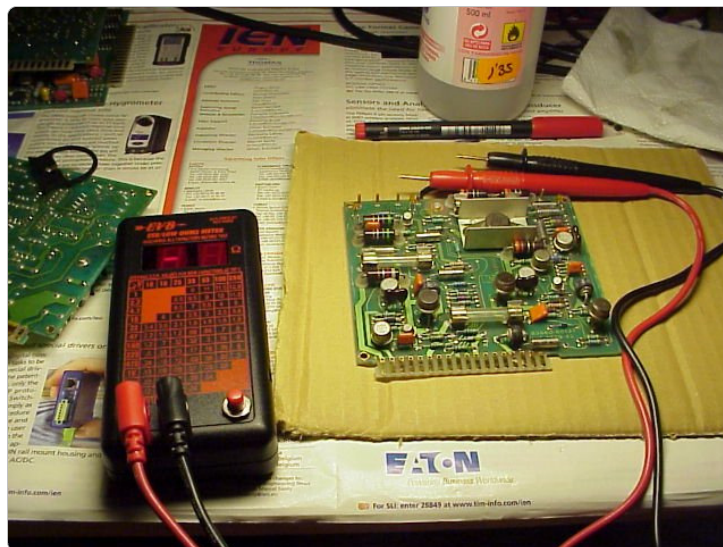
So I took my trusty ESR meter to check all of them:

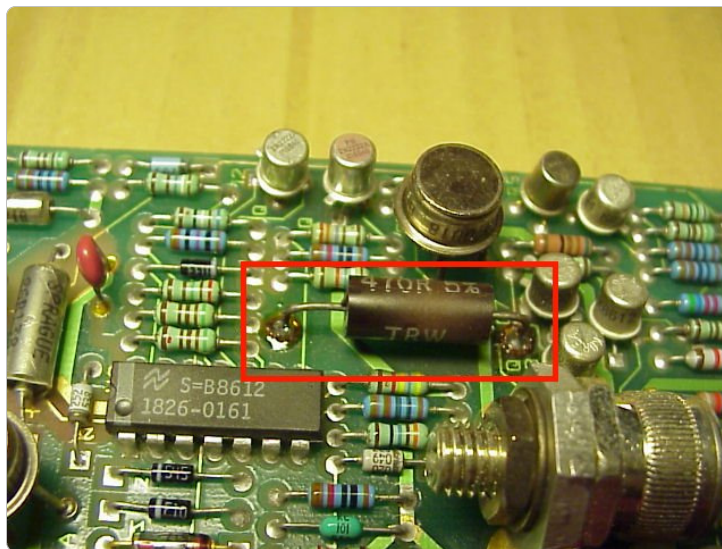
I did a thoroughly visual inspection of the boards, and found a power resistor with overheated solder joints:

So I cleaned and resoldered it carefully... this was a problem waiting to show up in the future!

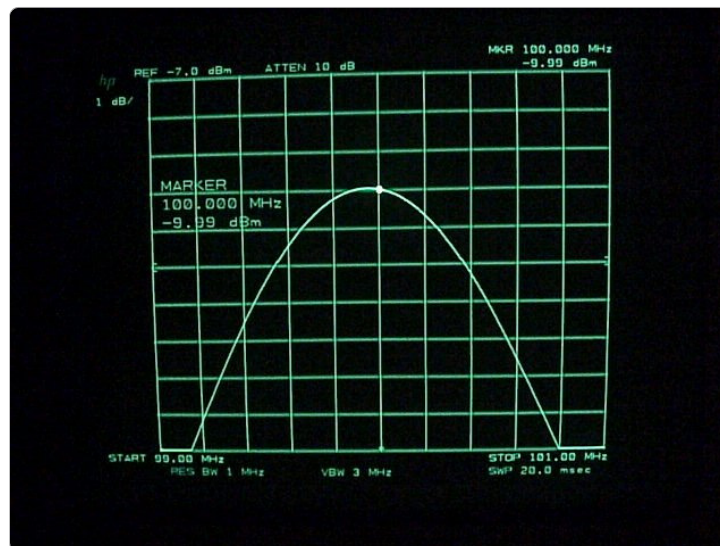
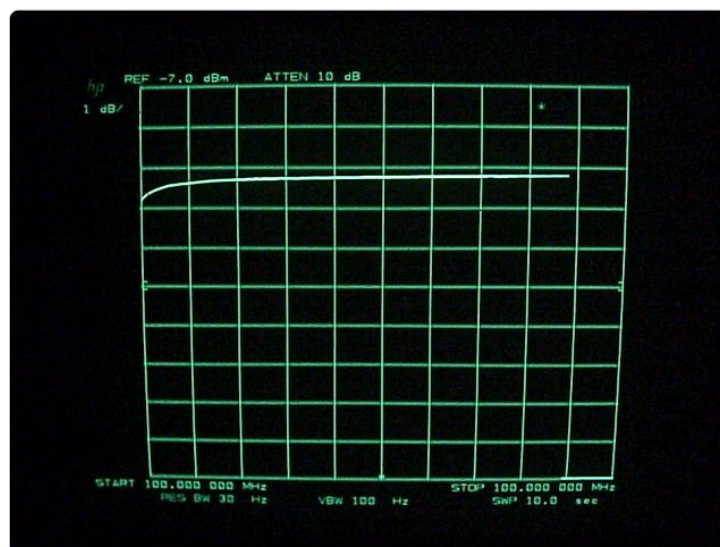
I have then checked the **ERROR CORRECTION ROUTINE**, which *measures the amplitude and frequency error factors and corrects the display for them*, according to the HP-8566 Manual. But it always ends with the message **ADJUST AMPTD CAL** and aborts the procedure. In that case, the manual calls for a **Manual Calibration Procedure**, explained also there. It consists of an amplitude calibration (pressing **RECALL 8** and using the **AMPTD CAL** control) and a frequency correction (pressing **RECALL 9** and adjusting by means of **FREQ ZERO** control), both based on the CAL signal. Here you can see the displays for both adjustments:

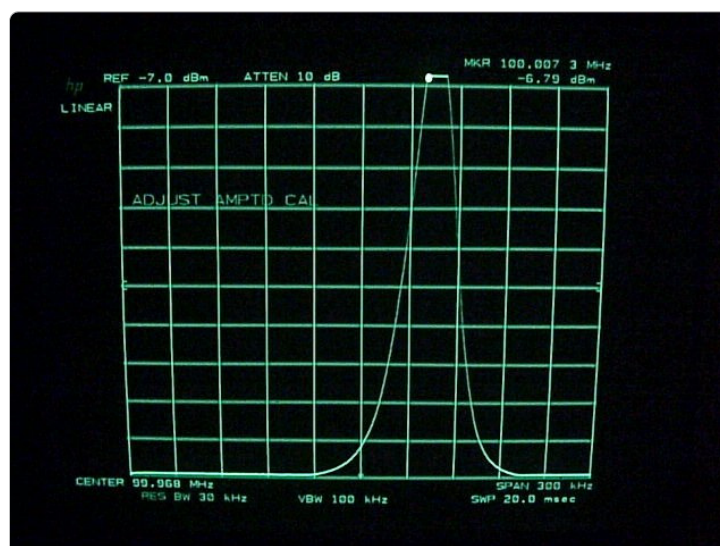
They can be successfully passed, but then, when I try again the **ERROR CORRECTION ROUTINE**, it fails in same point. Here you have the display showing the fault:

In previous steps, signal keeps inside the graticule but in this one, it is all over the top of it... suspicious!

I will investigate what is happening exactly at that moment, as previous steps run fine, in order to try to correct the problem and have the unit finish the procedure.

As I suspected and John suggested, the extra gain was a problem. It seems gain is too much to be compensated by the auto-calibration system. I have checked the CAL signal at different bandwidths and, yes, **30kHz RBW** has about 3dB more gain than the other RBWs:

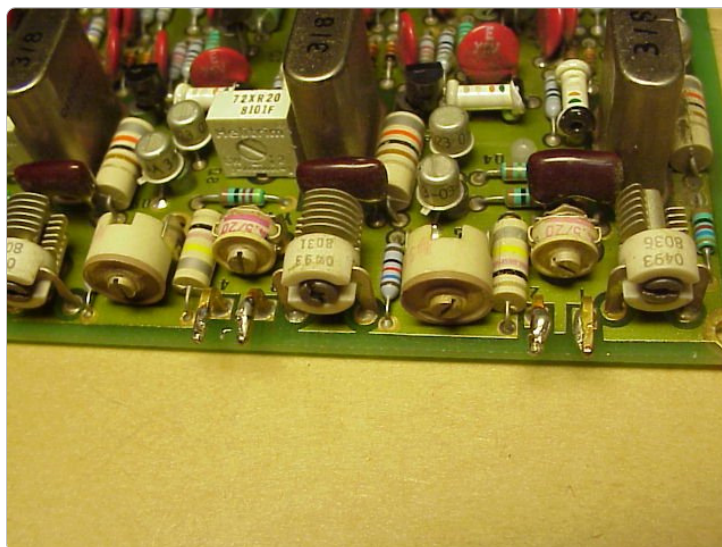
Someone had been here before, as there were some test pins with globs of solder. Of course, I cleaned them. But here you have the tiny work done by the *tech*:
