**E4448A-06A**

**S E R V I C E N O T E**

**PSA Series Spectrum Analyzer**

**E4440A, E4443A, E4445A, E4446A and E4448A**

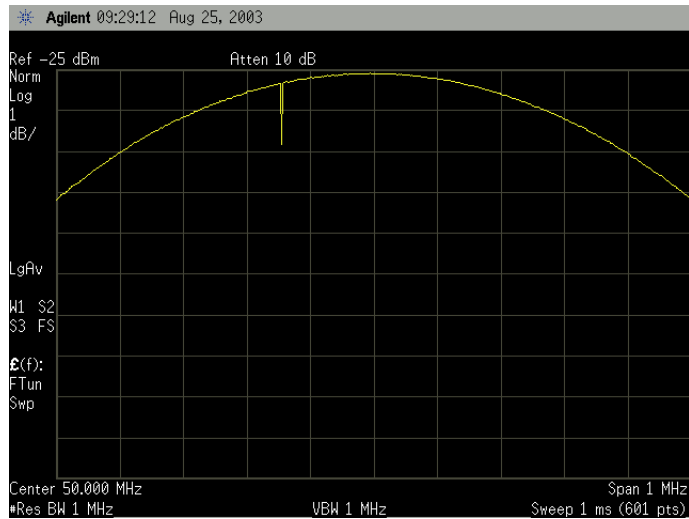
Effected instruments will randomly show an amplitude drop of approximately 2 to 3 dB.

Replace the A7 Digital IF assembly P/N E4440-60025 or E4440-60195 with the Digital IF exchange assembly P/N E4440-69195. Perform recommended performance verification procedures and possible adjustments. Please reference the PSA Service guide for additional details.
