**37718A-07**

# S E R V I C E N O T E

**OmniBER 37718A**

**Optical power warning label**

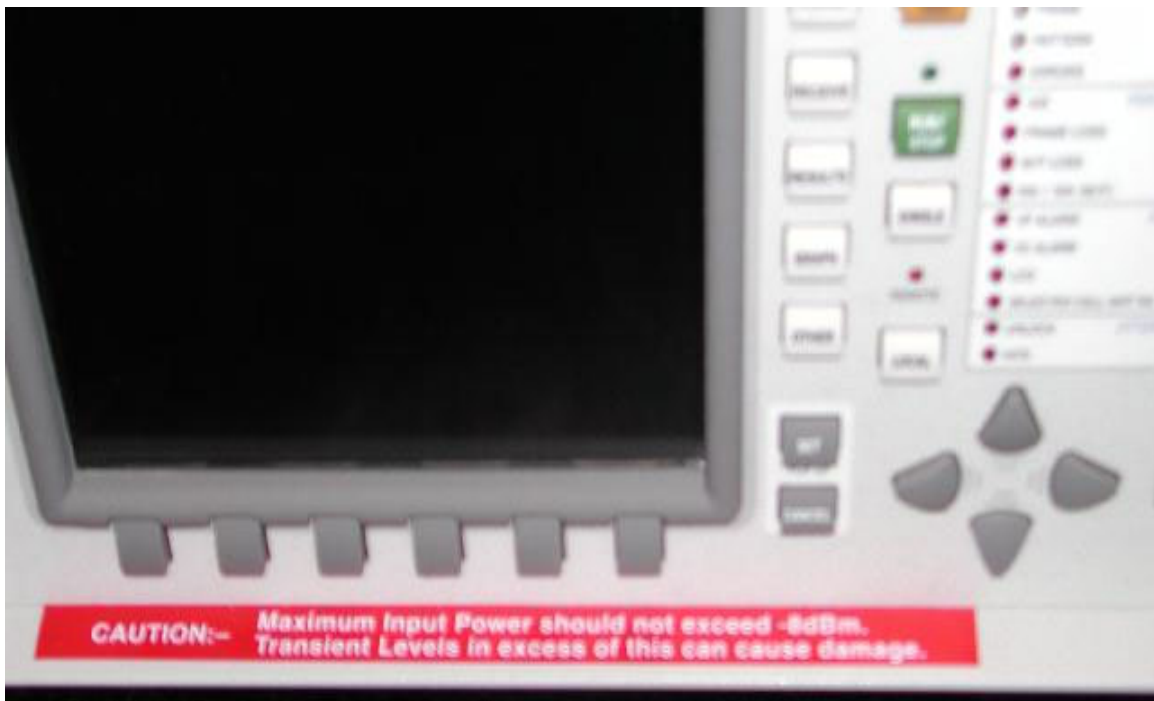
Early shipments of 37718A do not have the correct warning information with respect to the optical power

**"CAUTION:- Maximum Optical Input Power should not exceed -8dBm. Transient levels in excess of this can cause Damage."**

- 2 Change label if information does not match above. Label should be placed along front frame of instrument as shown below

Replace old optical warning label with the new one. Ensure that the letter is sent in the instrument pouch.
