SN J1981B-06

S E R V I C E N O T E

J1981B Telegra VQT

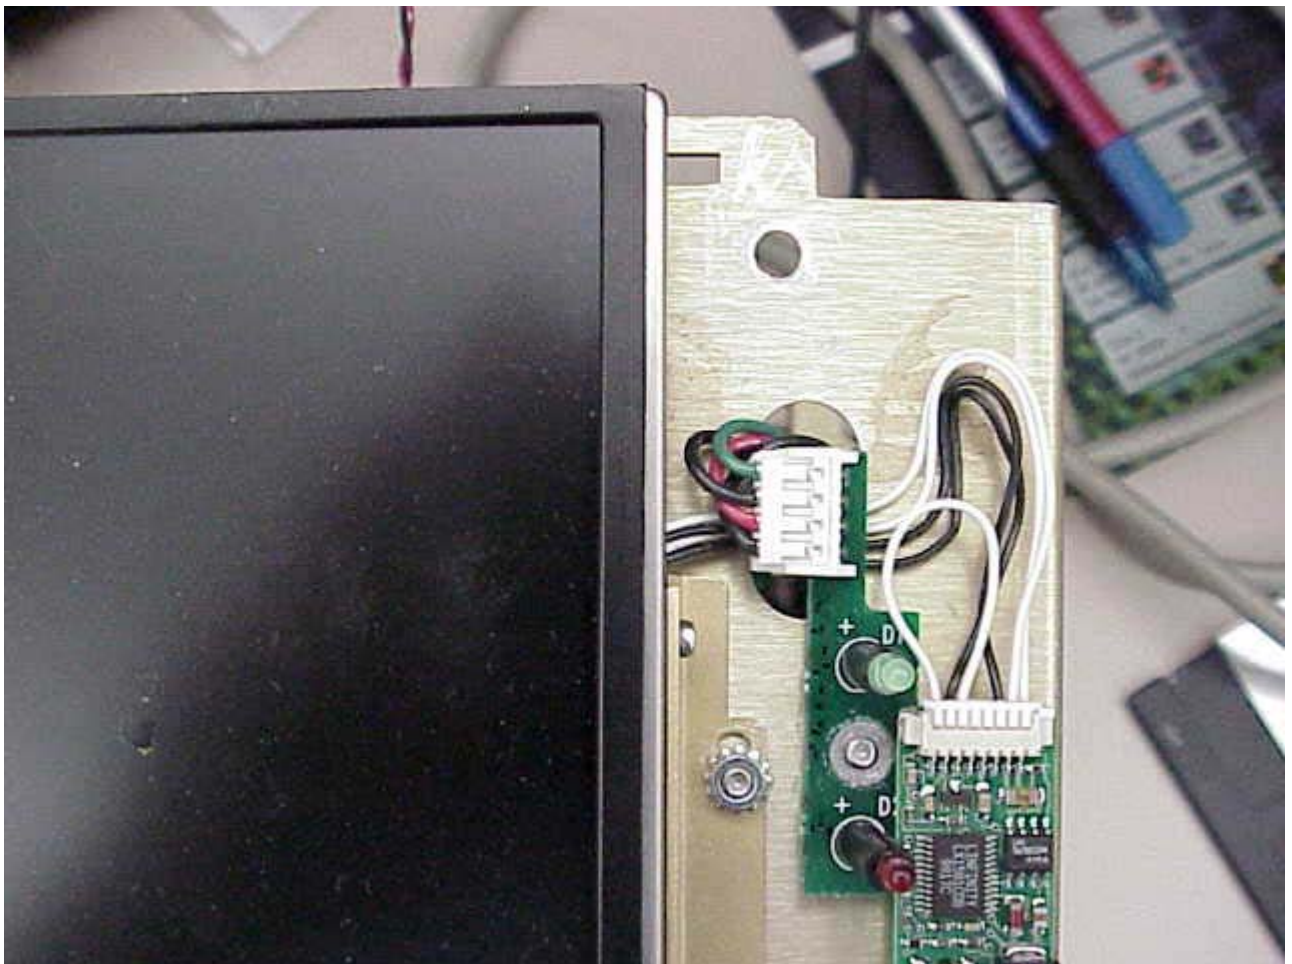
When the front bezel is removed from these units it is possible to damage the LED's. In order to preclude this damage an aluminum standoff is required to be inserted through the front panel sheet metal and fastened on the internal surface of the sheet metal. Please see the accompanying pictures.

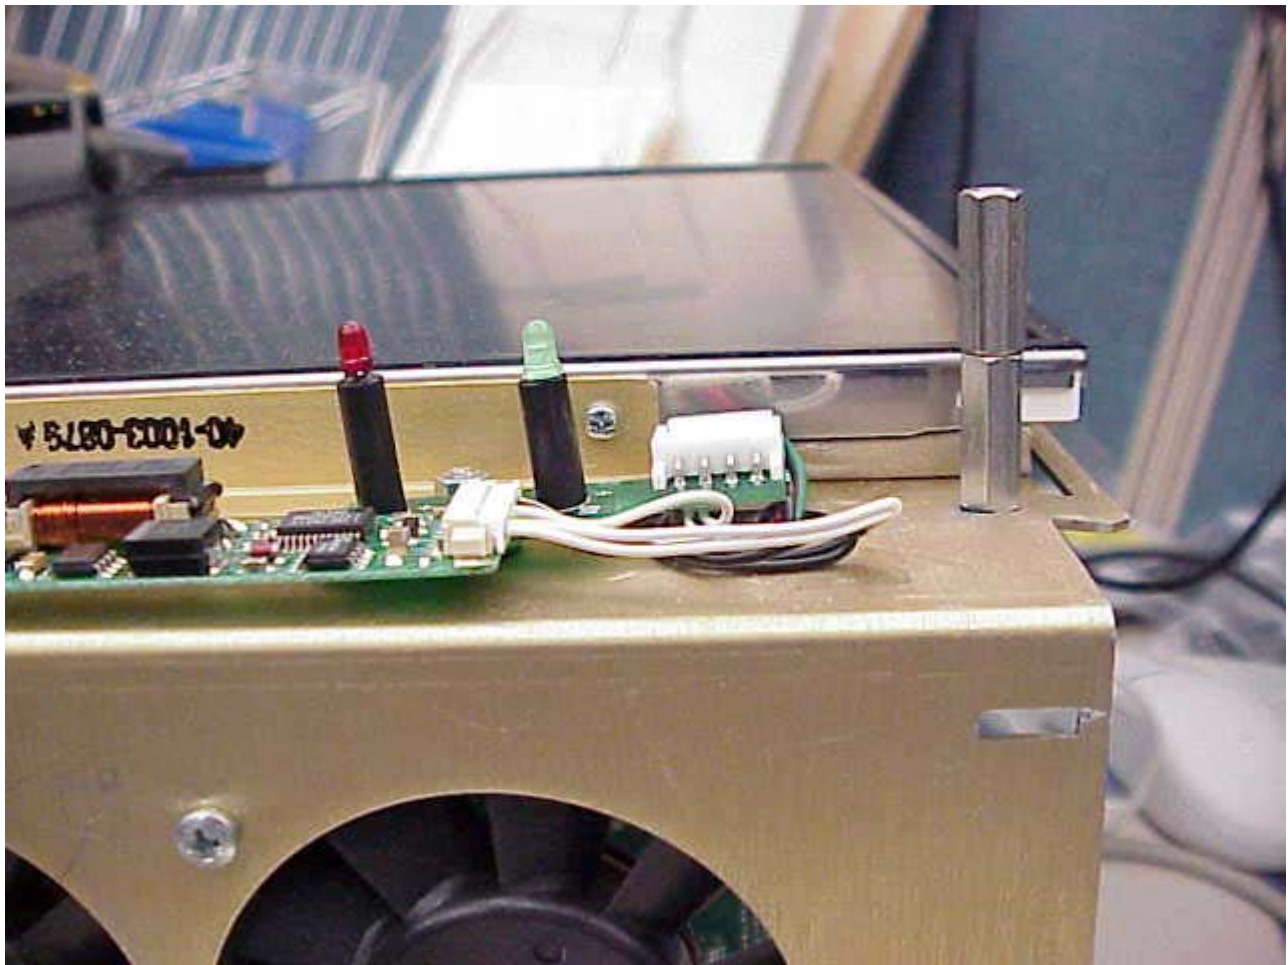
When the front bezel is removed, a hole in the sheet-metal is exposed. It is through this hole that the stand-off should be mounted. See second photo.

Remove stand-off prior to replacing front bezel.
