**3070-75-S**

# **S E R V I C E N O T E**

## Agilent 3070 Board Test Systems

### OPERATIONAL SAFETY HAZARD

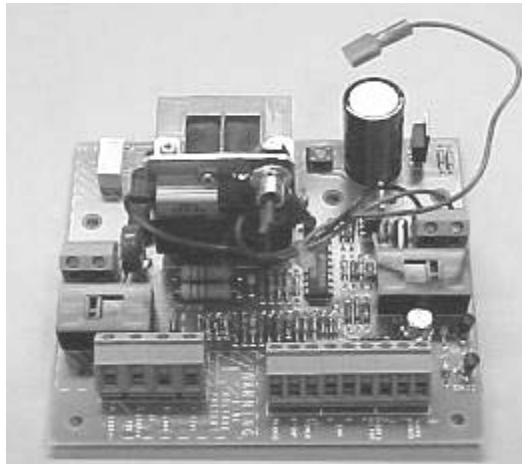
**Fig 1**

The solution is to replace the E1135-66501 control board in the PDU with a newer version (Fig 1) that incorporates a voltage regulator to the magnetic contactor.

Investigations revealed that the DC voltage supplied to the 0490-2318 from the E1135-66501 control board was higher than specified as there was no voltage regulation. Over time, excess heat can damage the coil of the magnetic contactor which leads to the described safety hazard.

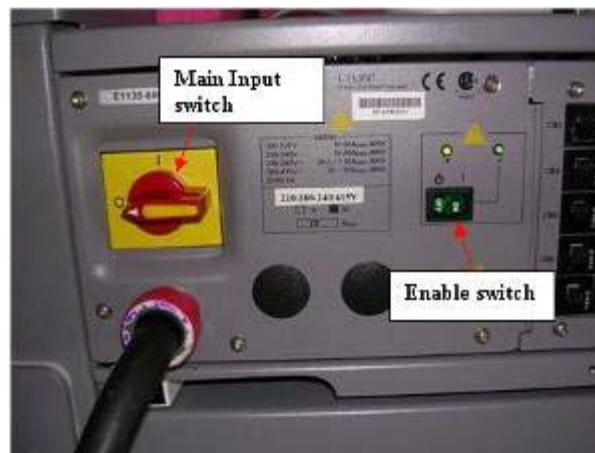
**Fig 2**

1. Shutdown the 3070 system using the standard operating procedure.
2. The E1135C has a mains disconnect device. Set this Main Input Switch to “0” (Fig 2). This is a safety feature to prevent the accidental turn-on of power from the mains while carrying out the job as described in this safety service note.

21. Remove all “Lock Out / Tag Out” devices before proceeding.
22. Turn on the PDU by setting the Main Input Switch to “1” (E1135C’s ONLY!!!)
23. Turn on the PDU enable switch. (Fig 2).
24. Test the safety feature of the PDU by pressing the EMO switch. The power will shut off immediately. This is observed by a click sound while the enable light will turn from green to yellow. The enable switch remains at the ‘1’ position.
25. Return the EMO switch back to its normal position.
26. Turn the enable switch to ‘0’ position and wait for 5 seconds before turning it back to ‘1’ position.
27. Observe the click sound and the green enable light.
28. Startup the 3070 system using the standard operating procedure.
29. Upon job completion, fill out and install the Service Note label (Part Number N7200-84366) to the PDU.

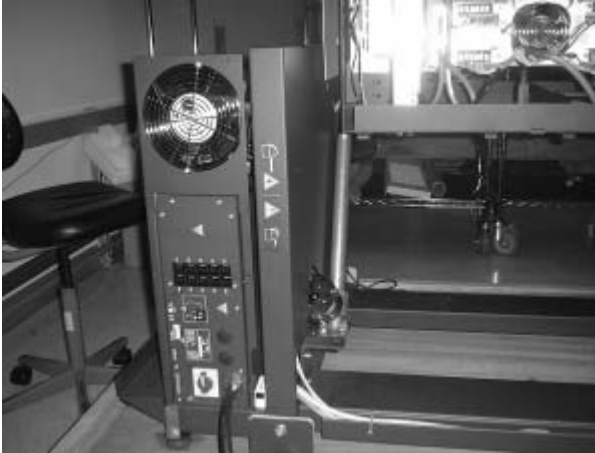
**Fig 3**

5. Remove the POD housing cover to gain access to the PDU.
6. Unplug the power cords at the back of the PDU and remove the PDU from the system for disassembly (Fig 3 & 4). The power cords on the side of the PDU cannot be easily removed, so place the PDU horizontally on the floor near the system in such a way the power cords are not affected.

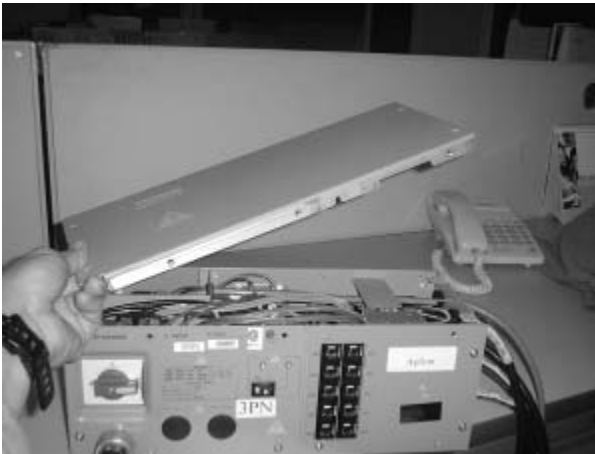
**Fig 5**

7. Remove the 17 M3.5 Torx screws holding the top and back covers of the PDU (Fig 5 & 6) using a T10 Torx driver. This needs to be done to access the E1135-66501 Control Board.

17. Double check all wiring connections to the new E1135-66501 control board.
18. Reinstall the 17 M3.5 Torx screws holding the top and back covers of the PDU using a T10 Torx driver.
19. Install the PDU back into the 3070 POD.
20. Reinstall the 3070 POD cover.

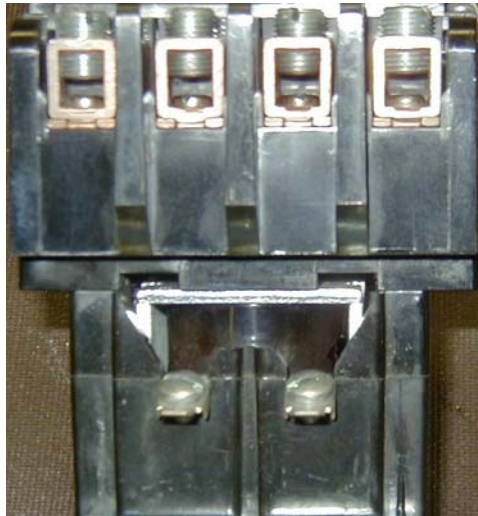
**Fig 7**

8. After opening the PDU. Inspect the contactor housing for cracks and “white” powdery type material (Fig 8). If the contactor has been or is suspected to be damaged, the entire PDU must be replaced by following the PDU Replacement procedure. If the contactor is good (Fig 7) continue with step 9.

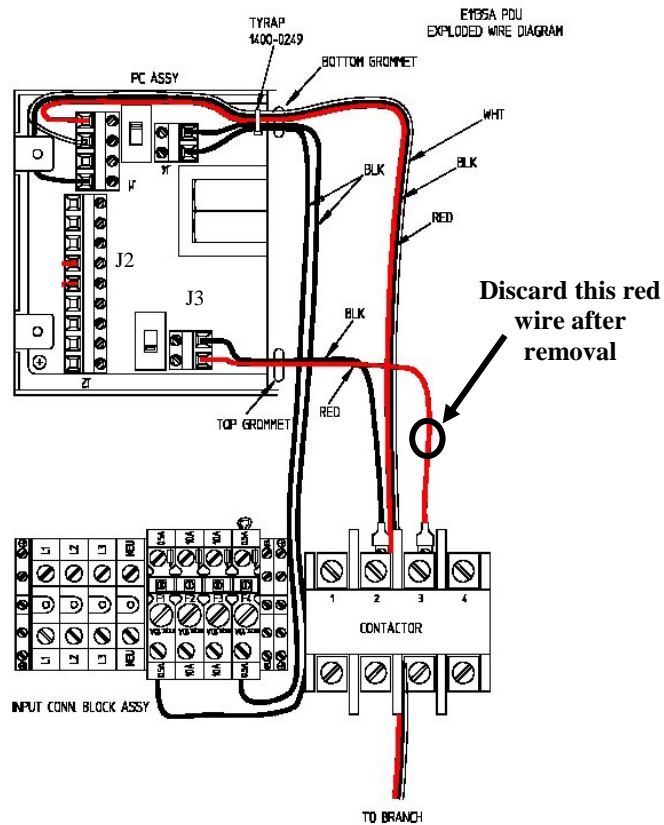
**Fig 9**

9. Remove the wires from the control board by using a small flat blade screwdriver. (Fig 9)
10. Make note of wire connections to J2 of control board.
11. Discard the red wire that was connected between “Contactor pin 3” and “J3 pin 1 control board”.

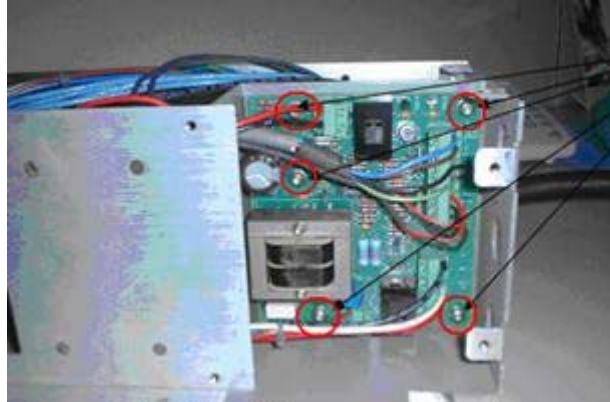
**Fig 10**

12. Remove the five M4 Torx screws holding the E1135-66501 control board to the PDU using a T20 Torx driver. (Fig 10)

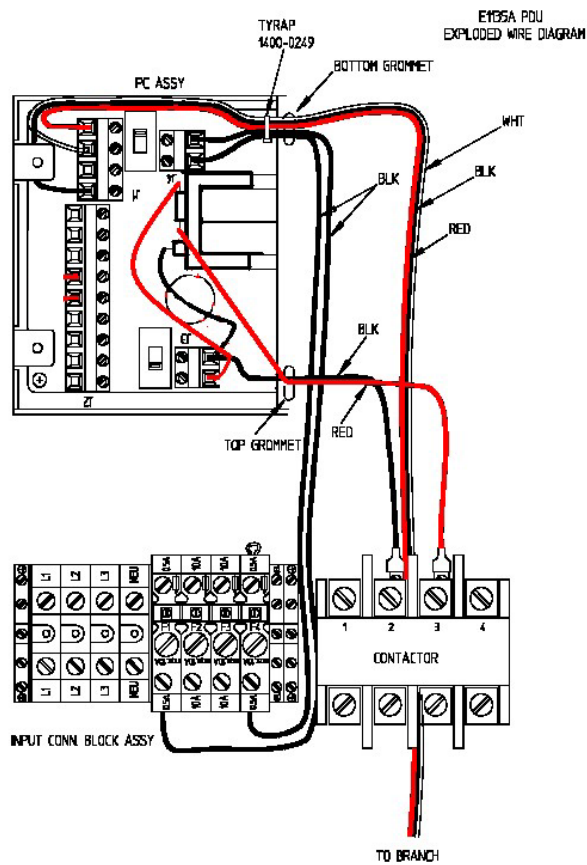
Fig 12

- Re-wire the control board using the wiring diagram in Figure 12 and wires removed from J2 on the control board in step 10.

Control Board to Contactor Connections		
Black Wire Contactor Pin 2	to	Control Board J3 pin 2
Black Wire Control Board J3 pin 2	to	Regulator on Control Board
Red Wire Contactor Pin 3	to	Regulator on Control Board
Red Wire Control Board J3 pin 1	to	Regulator on Control Board

**Note:** Wires from Regulator to J3 on control board are already connected when received from SPD.

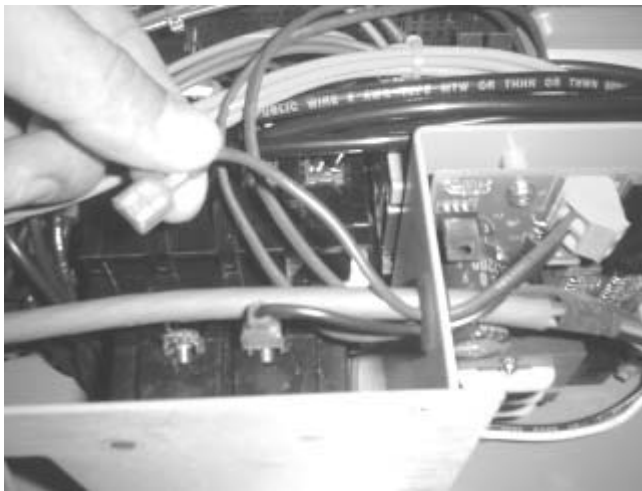
**Fig 13**

16. Figures 13, 14 and 15 show the new control board wiring.

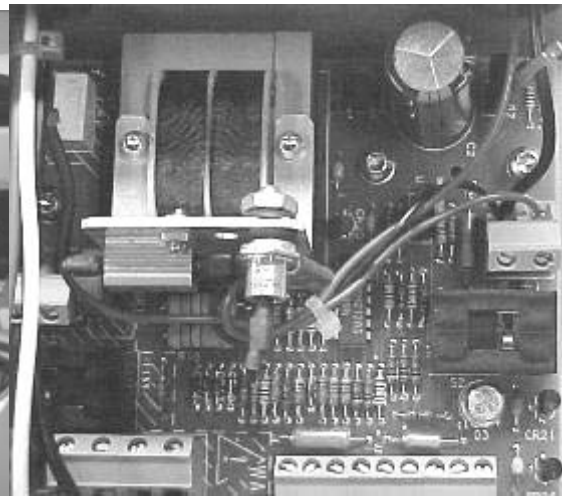
**Fig 14**

(New Control board with voltage regulator)
