**Nokia Customer Care
2115i/2116/2116i (RH-66)
Mobile Terminals**

**Antenna Description and
Troubleshooting**

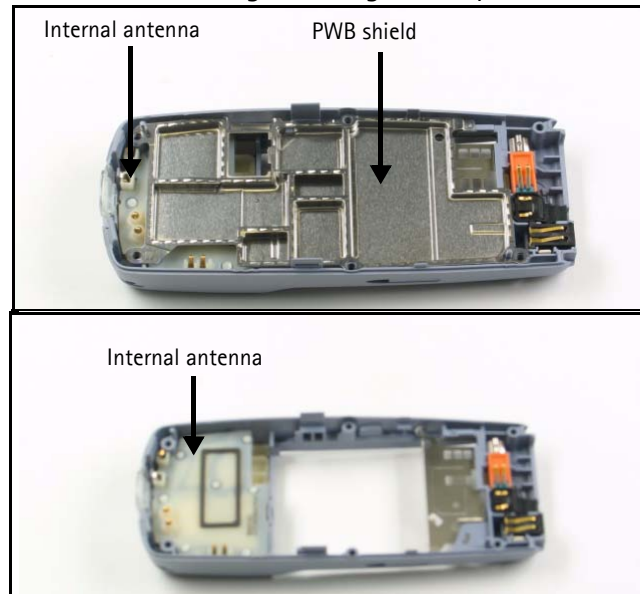
The internal antenna is assembled into the D-cover as shown in [Figure 1](#). If no internal antenna is installed, the antenna gain is degraded by more than 25 dB.

Figure 1: D-cover assembly

- If the internal antenna is missing, install one.
- If the radiator looks obviously damaged, replace the internal antenna.

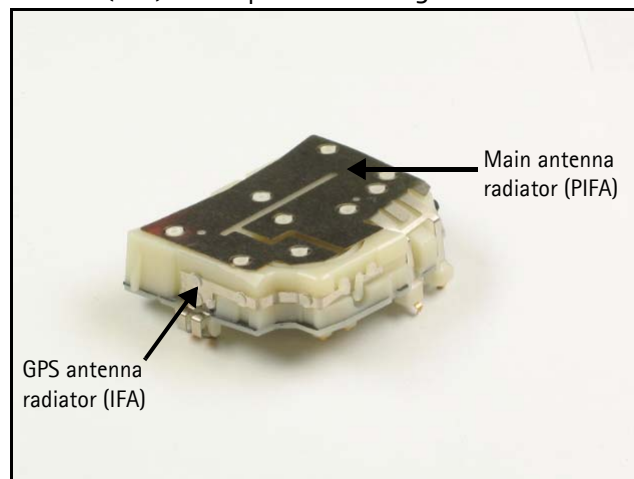
The internal antenna includes a planar-inverted F antenna (PIFA) radiator and an inverted F antenna (IFA) radiator (GPS antenna radiator) attached to a plastic carrier. An integrated hands-free (IHF) mini speaker is integrated inside the plastic.

Figure 2: Internal antenna

Note: The GPS antenna is only functional on the 6115i and 6116i models.

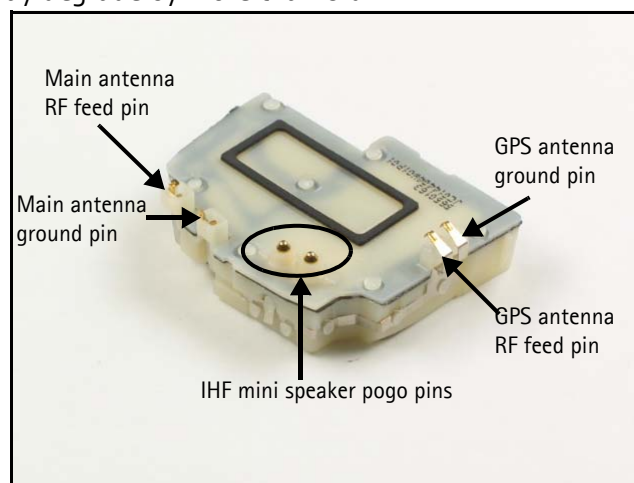
The main antenna and the GPS antenna have pins (spring clips) that must properly touch the PWB.

- If the main antenna's RF feed pin does not touch the PWB, the antenna gain degrades by more than 25 dB and the GPS antenna is detuned.
- If the ground pin of the main antenna does not touch the PWB, the antenna gain degrades from 5 to 10 dB and the GPS antenna is detuned.
- If the GPS antenna's RF feed pin does not touch the PWB, then the GPS antenna gain degrades by more than 20 dB.
- If the ground pin of the GPS antenna does not touch the PWB, the GPS antenna gain may degrade by more than 5 dB.

Figure 3: Back view of the internal antenna

- If either the RF feed pin or ground pin are broken or bent such that either pin does not touch the PWB, replace the internal antenna.
- If either the RF pin or ground pin springs appear damaged, replace the internal antenna.

In [Figure 3](#), the two pogo pins on the back of the internal antenna must properly touch the PWB. If not, the PCS gain of the internal antenna can degrade by 2 dB and no audio will emit from the speaker.

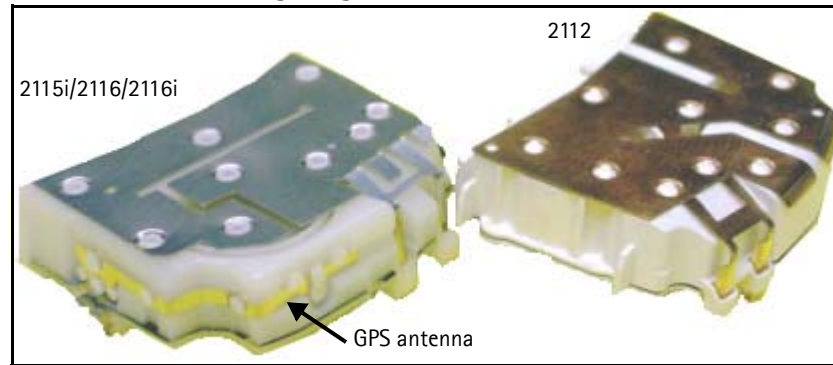
The internal antenna is mechanically similar to the one used in the 2112 mobile terminal. Following are important differences between these antennas:

- The slot pattern is different.
- The feed/ground leg locations are different.

- The 2115i/2116/2116i includes a GPS antenna. The 2112 does not.
Note: GPS is functional only in the 2115i and 2116i.
- The main radiators for the 2115i/2116/2116i include markings that begin with an "F". The 2112 markings begin with a "C".

Figure 4: Top view of the 2115i/2116/2116i (left) and 2112 (right) internal antennas

Installing the 2112 antenna in the 2115i/2116/2116i is not compliant with Nokia's FCC submission because the 2112:

- Uses a single-band (no PCS)
- Does not have a GPS antenna
- Is not tuned correctly for the 2115i/2116/2116i mechanics
- Does not make contact with the feed/ground pads on the PWB

- If the wrong antenna is installed, install the correct one.
- If the slot in the radiator has a significantly different shape, install the correct internal antenna. Be aware that the shape of the slot can vary slightly. The length of the horizontal slot and the opening of the vertical slot can vary by a few millimeters because the antennas are tuned for each batch of plastic frames.
- If there are other obvious damages to the radiator (e.g., dents and corrosion), replace the antenna.
- If the pin is stuck or has excessive friction with the plastic tube/guiding feature, the spring will not work properly. Replace the antenna.

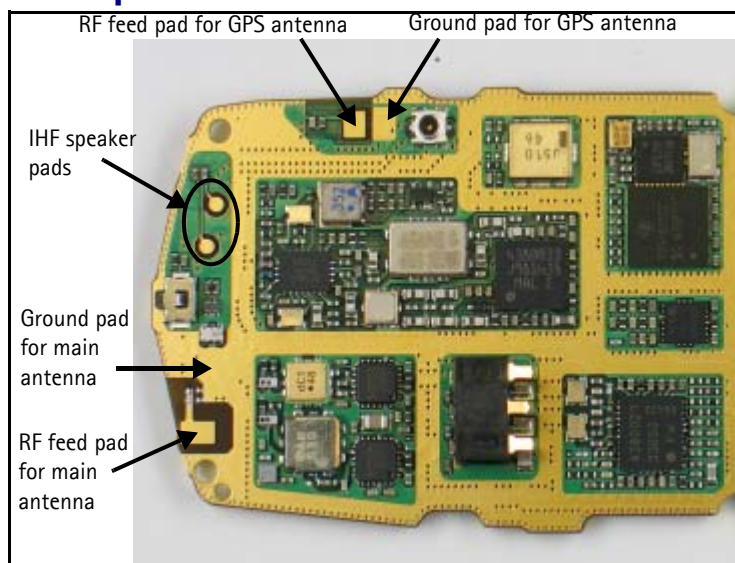
Figure 5: PWB layout of IHF speaker, RF feed, and ground pads

If any of the RF feed or ground pins are obstructed, removed, or covered, the RF pin does not touch the PWB and the antenna performance degrades. If any of the IHF speaker pads are obstructed, removed, or covered, the speaker's pogo pin does not touch the PWB and the PCS antenna performance could degrade. See the "[Damaged IHF Speaker Pogo Pins](#)" section for antenna performance degradation if any pogo pin does not touch the PWB.

- If corrosion is present or the pad is missing, replace the mobile terminal.
- If a pad is obstructed or covered, clear and/or clean the pad.

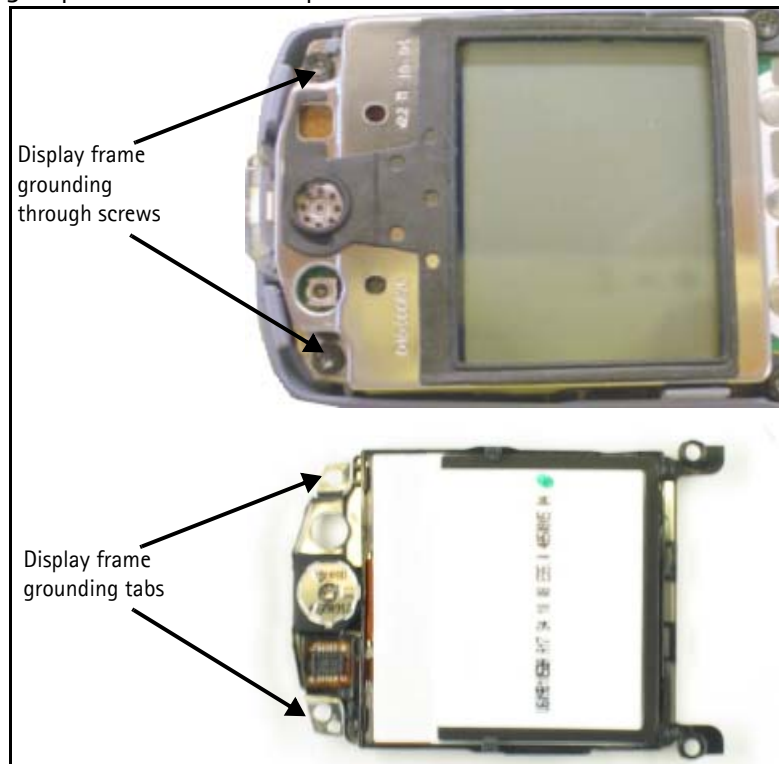
The display frame is grounded to the PWB through two ground panels. The display frame grounding impacts the radiation performance of the mobile terminal.

Figure 6: Display assembly ground points

- If the clips do not touch the PWB, are corroded, or are obstructed, replace the display frame.

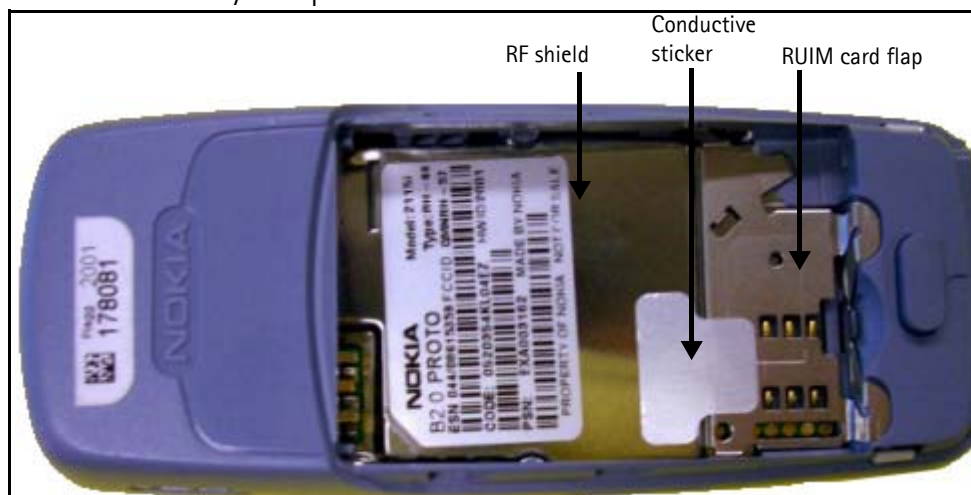
The RUIM card flap must be grounded to the RF shield with a conductive sticker. Disassembling the RF shield from the chassis damages the sticker. You must remove the sticker to change the antenna module or the RUIM card flap. If the sticker is damaged or missing, then the radiated sensitivity at maximum power could be reduced by 1-2 dB.

Figure 7: Conductive sticker grounding the RUIM card flap to the RF shield

- If the conductive sticker is missing or ripped, replace it.
- If the RF shield is replaced, install new labels (type labels) and a new conductive sticker. If the conductive sticker is located underneath other labels, then it may be necessary to replace all other labels as well.
