# CCS Technical Documentation

## RH-3 Series Transceivers

# Troubleshooting – Antenna

This troubleshooting guide addresses potential failures that will affect antenna performance of the RH-3/RH-3P phone, and discusses methods for correction of these failures.

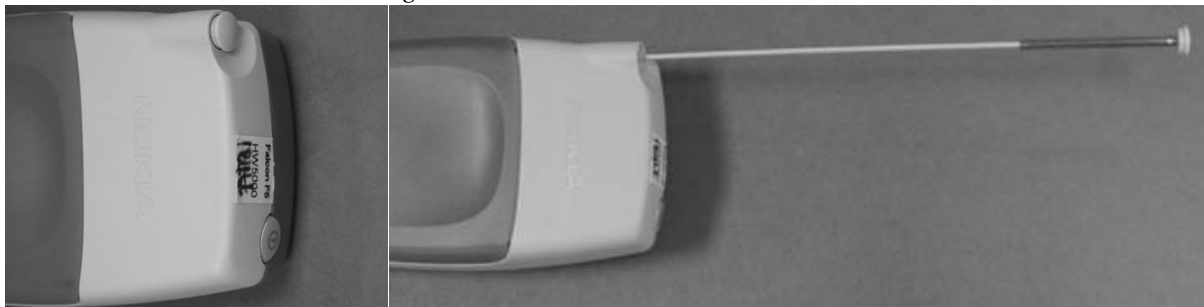
Figure 6: Back of RH-3/RH-3P phone, whip retracted and whip extended

Note in Figure 6 that when the whip is properly installed that the cap clicks into the D-cover when the whip is fully retracted.
