**Nokia Customer Care
6265/6265i/6268 (RM-66)
Mobile Terminals**

**Antenna Description and
Troubleshooting**

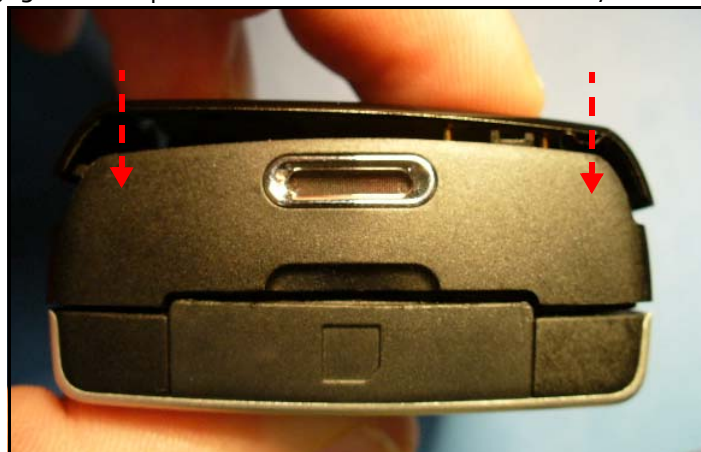
Figure 3: E-cover assembly installation

To re-install the E-cover assembly, align the E-cover above the D-cover and apply vertical force to engage the snap-in feature in the D-cover assembly, as shown.

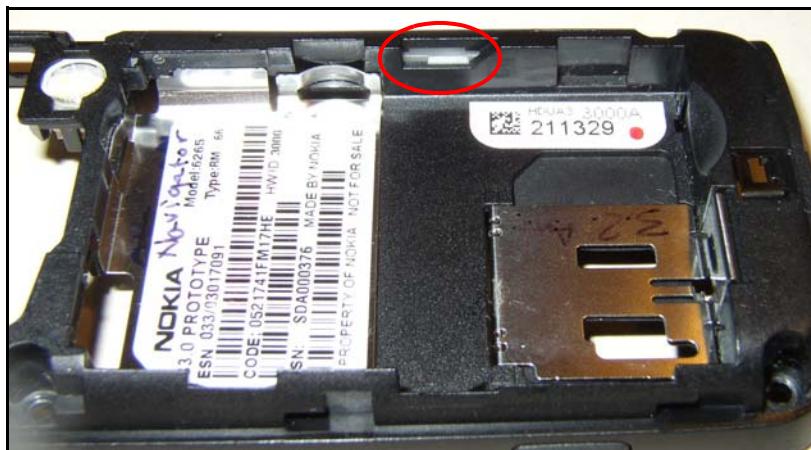
Figure 12: Outer catch inside D-cover

1. Release the outer catch of the in the D-cover hole that locks the BT antenna.

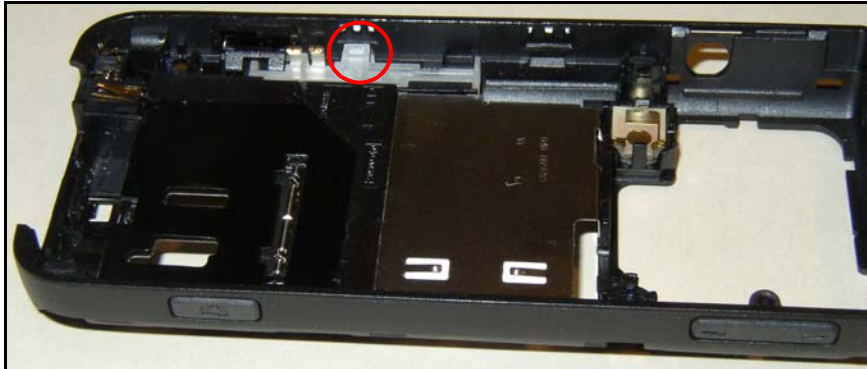
Figure 13: BT antenna inner catch inside D-cover

2. Release the inner catch inside the D-cover that locks the BT antenna and the outer catch. The spring contacts that feed the BT antenna are located to the left of the catch.

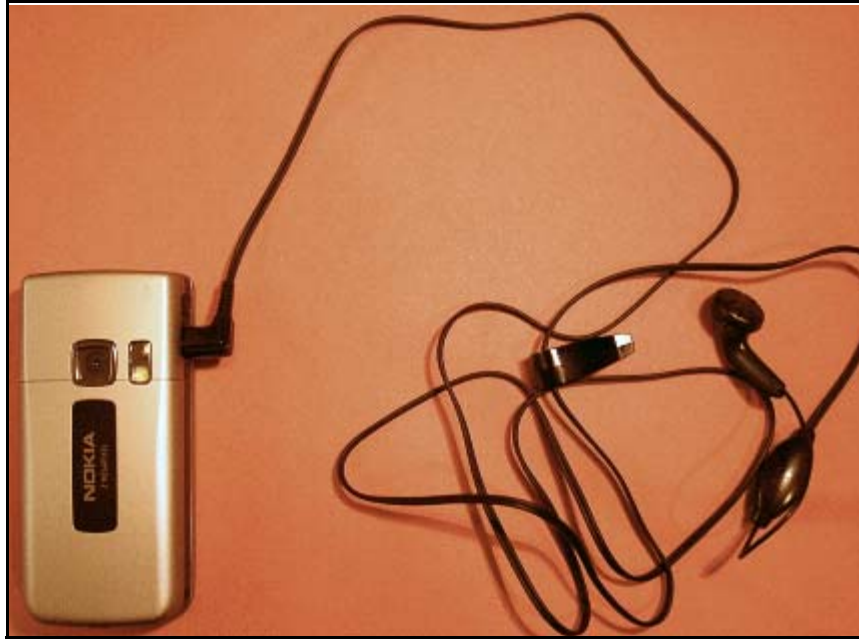
Figure 17: FM antenna - Universal Headset Jack (UHJ) connector

FM antenna formed by connecting a headset to the Universal Headset Jack (UHJ).

The FM antenna uses the connection through a headset and the Universal Headset Jack or the Pop-port™ connector to create an FM antenna of reasonable gain. The RF test points are on the front of the main PWB at the bottom right side, near the end of the Pop-port™ connector (on the opposite side of the PWB.) There are antenna impedance matching chip components on the main PWB.

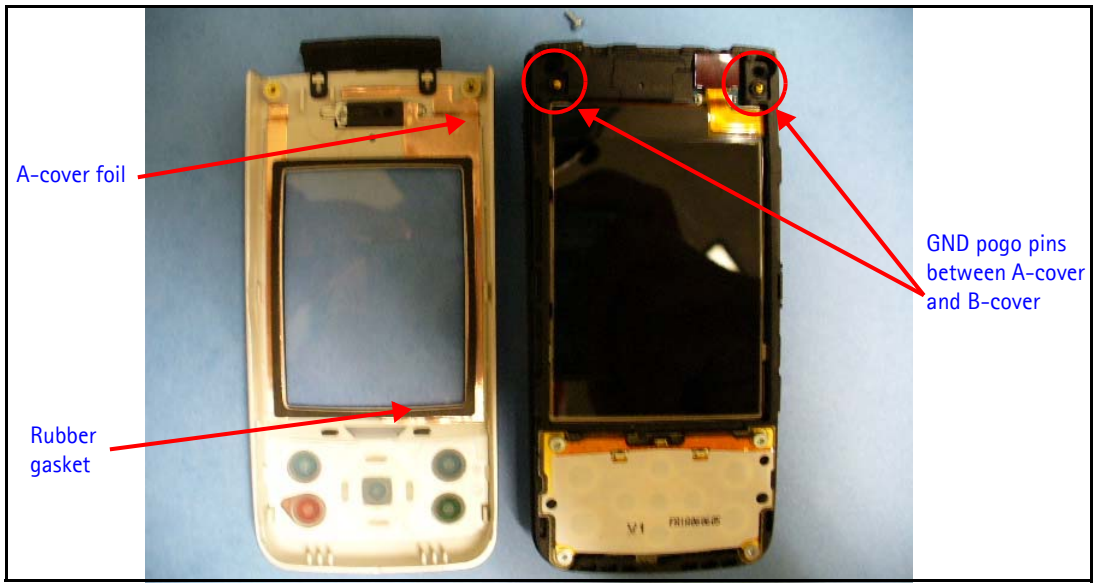
Figure 24: A-cover foil and GND pogo pins

A copper foil is glued inside the A-cover. It is grounded to the B-cover (slide mechanism) by 2 pogo pins pressed into the LCD frame. The foil is partially covered by a rubber gasket that is sandwiched between the A-cover and the LCD when assembled.

- If the A-cover foil is damaged (cut, scratched, corroded), replace the A-cover assembly.
