TechInfo Sheet

Product Group: Hi-Fi Audio

Model: CR20 (CD Changer mechanism)

Subject: Disc spacer comes off

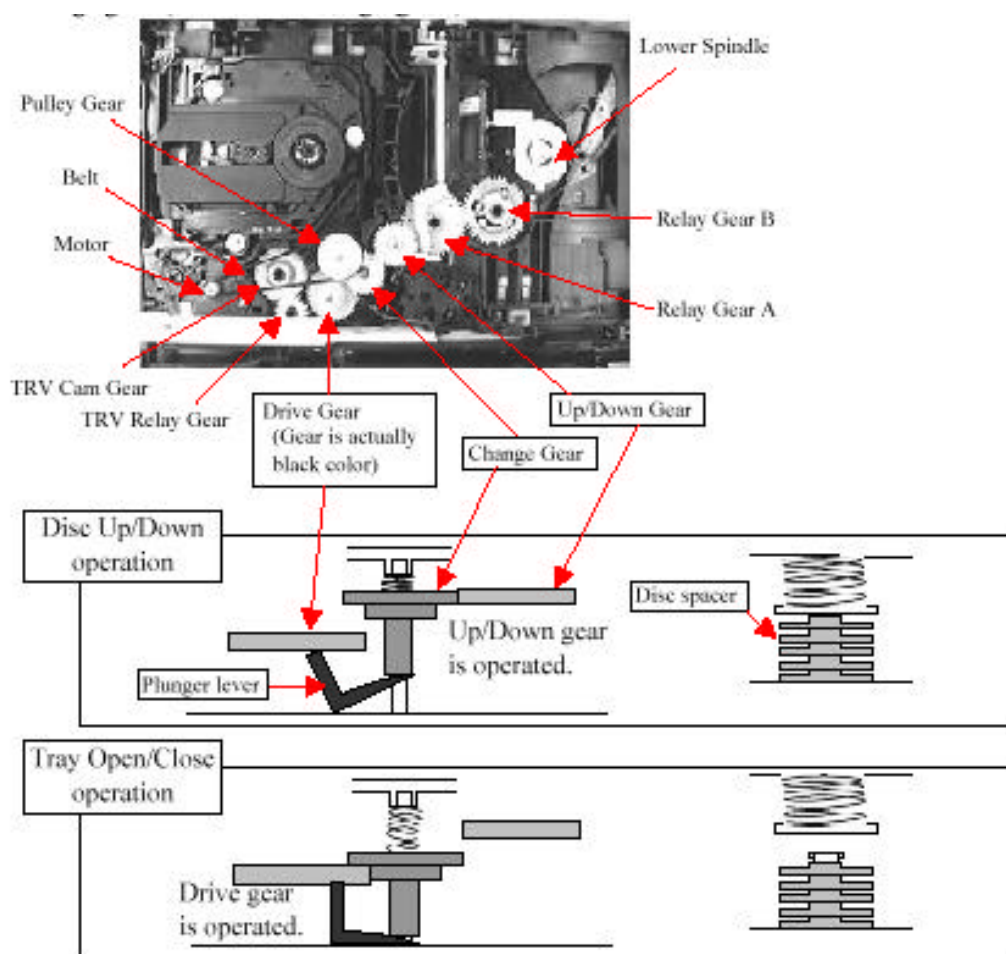
Symptom: The Disc spacer coming off affects other mechanical operations.

Cause: This mechanism controls the switching of Disc Up/Down and Tray Open/Close operation using the Change gear. (Refer to following diagrams)
If the Change gear does not drop down due to tight engaging between the Change gear and Drive gear when switching to Tray open/close operation, the disc spacer will come off.

Remedy: Replace the Change gear spring to a stronger one.

Original	New
RMB0549	RMB0549-1
