Model: Iris/Lilac/Cattleya Platen Cover		Date: 24-Oct-01	No.: RA749001
Subject: Platen Cover Hinge		Prepared by: M. Tsuyuki	
From: Technical Services Dept., GTS Division			
Classification:	<input type="checkbox"/> Troubleshooting	<input type="checkbox"/> Part information	<input checked="" type="checkbox"/> Action required
	<input type="checkbox"/> Mechanical	<input type="checkbox"/> Electrical	<input type="checkbox"/> Service manual revision
	<input type="checkbox"/> Paper path	<input type="checkbox"/> Transmit/receive	<input type="checkbox"/> Retrofit information
	<input type="checkbox"/> Other ()

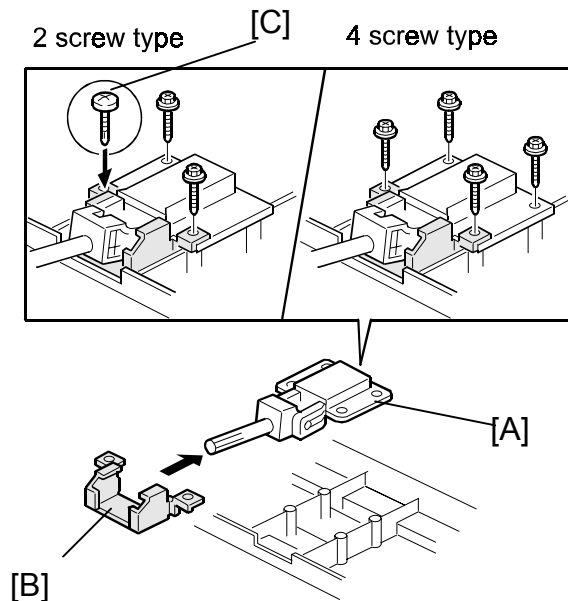
When the platen cover is opened and/or closed, the hinge of the cover breaks and a hinge fragment may hit the user's face.

1. Remove the platen cover hinge [A].
2. Attach the cover [B] to the platen cover hinge as shown.
3. Re-install the hinge with the cover.

If the platen cover hinge has two screw holes, use the self-tapping screw [C] packed together with the cover.

Install the cover for the platen cover hinge as shown at the next service visit (P/N A7499451).

The cover has been added to the hinge and the hinge has been further strengthened from August 2001 production.
