ZPV display repair and modification.

By F5RCT STRICKER Jean-Matthieu

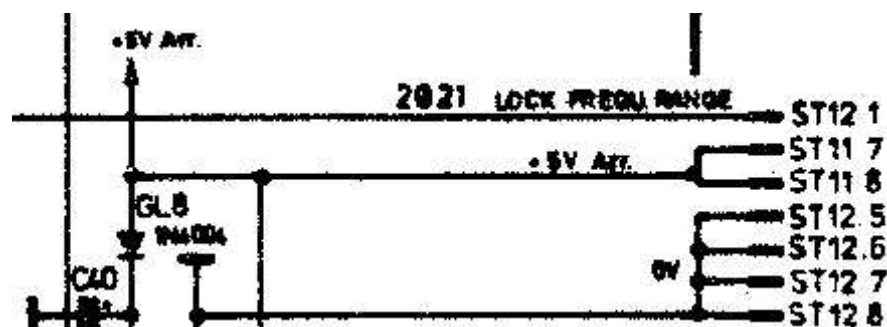
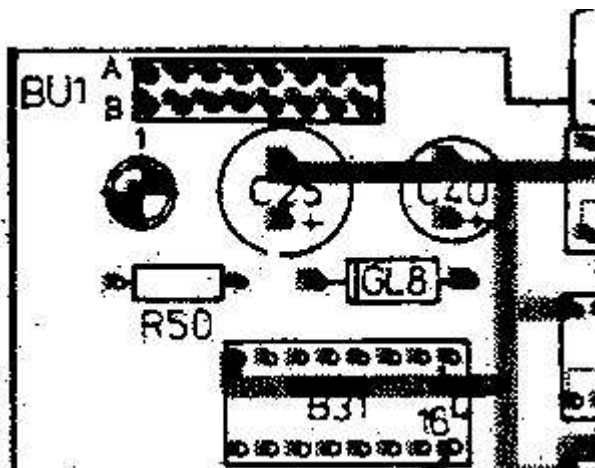
One weak point of the ZPV are the digits LED displays TIL311.
With ageing, and heating, they become defective.

To increase a little the life and reduce heat dissipation, a silicon diode GL8 has been inserted on the +5V power supply of displays.

By inserting a 1A Schottky diode in series with the existing silicon diode it will reduce the voltage by 0.3V to 0.4V without affecting the brightness.
This diode is located at the left up corner of the front panel board.
