SERVICE BULLETIN

PRODUCT: Computer Monitor
BULLETIN: MON00-003
MODEL: DP17LT, DP17LS

SUBJECT: Bright Back Raster with Retrace Lines

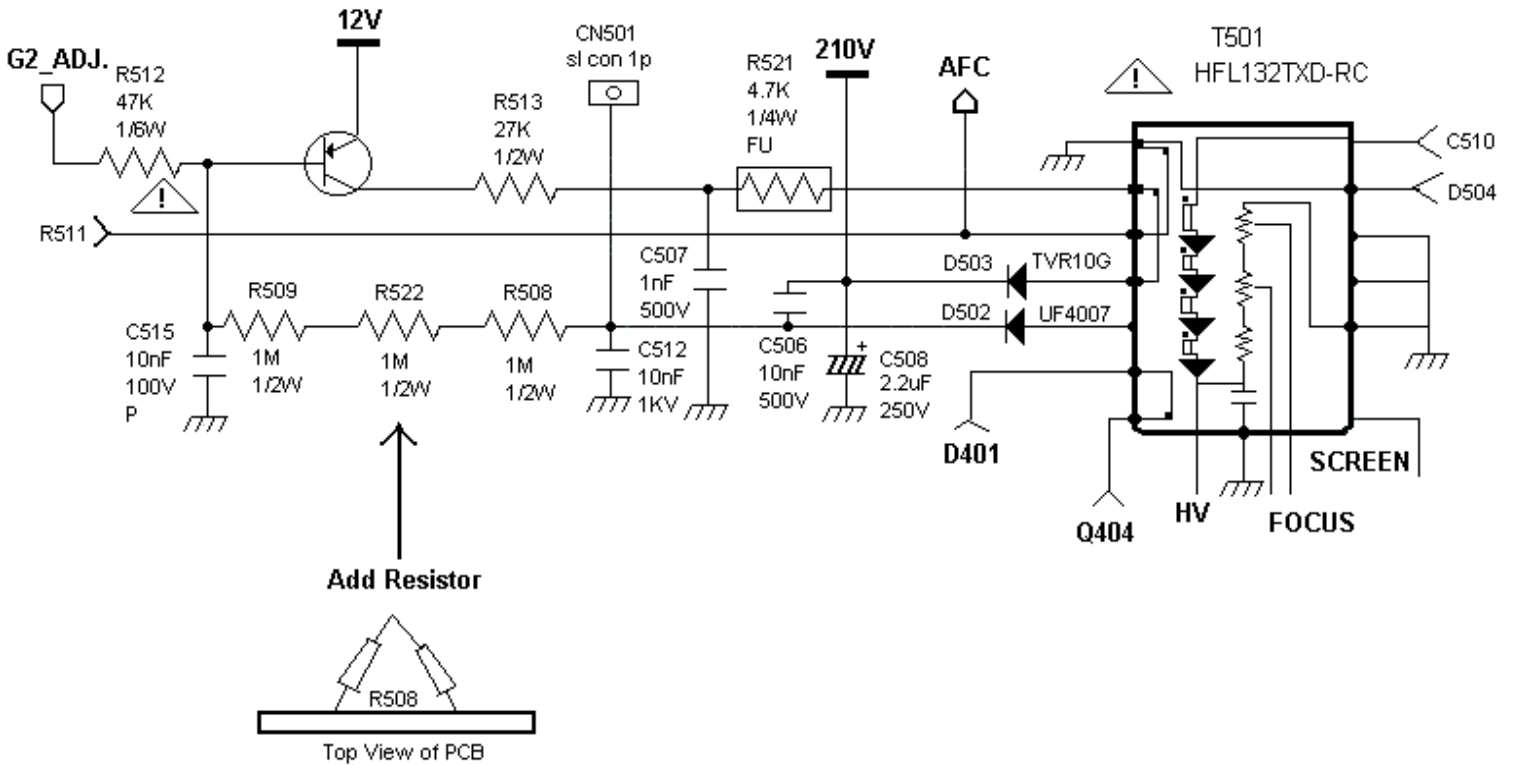
Circuit Diagram

BACKGROUND: Due to a high current draw from the fly-back transformer, resistors R508 or R509 may open. This will cause maximum brightness with retrace lines on the display.

SOLUTION: Remove 1.5M resistors R508 and R509. Replace R509 with a 1M-ohm ½ watt resistor. Replace R508 with a 1M-ohm ½ watt resistor. Also, add a 1M-ohm ½ watt resistor in series with R508. Designate the added resistor as R522. See diagram on page 2.
