| Product : CRT monitor | Bulletin No : 02-C/M-E0080 |
| Model : PN22N* (SM1200NF) | Bulletin Date : Aug.26,2002 |

SUBJECT : 1200NF duplex operation when power button off & on.

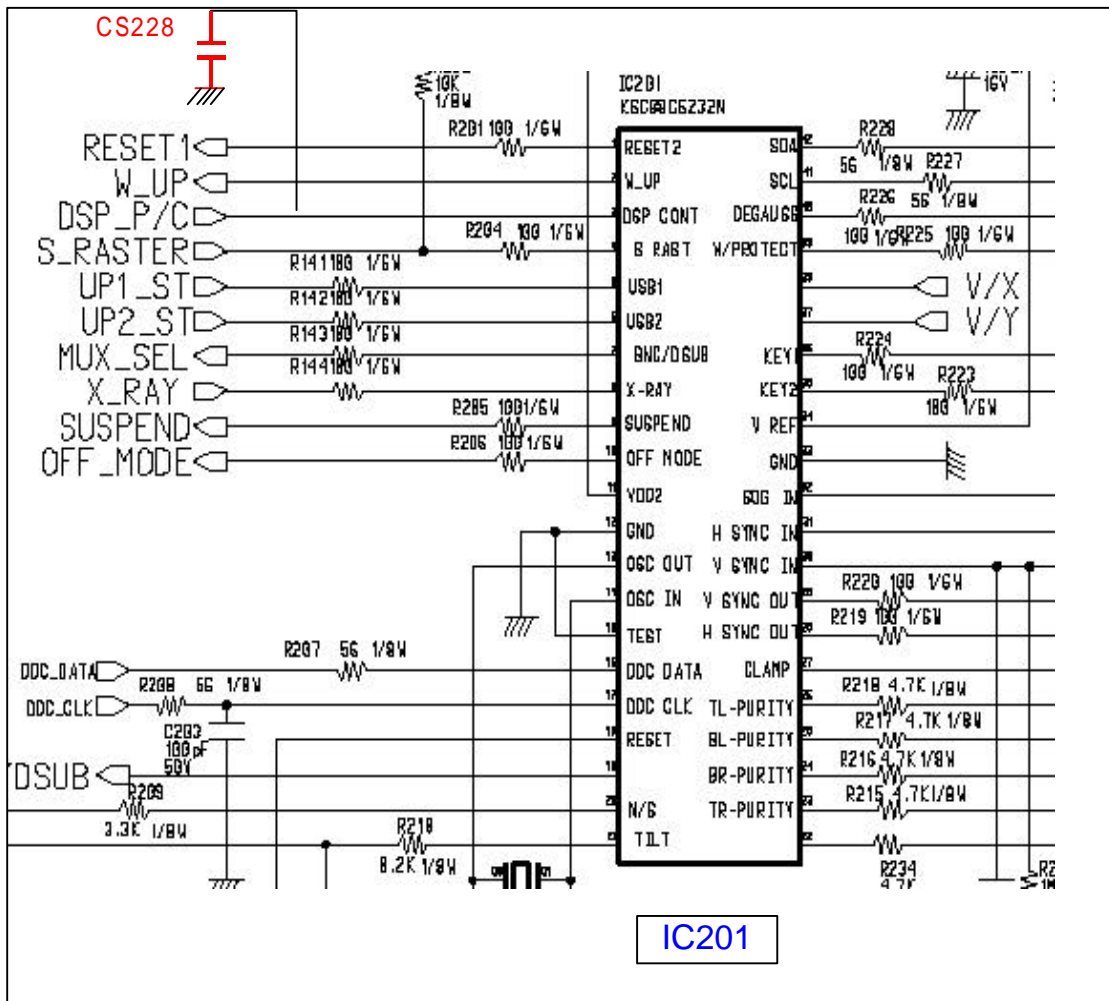
Schematic Diagram

Root cause : Miss matching between Cg Control Board and Micom IC
(Generates abnormal pulse => cause Micom wrong operation)

Solution Change CS228 ceramic condensor as below specification.(Reduce abnormal pulse)
Samsung applied this countermeasure from Aug.20.2002

| Location No. | OLD (before) Parts | | NEW (changed) Parts | | * I.C | |
|---|---|---|---|---|---|---|
| CS228 | 2305-000665 | C- FILM,MPEF;100nF,5%,63V | 2305-000412 | C- FILM,MPEF;470nF,5%,63V | | |
