Product : CRT monitor	Bulletin No : 02-C/M-E0081
Model : AQ19L,AQ19J*	Bulletin Date : Aug.28,2002
	ECN Date : Aug.28,2002

SUBJECT : Before service to prevent touch PCB pattern and metal guide

Model name : AQ19L* / AQ19J*

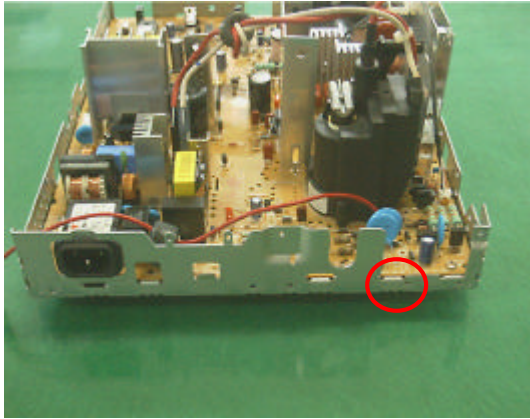
Main PBA

Background : The 540V PCB pattern can touch with metal chassis guide part although pattern covered with protection paint.
 In this case cause some parts failure (R513/R570)
 Problem range : PCB ver MP 1.2 ~ MP 1.4 (Production: Oct.2001 ~ Aug.2002)
Permanent solution : Change PCB pattern from ver 1.4 to ver 1.5 (Sep.2002~)

Solution Do "+1" service for all returned units if its PCB ver is MP1.2 ~ MP1.4.
 Bend metal guide to prevent touch with PCB pattern.
 Refer to additional information for detail work instruction.
