SERVICE BULLETIN

Product:	:LCD monitor	Bulletin No.	:	02-C/M-E0069

Model : GH17L,GH17E,GH17V~ (exclude GH17P) **Bulletin Date :** 06-May-02

SUBJECT: Before service to prevent Inverter failure problem.

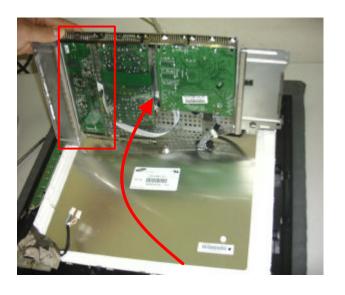
Check inverter whether its part number is BN44-00064A or not (-41A,29A,60A)

In case of 64A, then check the tape color which around trans.

- -. Blue color => Replace with service inverter (BN44-00041A)
- -. Yellow or Green Color => Do not need to replace.

(Improved version)

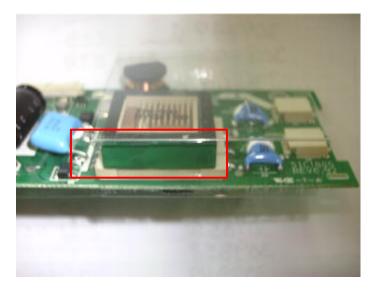
BN44-00064A INVERTER (IMPROVED VERSION)
Yellow or geen tape => Do not need to replace.

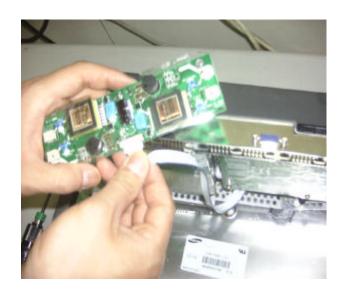
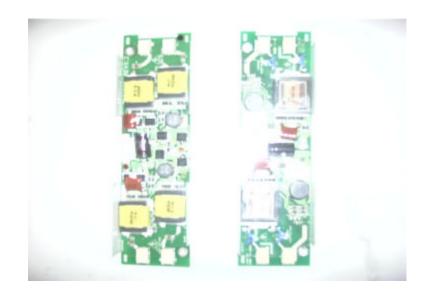
BN44-00041A (4 Trans) BN44-00064A (2 Trans)

Replace inverter carefully.
