SERVICE BULLETIN

Bulletin #: DLP03-004

Subject: Squealing noise comes from set, near optical engine area.

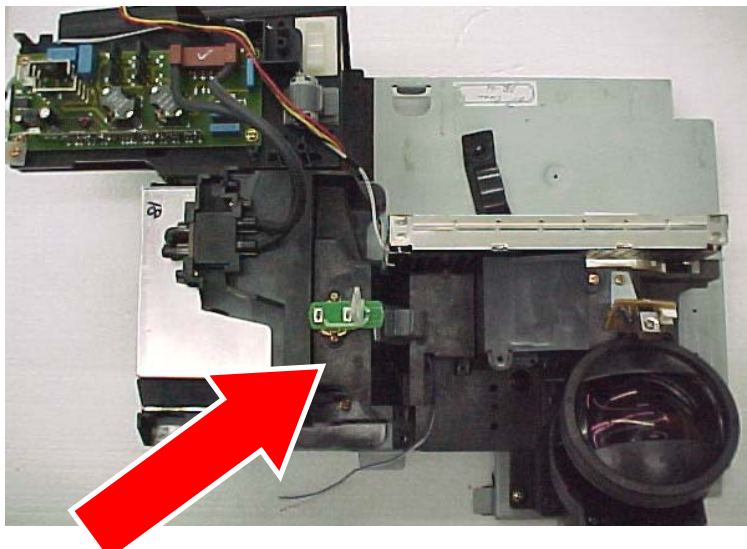
Remove Cover

Solution: Replace color wheel. Part # BP96-00250A

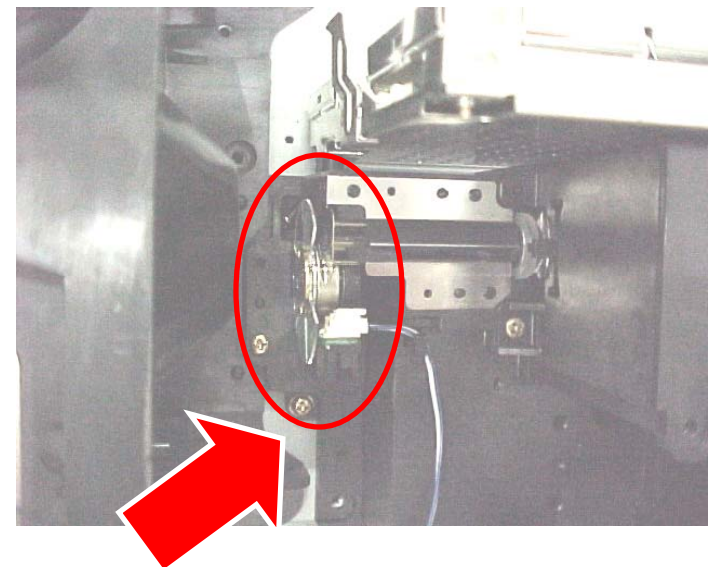
Remove Color Wheel
