# Car Stereo Service Bulletin

**Model:** XR-210A/6150

**No.** 109

**Subject:** Error In Schematic Diagram

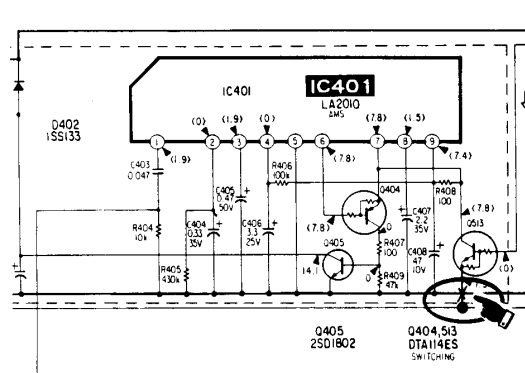
The emitter of Q513 (DTA114ES) should not be connected to ground.

The proper connection is to the anode of D526 and S902.  
Please correct your service manuals.
